Differentiation of Water Sources using Analytical Water Chemistry Data

Derek Morris, John Bryant CPG-9926, and Michael Gehrig

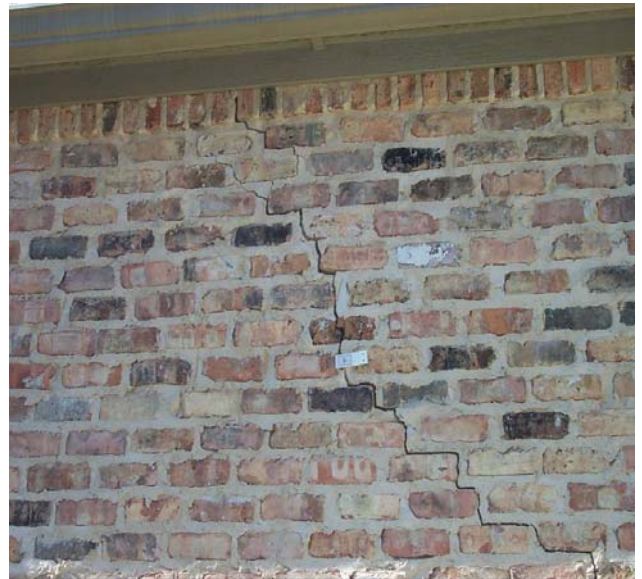
The first case history shows a house that had developed diagonal cracking, as shown in Figure 1, to an extent that remedial repairs were being contemplated. The foundation was being adversely affected by a noticeable heave in one corner of the slab foundation, as shown on Figure 2. A number of things could have been responsible for this

In this locality, drinking water was artificially fluoridated, so that the presence of fluorides, the naturally occurring form of fluorine, excludes rainwater as the sole source of the ground water mound. Likewise the very low levels of chlorine largely excluded a leak in the pool liner (although chlorine levels will dissipate with time and therefore distance, so that this observation is less conclusive at large distances from a pool). Total dissolved solids were reasonably high, as were chlorides and alkalinity (higher than the water supply), which would be consistent with either groundwater or a substantial travel path of mains water through soils. Resistivity was also lower than either pool or tap water, indicating prolonged contact with fine-grained soils; and the pH was a little less than mains water, indicating some possible mixing with rainwater (which is almost always more acid than groundwater).

In this case, it was recommended that the domestic water lines be tested, and a slow leak was found a short distance away, but linked to the ground water mound by the plumbing trench. Expansive clay soils were also found to be present under the relevant corner of the house, which had evidently been activated by the additional water. Since this eventuality was covered by the homeowner’s insurance policy (including the cost of foundation and structural repairs), the client was unusually pleased with the outcome of this investigation.

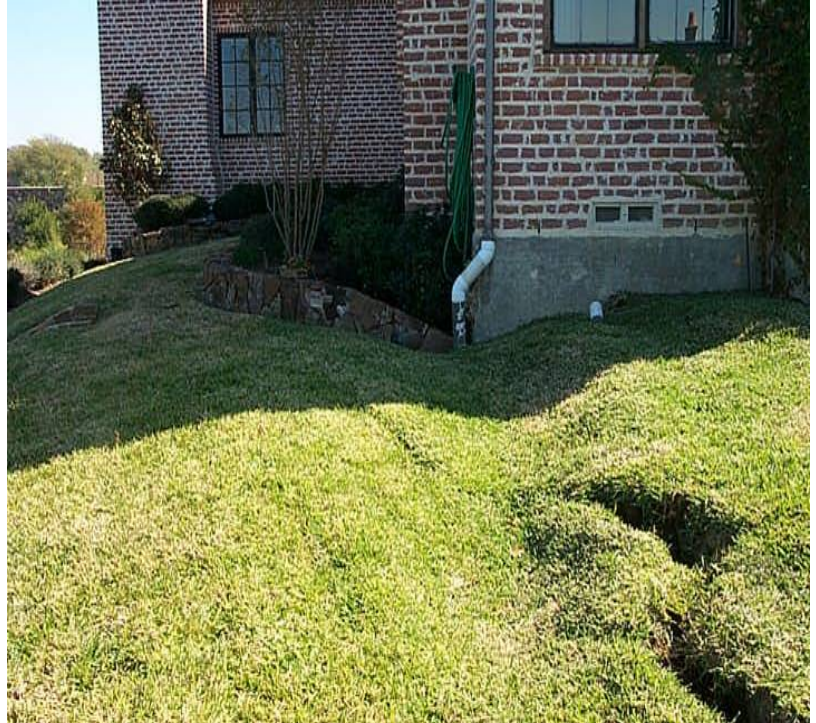
In this example, a multi-million dollar house was being threatened by a landslide that intersected the front part of the foundations. This property faced a lake that had been privately constructed, and shortly after construction an incipient slope failure had started to develop, essentially consisting of a rotational failure surface sliding into the lake.

Figure 3 shows one side of this, extending underneath the side of the house facing the lake. At this time, cumulative movements were about 0.3 m (1 ft.), and inclinometer measurements showed that the displacements were increasing at the rate of several mm. per month, accelerating during wet periods. Because the house was actually supported on substantial concrete piers, the structure appeared intact, with no evident distress in the form of cracking or floor slab dis-elevations. There was also a pool present, although this had been constructed separately and the shell appeared intact. Water chemistry data from two boreholes drilled on the site gave the following results:

Sampled groundwater showed calcium concentrations much higher than water supply values, which tended to exclude a rainwater source. Sodium and chloride levels were lower than the water supply, which probably excluded line leaks, but implies that any groundwater would be freely flowing without spending considerable residual time in the ground. Fluorides were present, but again below tap water values, and were therefore

probably picked up primarily from the soil mineralogy. No chlorine was detected, therefore no nearby tap water. Hardness and Dissolved Solids much higher than reference, also implying a groundwater source. The pH was low, which would normally correlate to a rainwater source, but in this case one of the local water supplies also provided somewhat acidic water, so that this observation was inconclusive - however it did imply that any detention times in the ground must have been reasonably short.

Overall, these results indicated a groundwater source, but one that originated not very far away, and was reasonably freely flowing with short transit times in the subsoil.

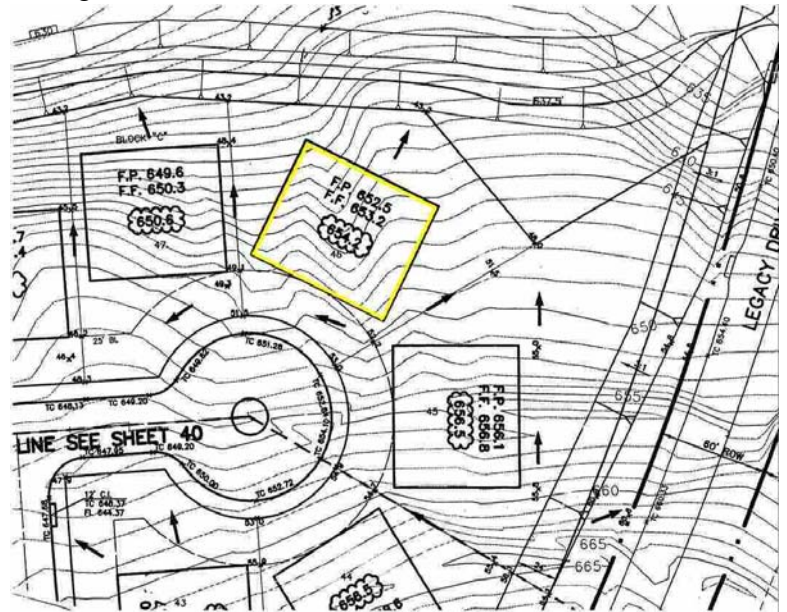
Subsequent study of the original ground contours from the grading plans revealed a historic drainage gully through the site, as shown on the adjacent Figure 4. This almost certainly acted as a short underground aquifer conducting a certain proportion of the uphill runoff underneath the property. The significance of this observation in this case, was that the responsibility then transferred from the homebuilder to the site developer, who had been responsible for the infilling of the original site contours (probably with poor quality fill from the site of the present-day lakebed), and the matter was then referred to legal counsel for adjudication.

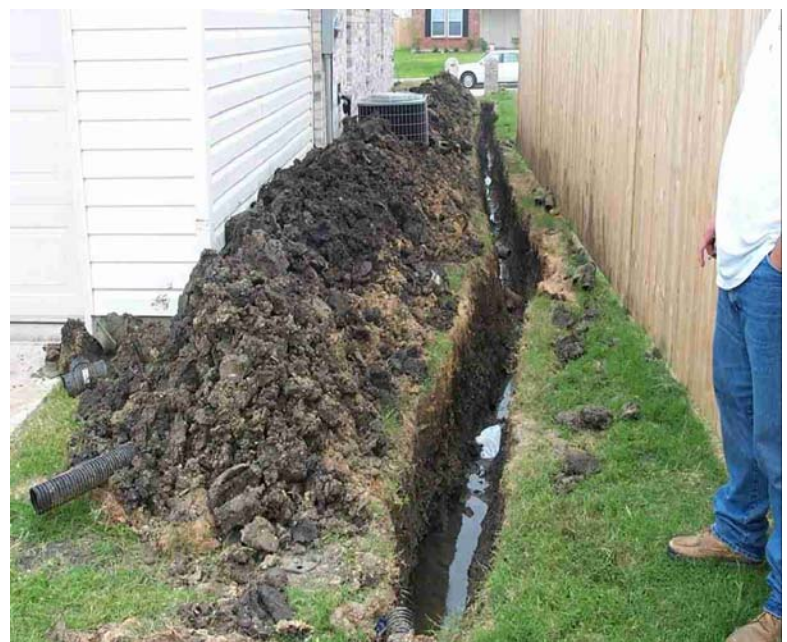
The third case history involved a developer that had a problem with recurring wetness in a new development. This was evident every time utility trenches were laid out, as can be seen from Figure 5. The question was whether this was simply due to unusual rainfall, or something more, like a water supply pipe, adverse roof guttering directing rainwater to the wrong places, groundwater or runoff from surface drainage. Again trace element concentration measurements were taken from the water in question, and the following results obtained:

In this instance, chlorine levels were below detection in both cases, so this parameter was inconclusive (there was no pool on the property anyway, so this could be excluded as a source). The pH measurements showed it to be significantly more alkaline than rainwater or even local tapwater, thereby excluding local rainwater as a possible source. Concentrations of calcium, sodium, chloride & fluoride were all higher than tap water, so these could really only have come from the soil mineralogy. Likewise levels of hardness, dissolved solids, and alkalinity were also significantly above either tap water or rainfall levels, which again implies substantial leaching through long distances in the soil, rather than short transport distances from surface run-off or water leaks. Further substantiation was shown by the conductivity which was much higher in the sampled water, consistent with considerable transport through permeable media

As a result, it appeared likely that the explanation was perched water seepage at this site, from subterranean sources. This was later addressed by further hydrogeological studies, which confirmed this assessment. As a result, responsibility could not be placed upon any individual homeowner or builder, and it became necessary to accept that subground seepage resulting in a high water table was simply a generic problem here.
