# Why Did It Fail?

David W. Fowler

CAEE Annual Alumni Ethics Seminar  
*Austin, Texas*

# The Big Dig

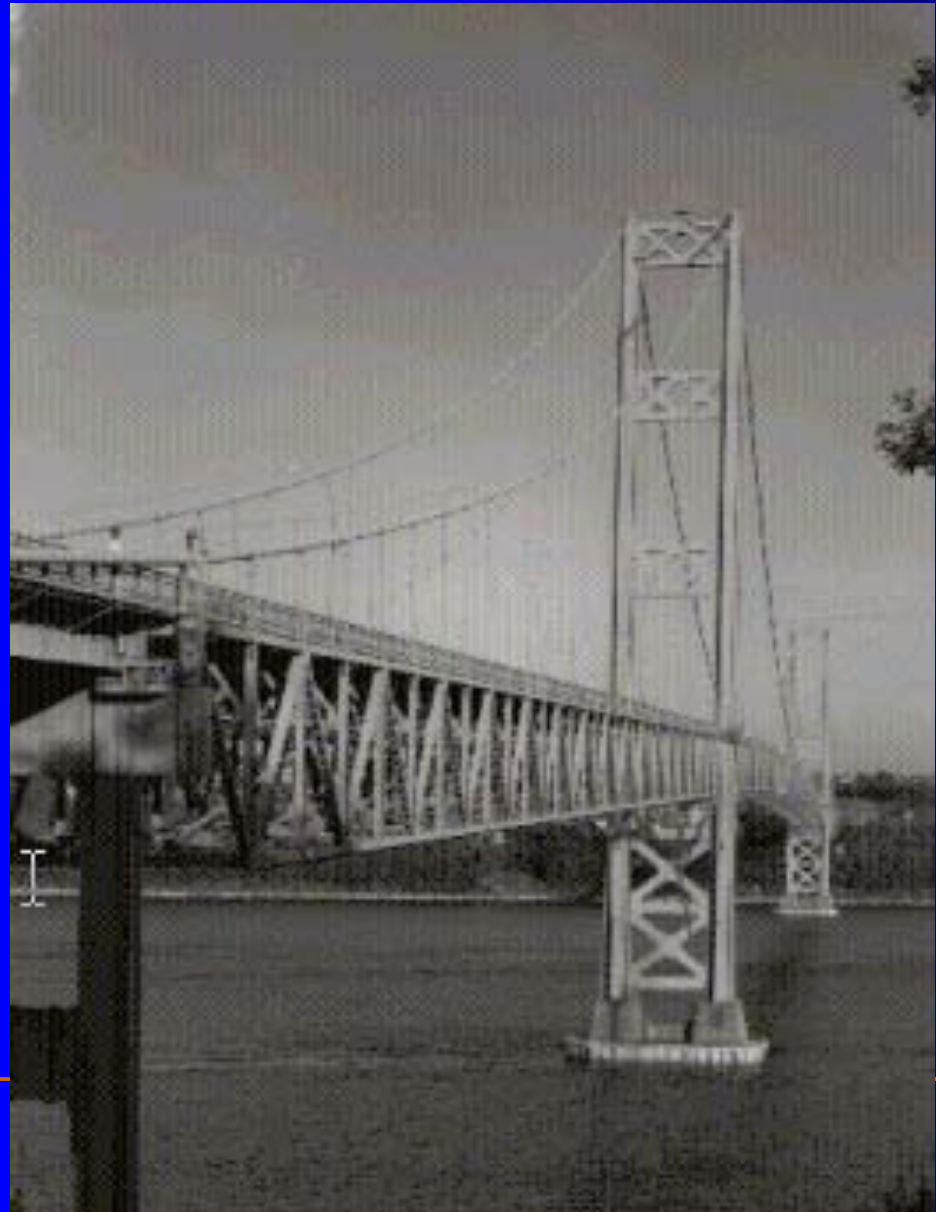
# Replacement Bridge (1950)

- Truss girders allow wind to pass through
- Torsional rigidity was increased
- Wind tunnel testing was performed to verify design

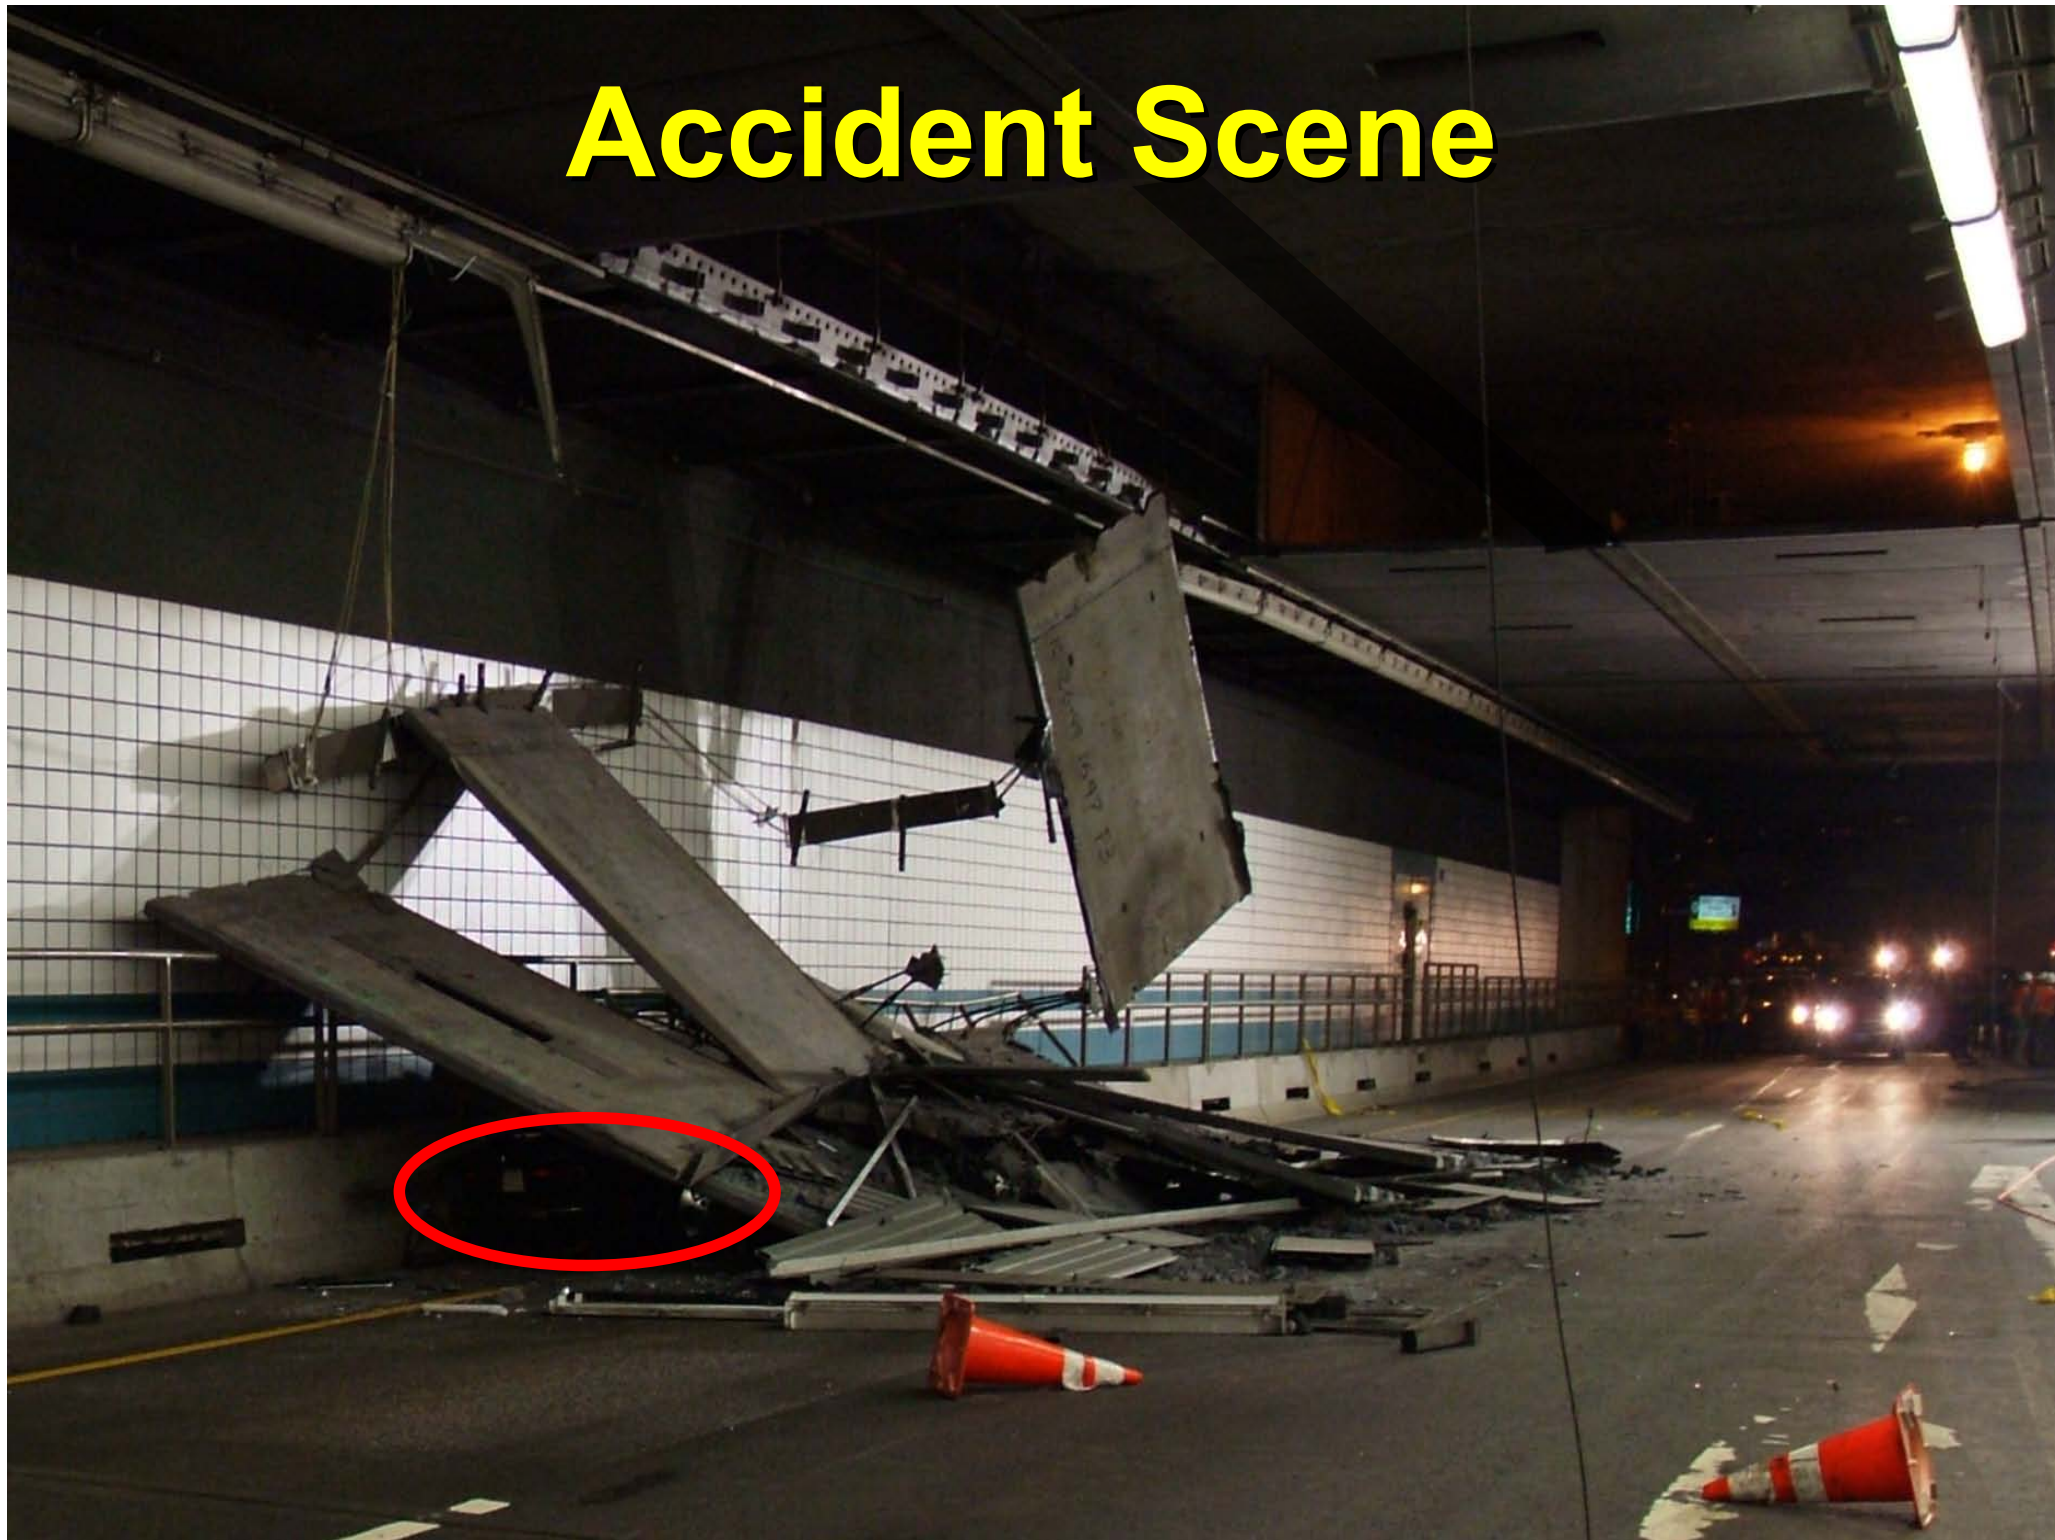
# Accident Scene

- 7/10/06, 11pm – A 1991 Buick occupied by a 46-year-old man and his 38-year-old wife was traveling east when a section of the tunnel's suspended roof collapsed.
- About 26 tons of concrete and structural framing members fell on the passenger side of car – killing the woman instantly.
- The driver escaped with minor injuries.

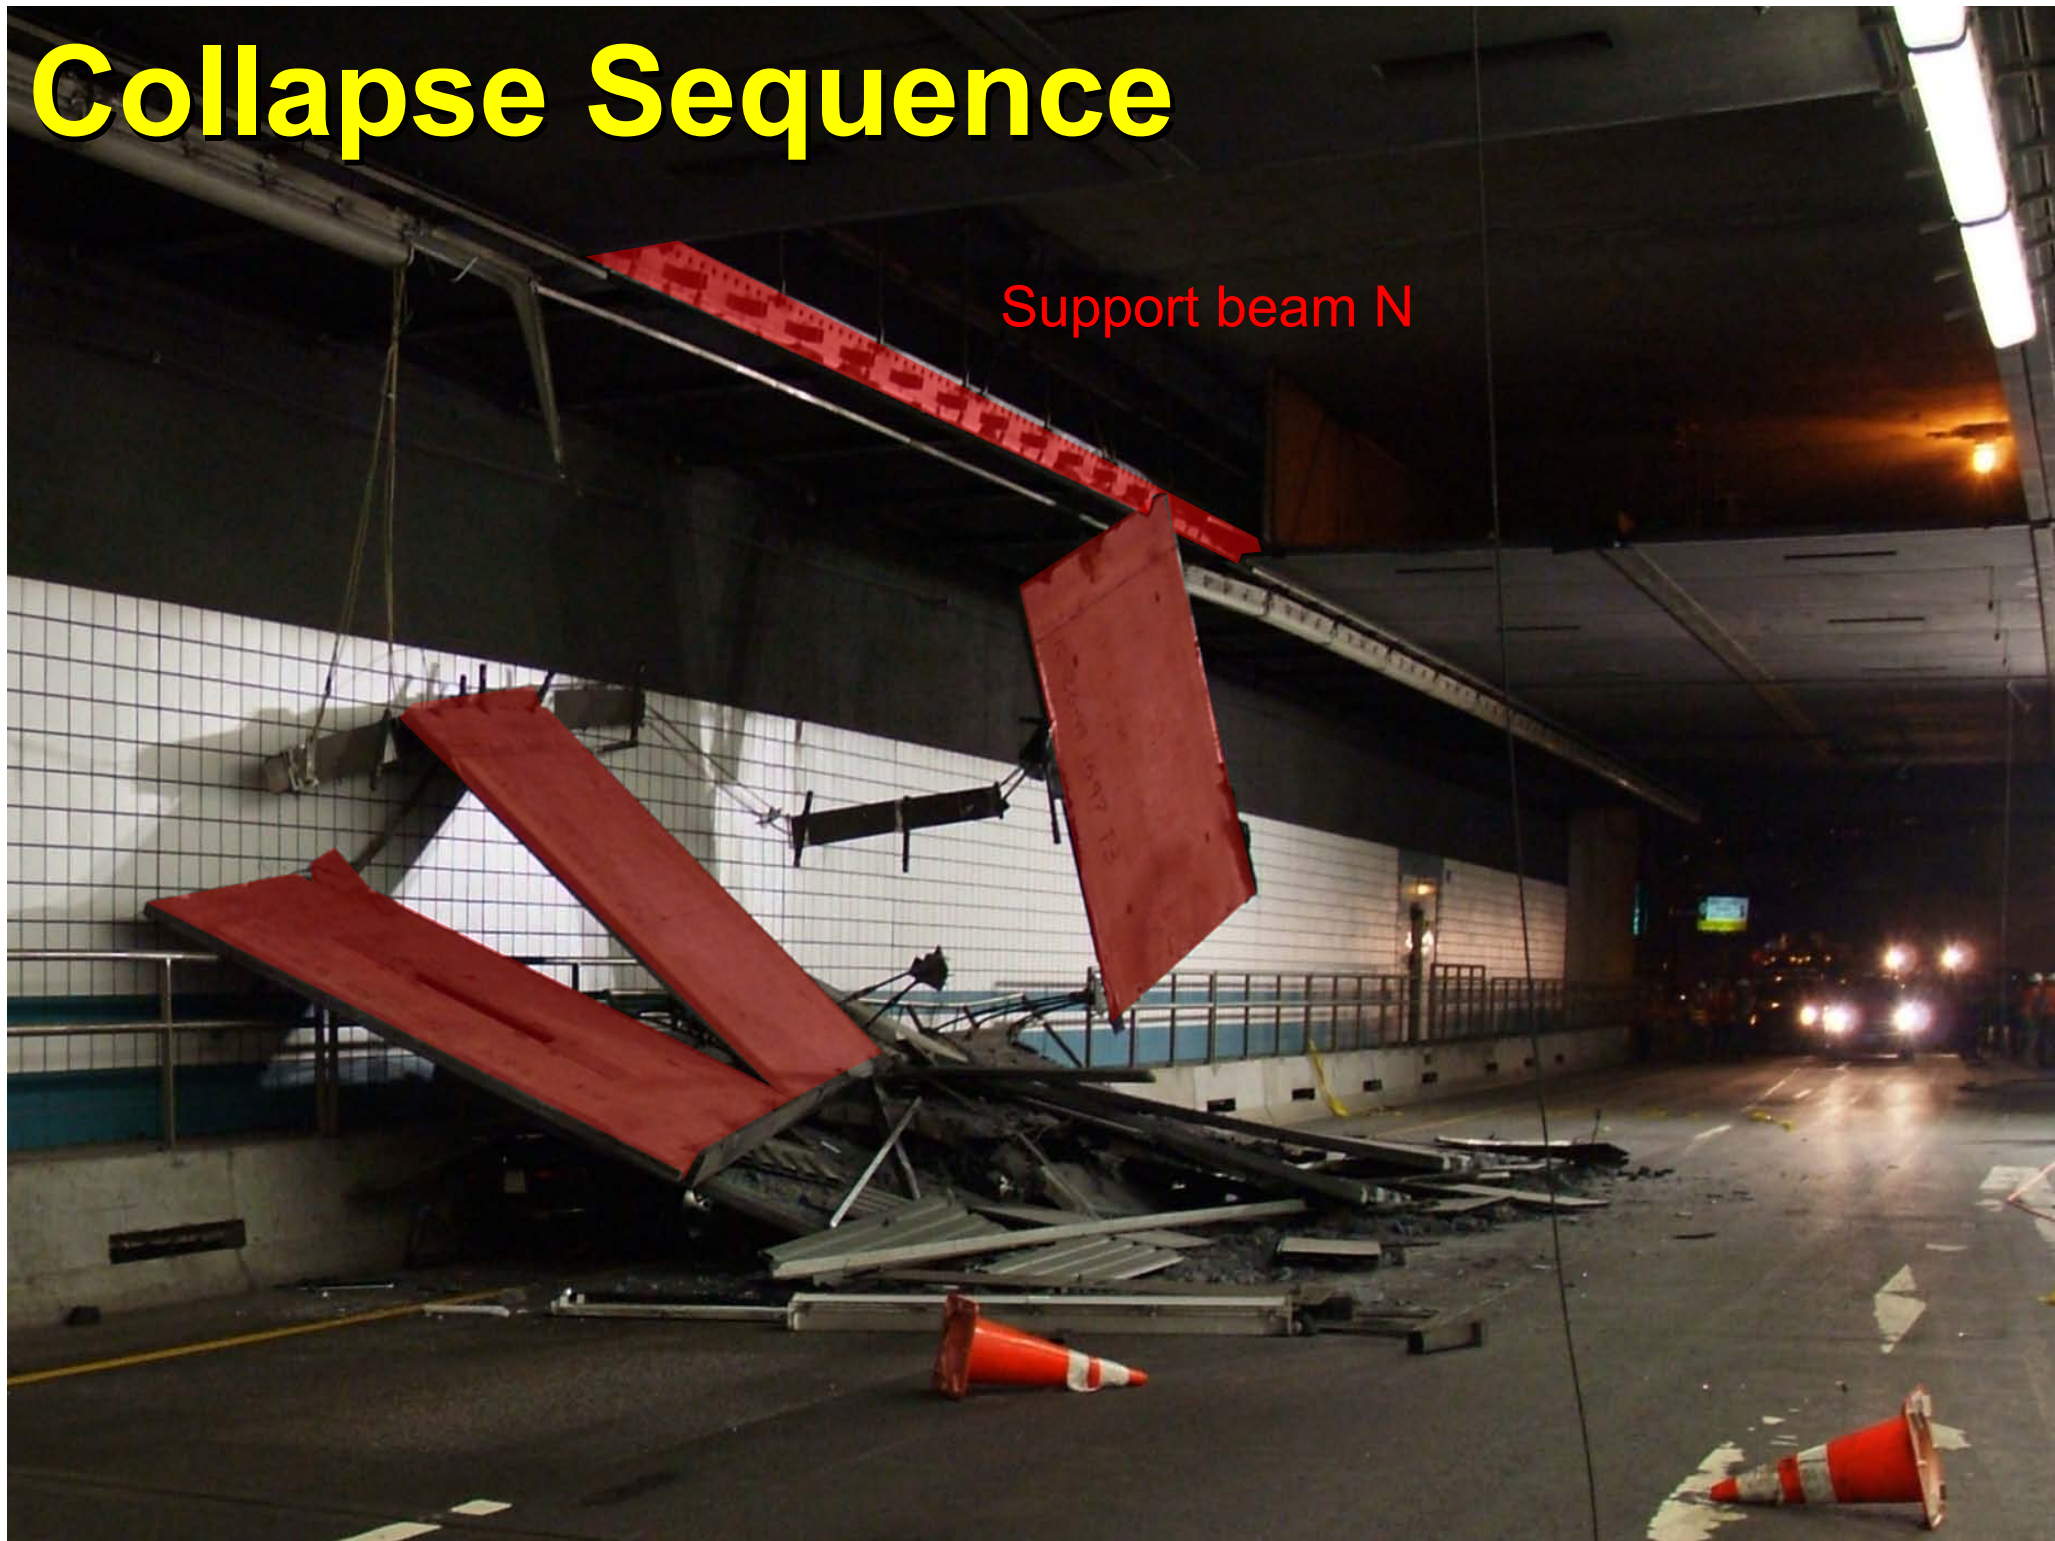
# Collapse Sequence

Support beam N

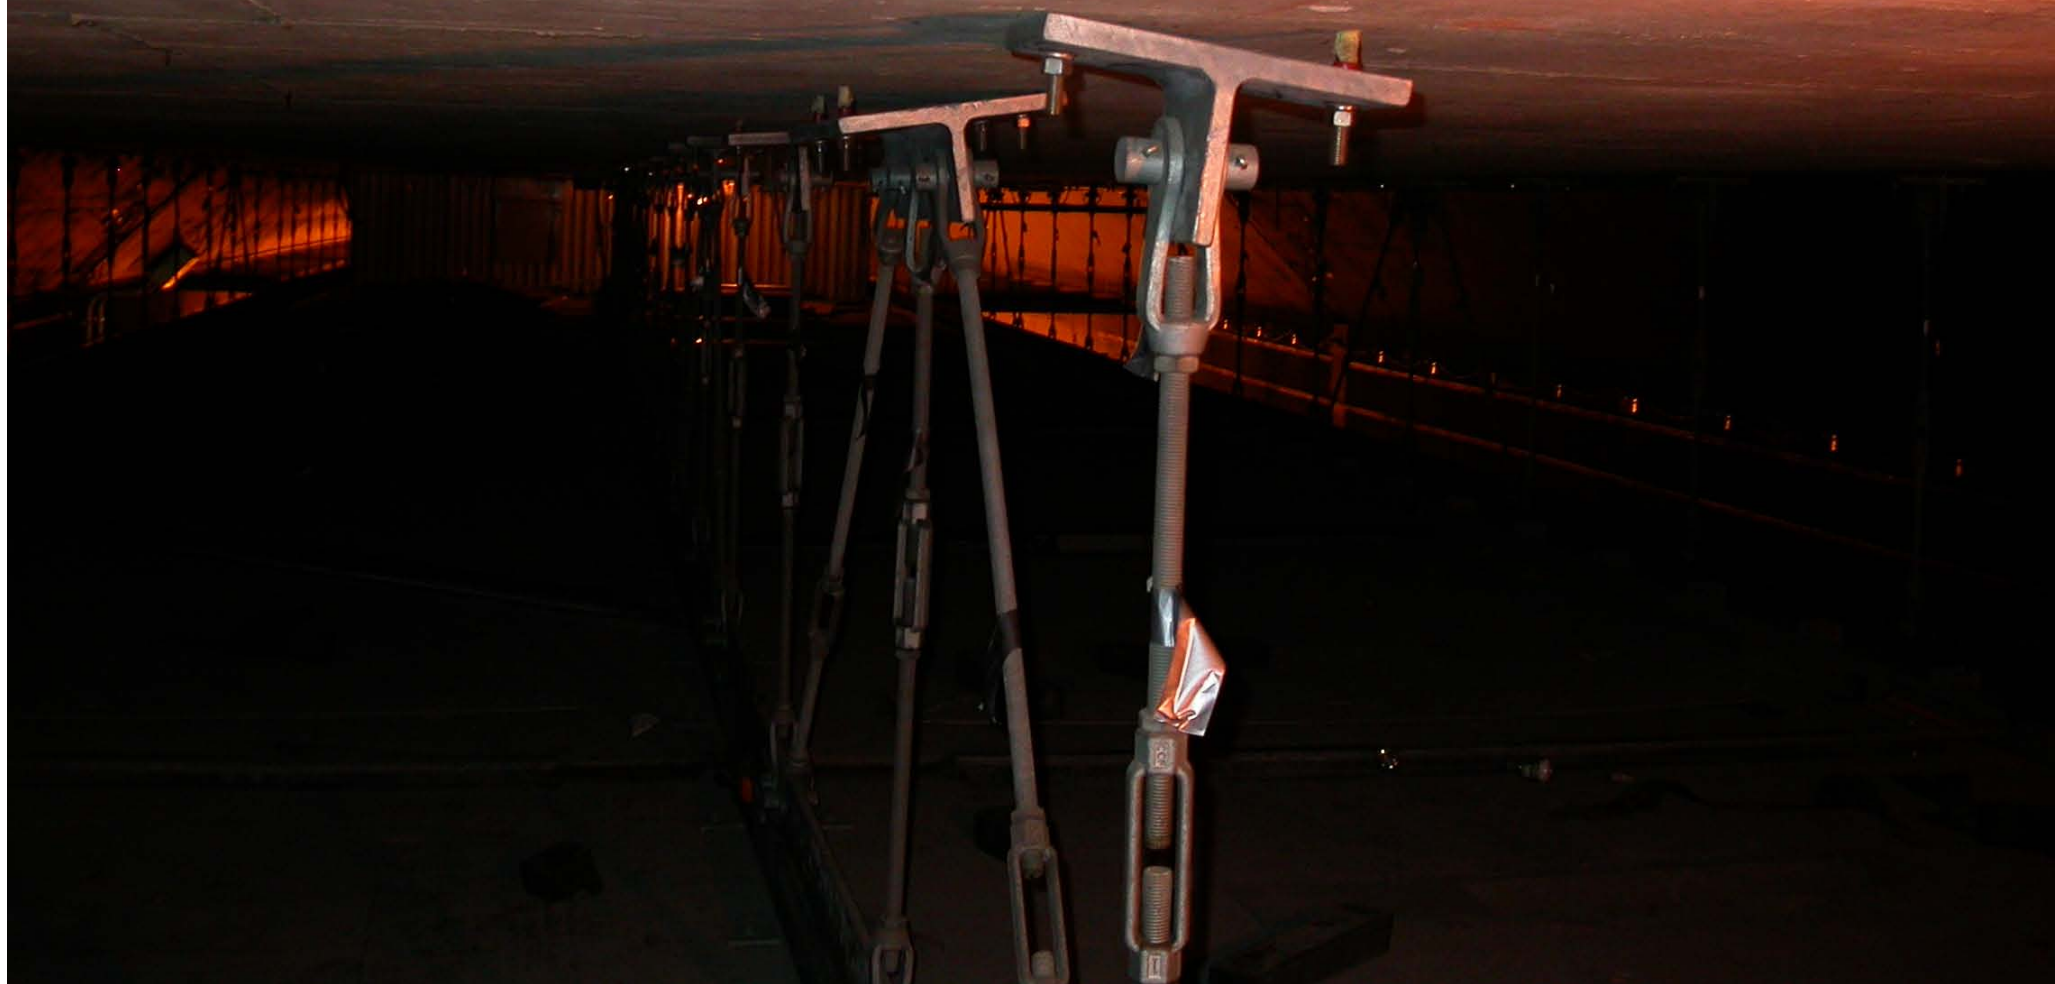
# **Displaced Anchors Found in Westbound Tunnel: Accident Waiting to Happen**

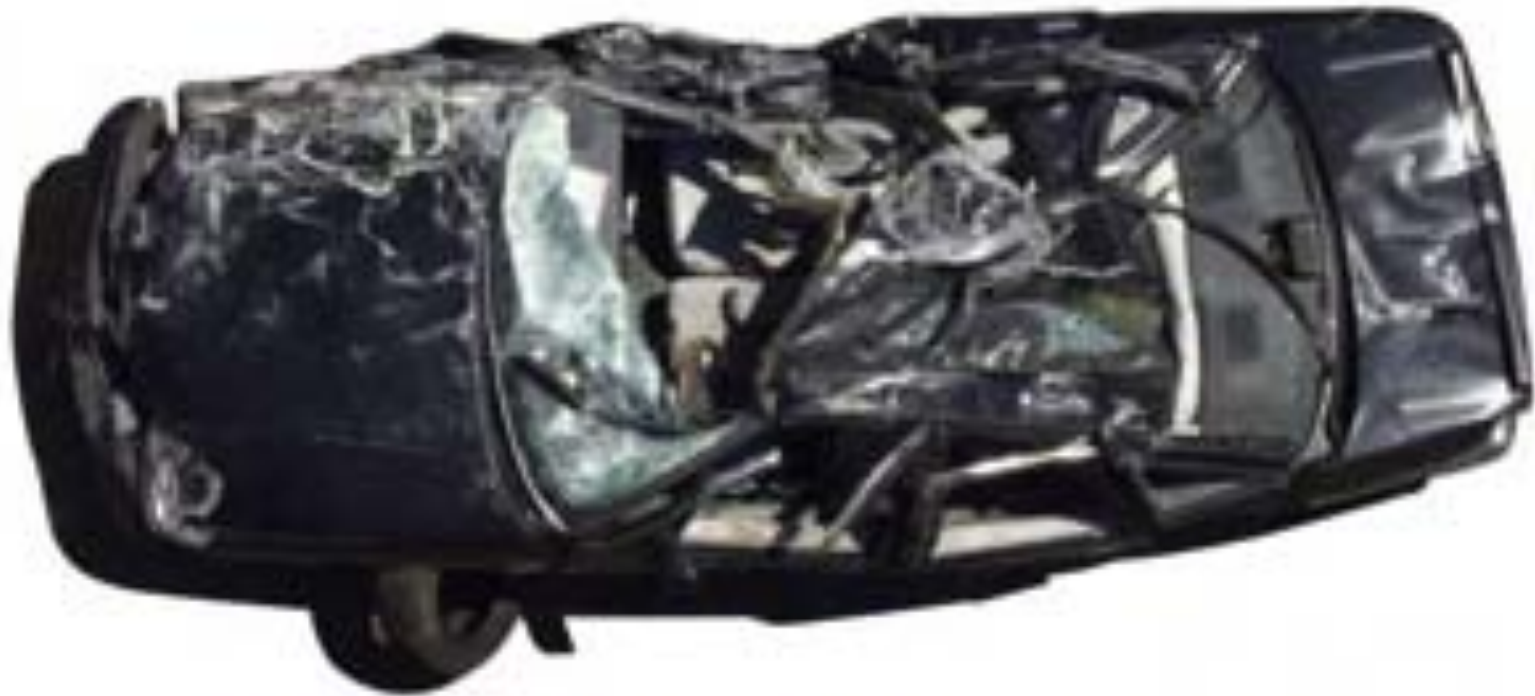
# Car Crushed by Ceiling Panel

The car that was crushed by falling ceiling panels, killing passenger Milena Del Valle in a Big Dig Tunnel in Boston.

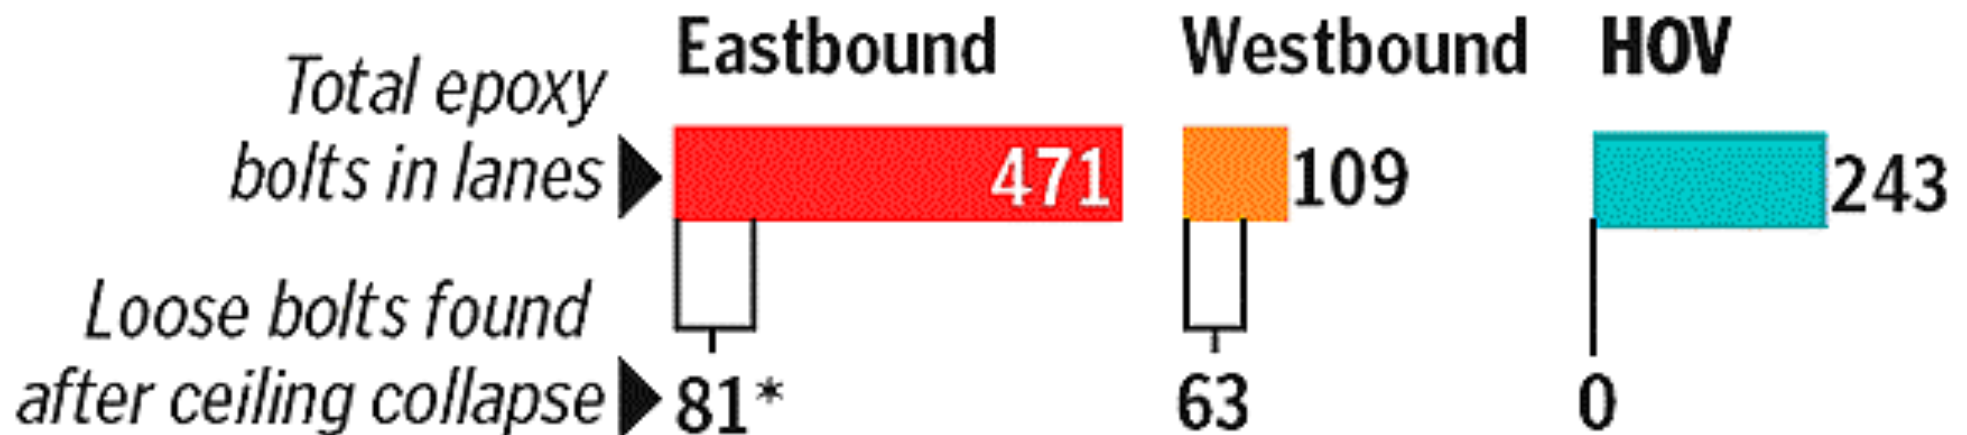
# Result of pull out tests

Bolts in the HOV lane were tested to hold 6,350 pounds, nearly twice the amount for bolts in the eastbound and westbound lanes.

\* Includes 20 that failed when ceiling collapsed

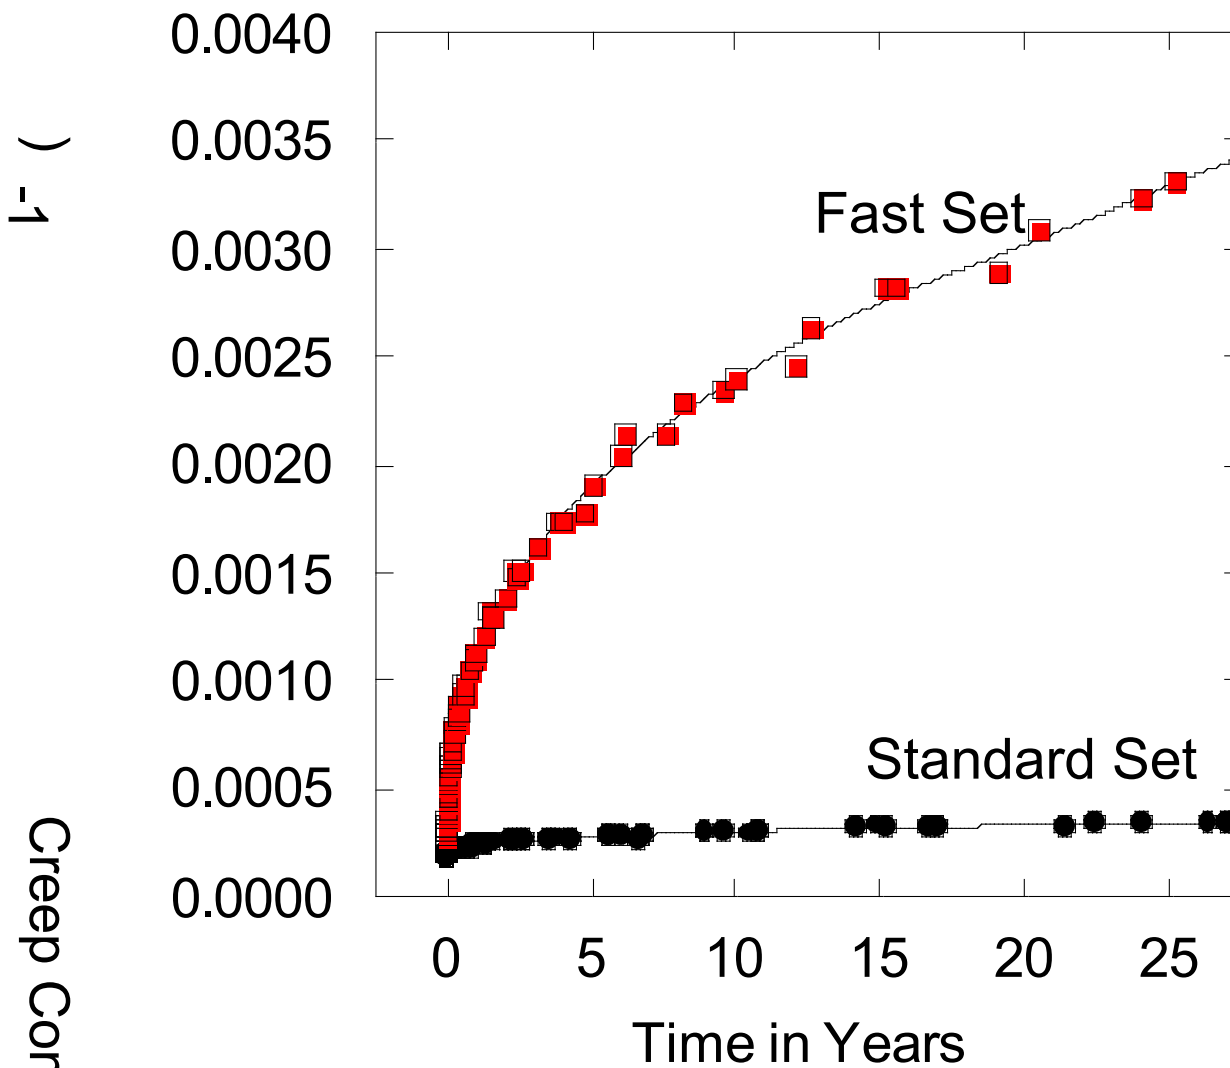
- Tests performed in 1995 and 1996 showed that Fast Set failed to meet the standard for creep, although the standard epoxy did.
- The manufacturer knew that this epoxy was being used in the tunnel, but **never communicated the potential problem** to the contractor nor even that the Fast Set was being used instead of the standard epoxy.

↑  
Increasing  
anchor  
displacement

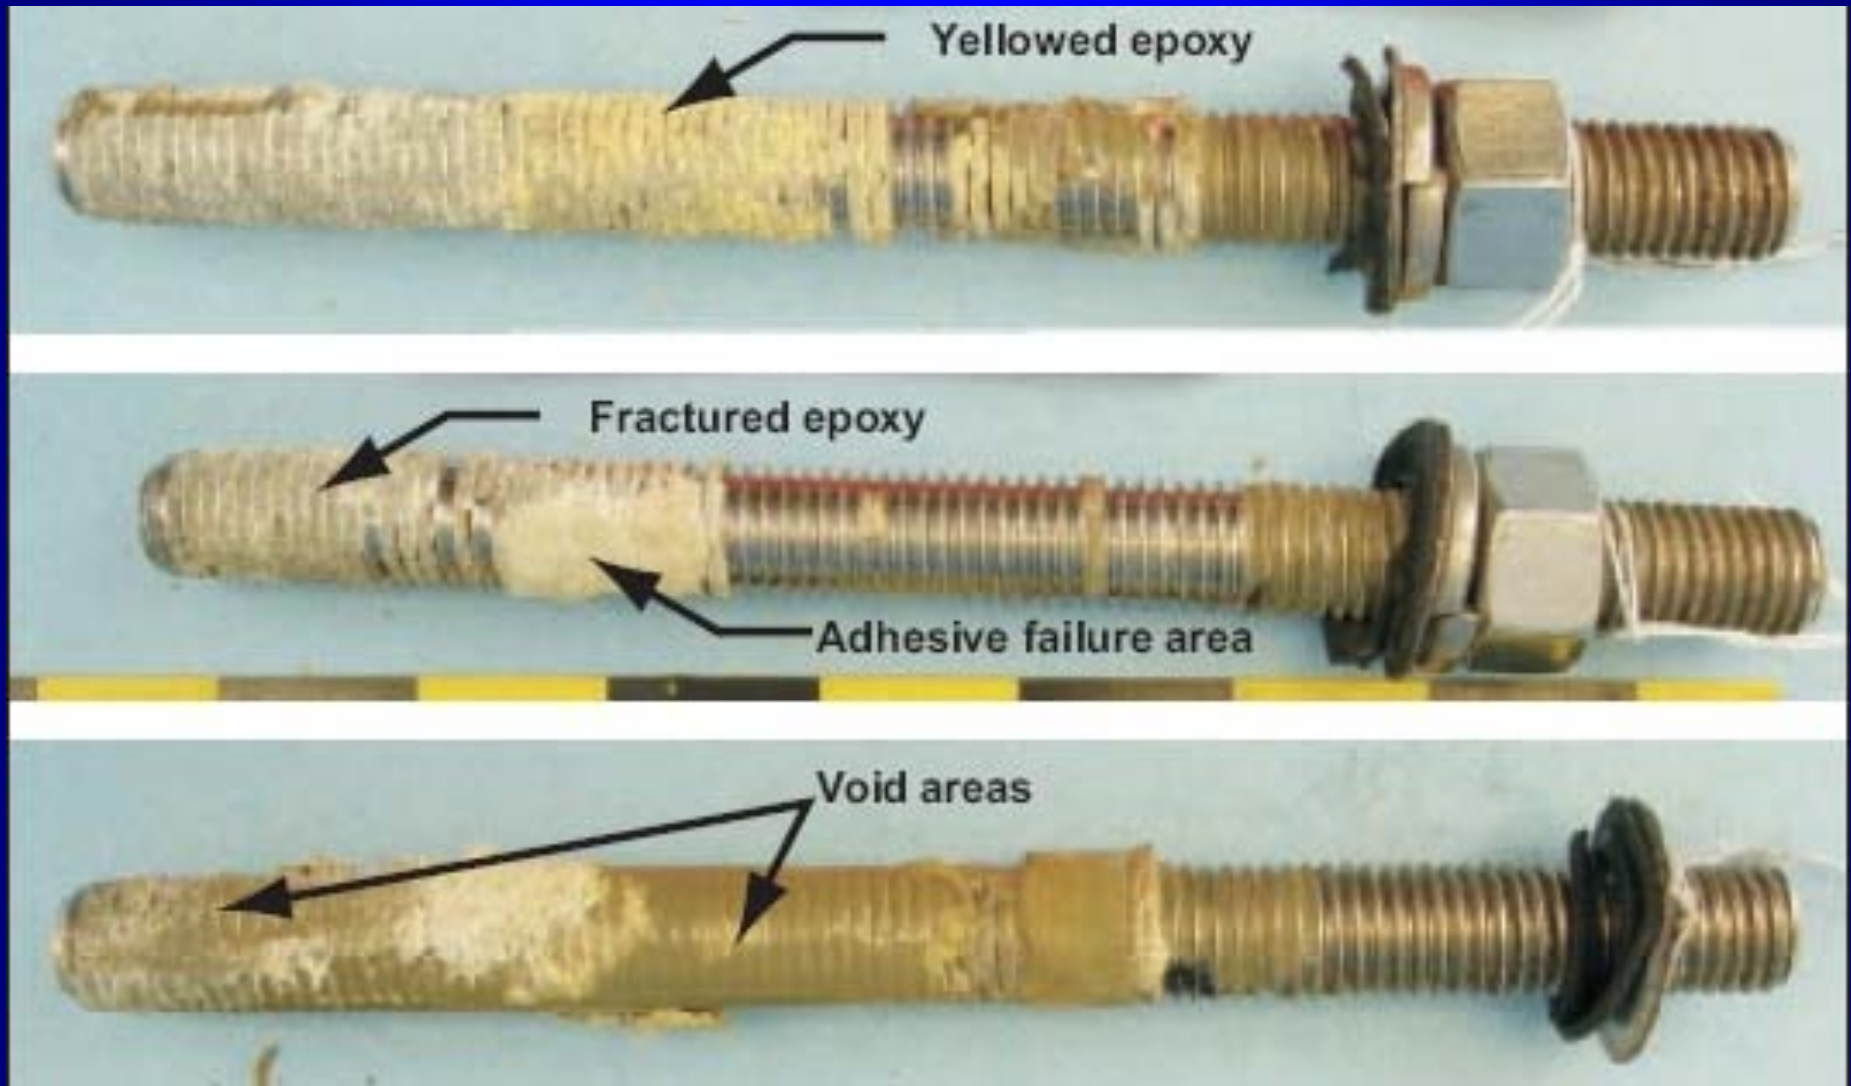
# Failed Adhesive Anchors

- Even in 1999, it was discovered when a “pulled-out” bolt was removed, that most of the bolt was bare - not enough epoxy - and the epoxy on the tip was brittle and easily crumbled.
- The holes had not been fully filled with epoxy.
- It was determined that this could have caused a loss of up to 38% of the pull out capacity
- Also found that dust had adhered to the bolt, affecting bond.

The National Transportation Safety Board determined that the probable cause of the July 10, 2006 ceiling collapse was **the use of an epoxy anchor adhesive with poor creep resistance, that is, an epoxy formulation that was not capable of sustaining long-term loads.**

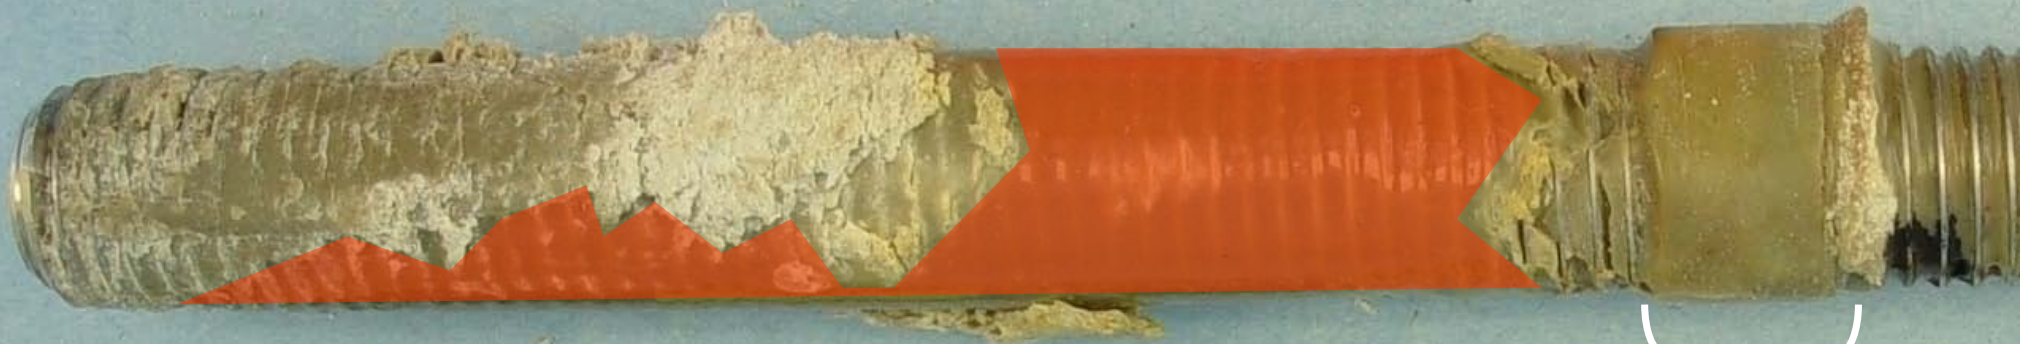
# Epoxy Voids

Seal plug  
position
