Forensic Engineering = Detective Engineering

David W. Fowler

The University of Texas at Austin

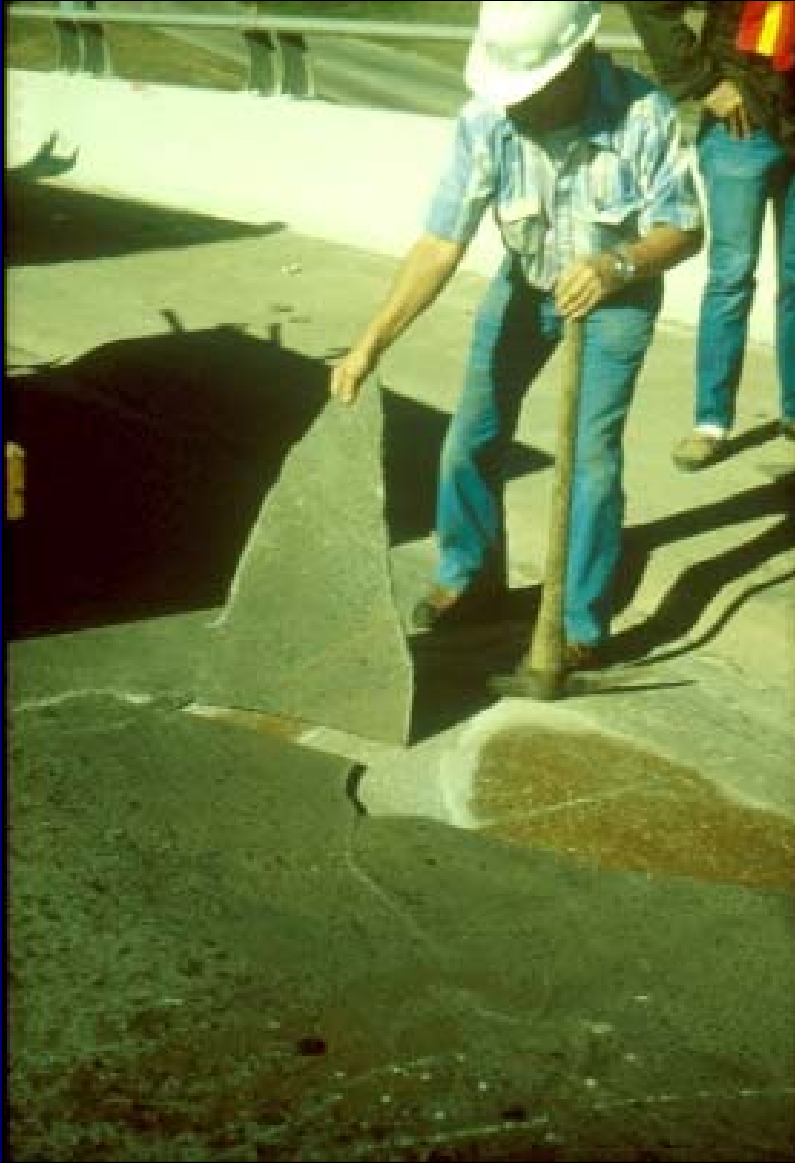
- An owner's worst nightmare!
- Delamination of a PC overlay
- Entire overlay was replaced
- Cause? An excessively thick bonding coat of resin which had a very high coefficient of thermal expansion.

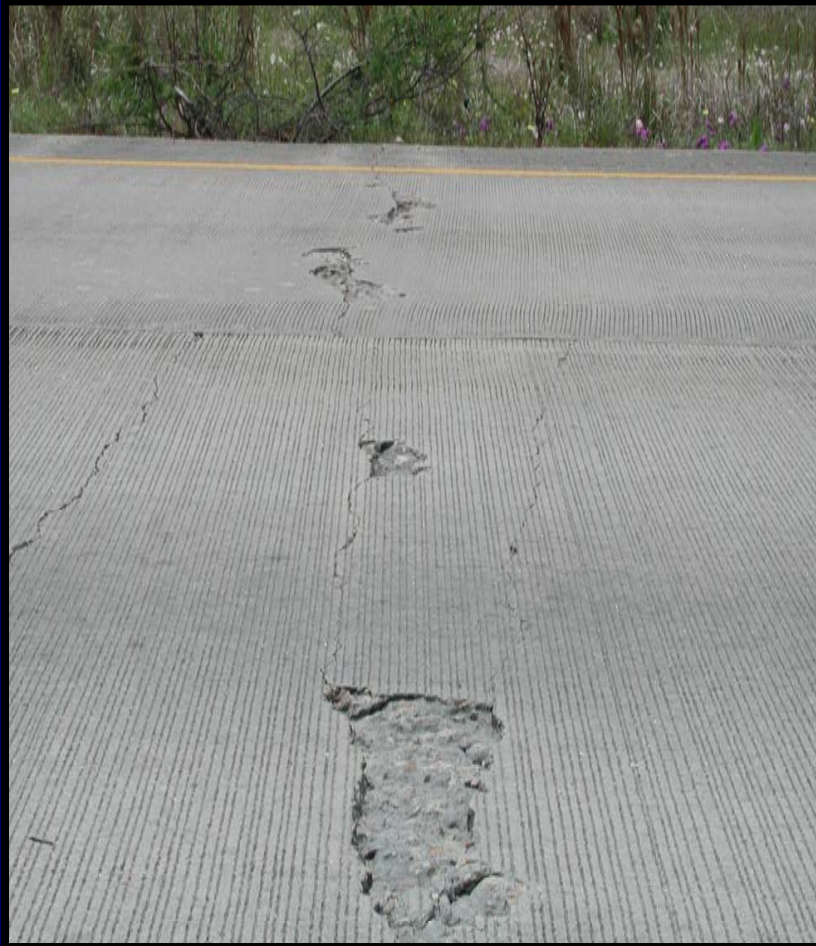
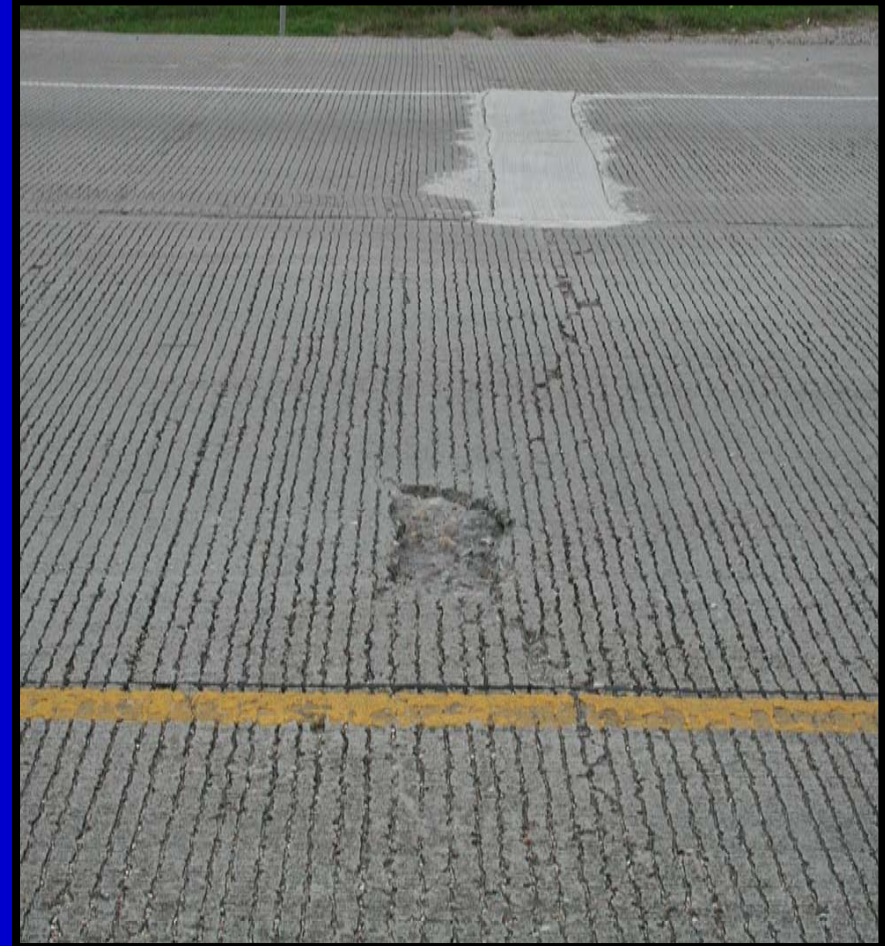
Spalling in concrete pavements— thermal expansion and contraction ts

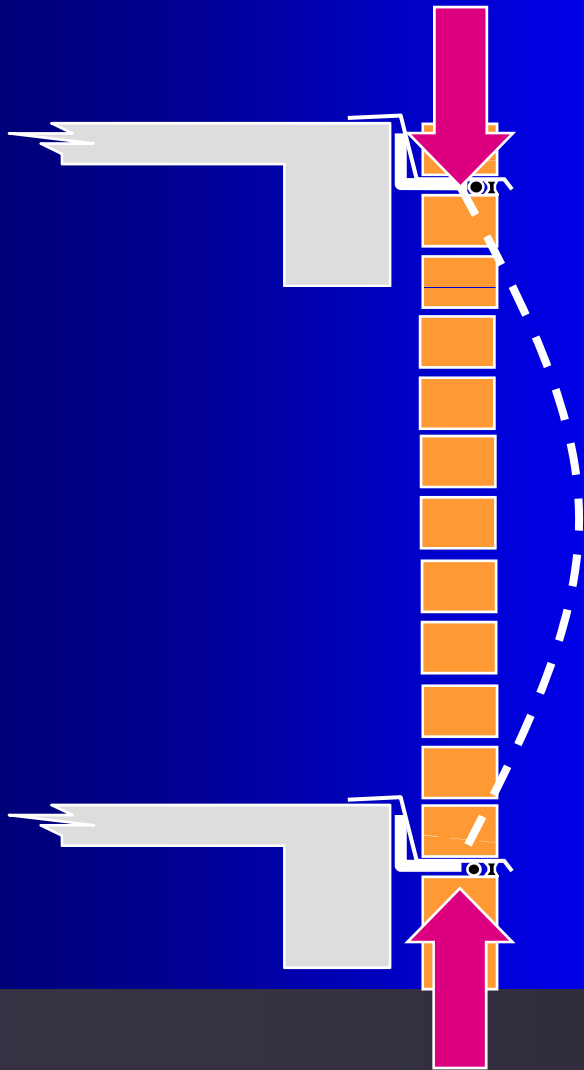
Buckled Masonry

Absence of an expansion joint under shelf angle may cause compression of masonry that can lead to buckling, local spalling of masonry, and collapse of entire panel.

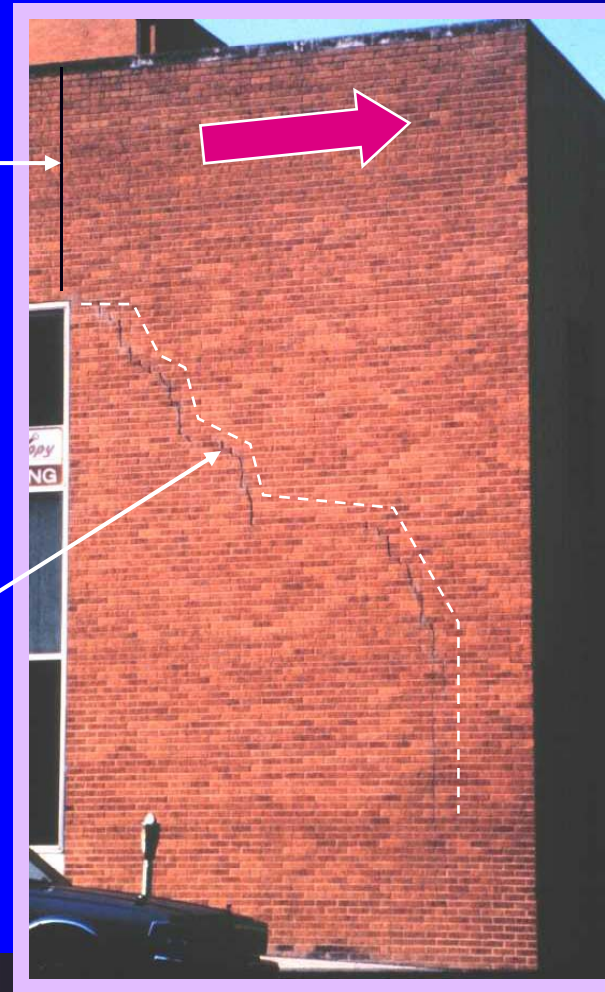
Expansion joint
should have been
placed here.

Absence of expansion
joint caused shear crack.

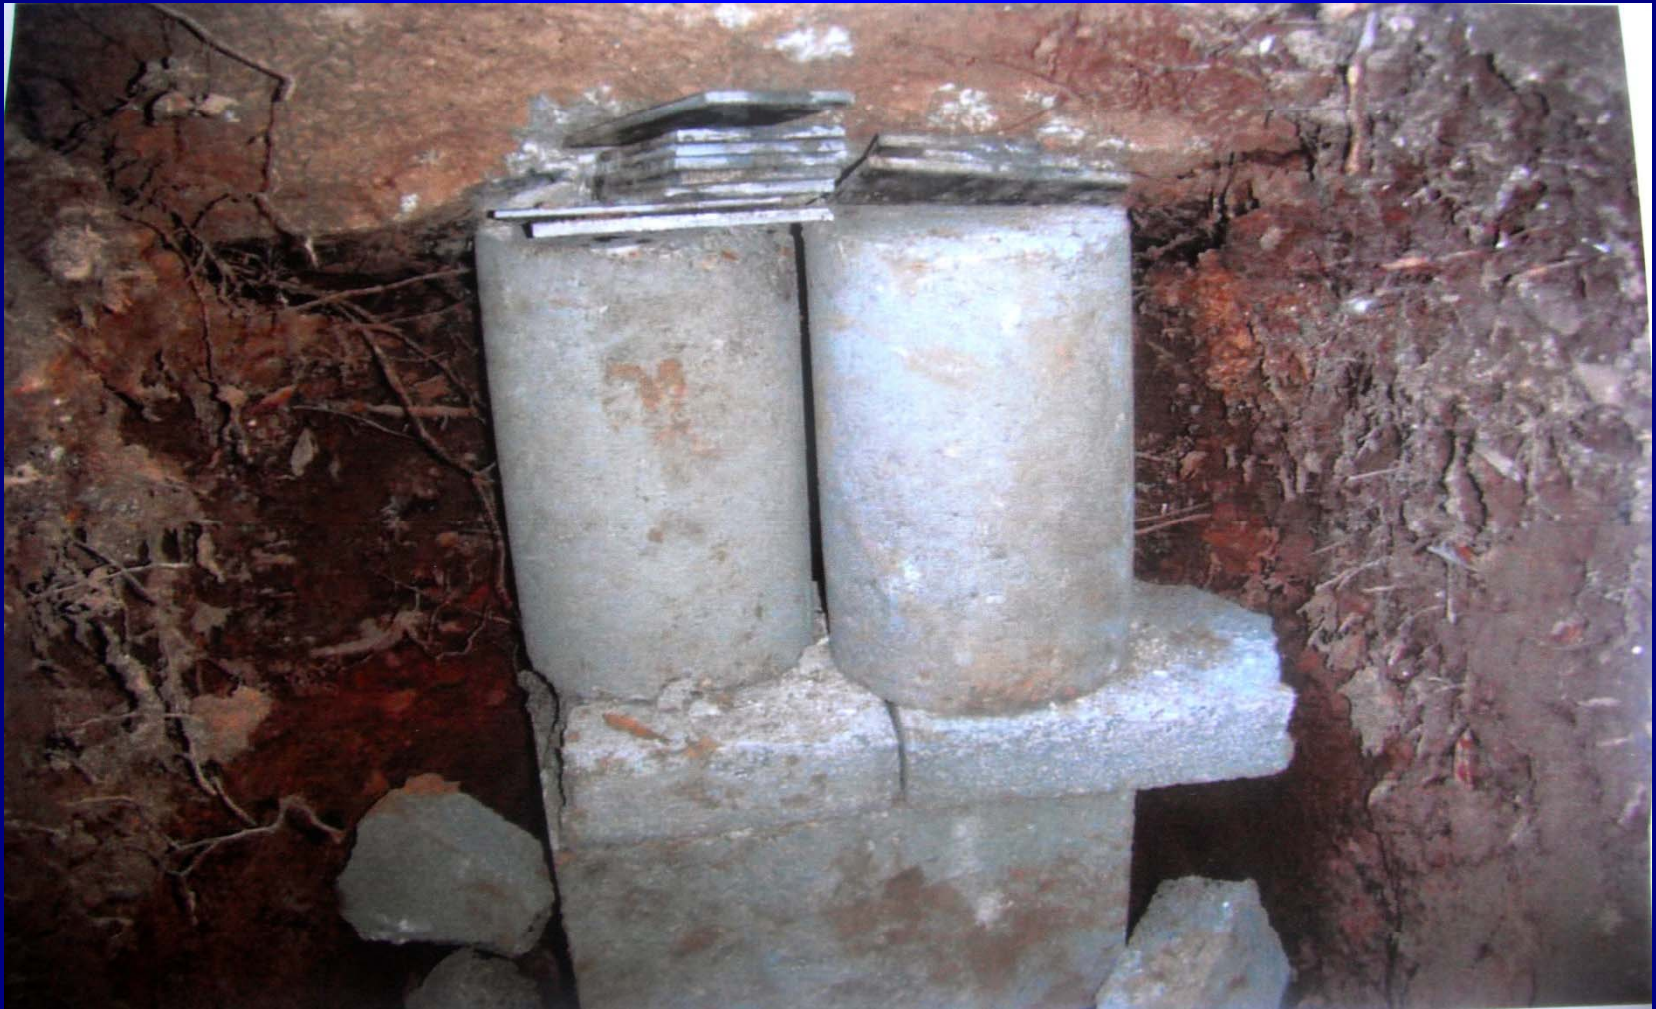
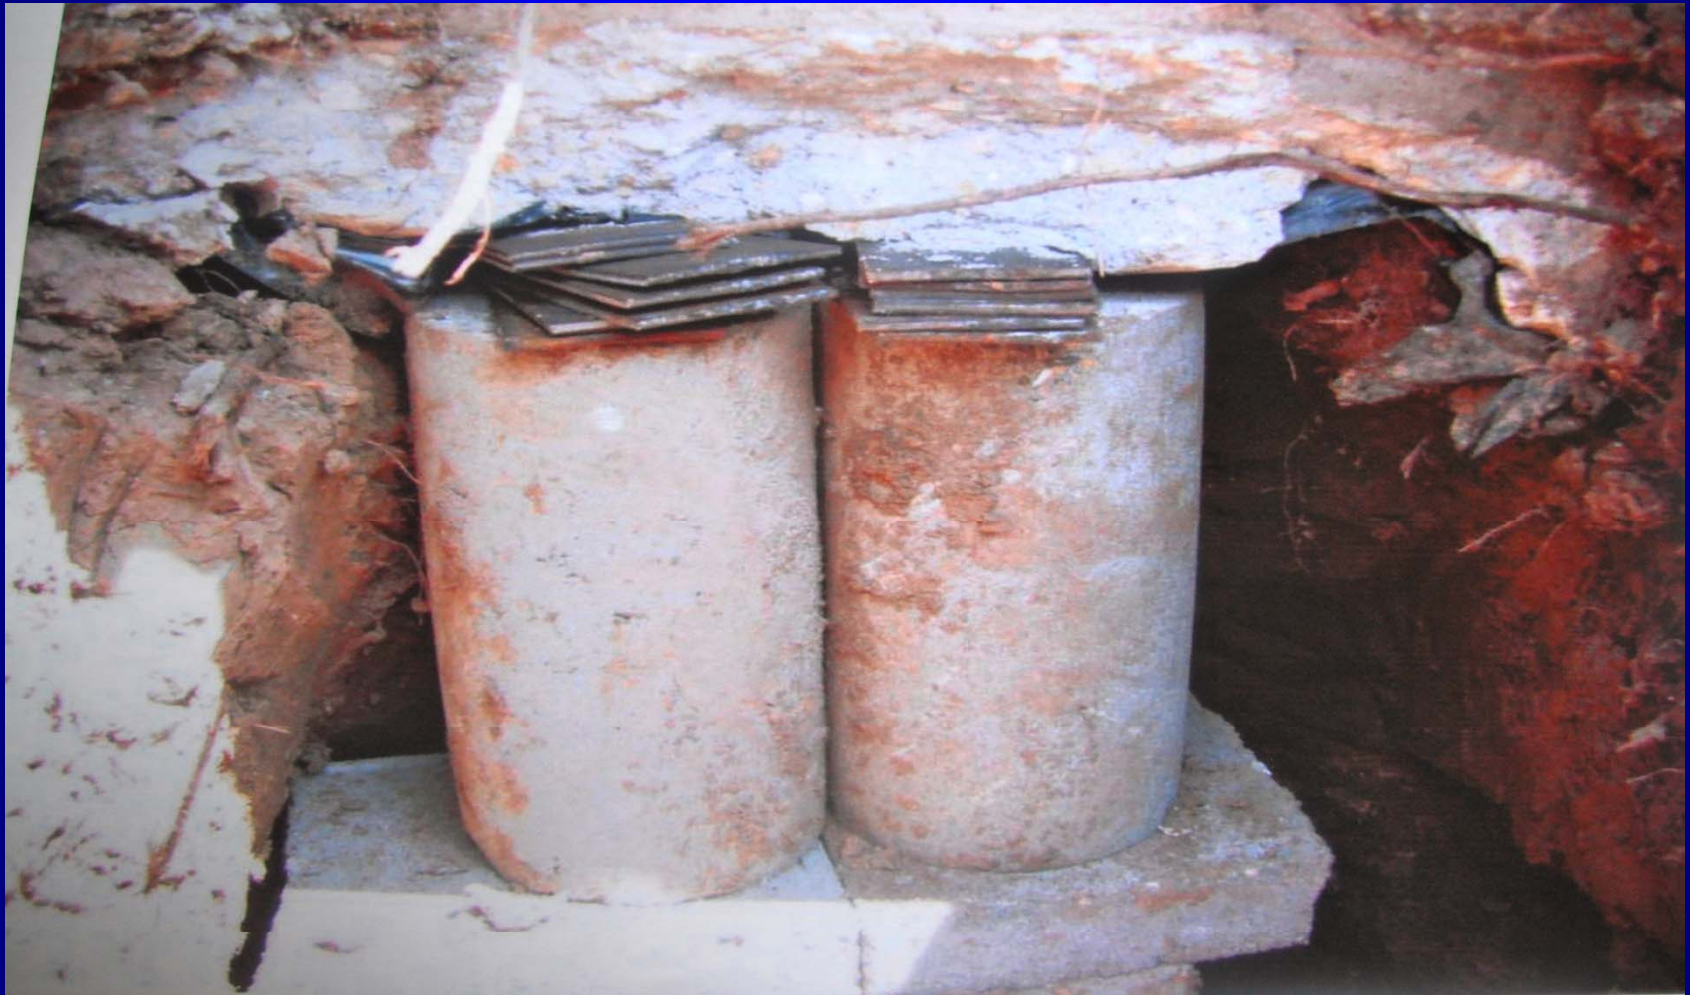
- Two-story apartment rock veneered apartment
- Less than a year after it was repair with pressed piles it exhibited over 4 inches of settlement.
- The following photos show what they found when they exhumed the foundation.

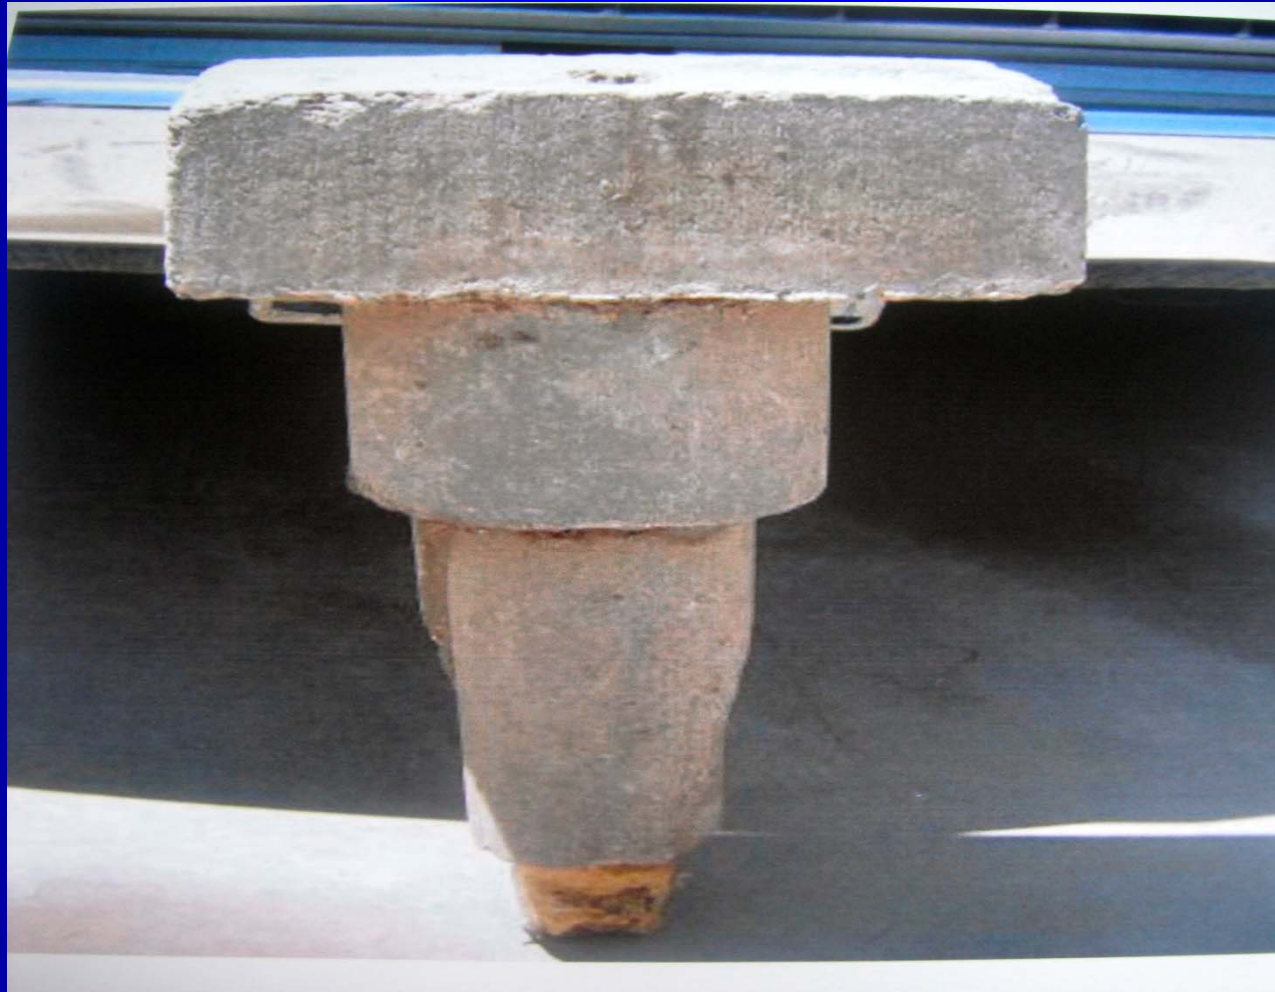
Paper cup formed the tip

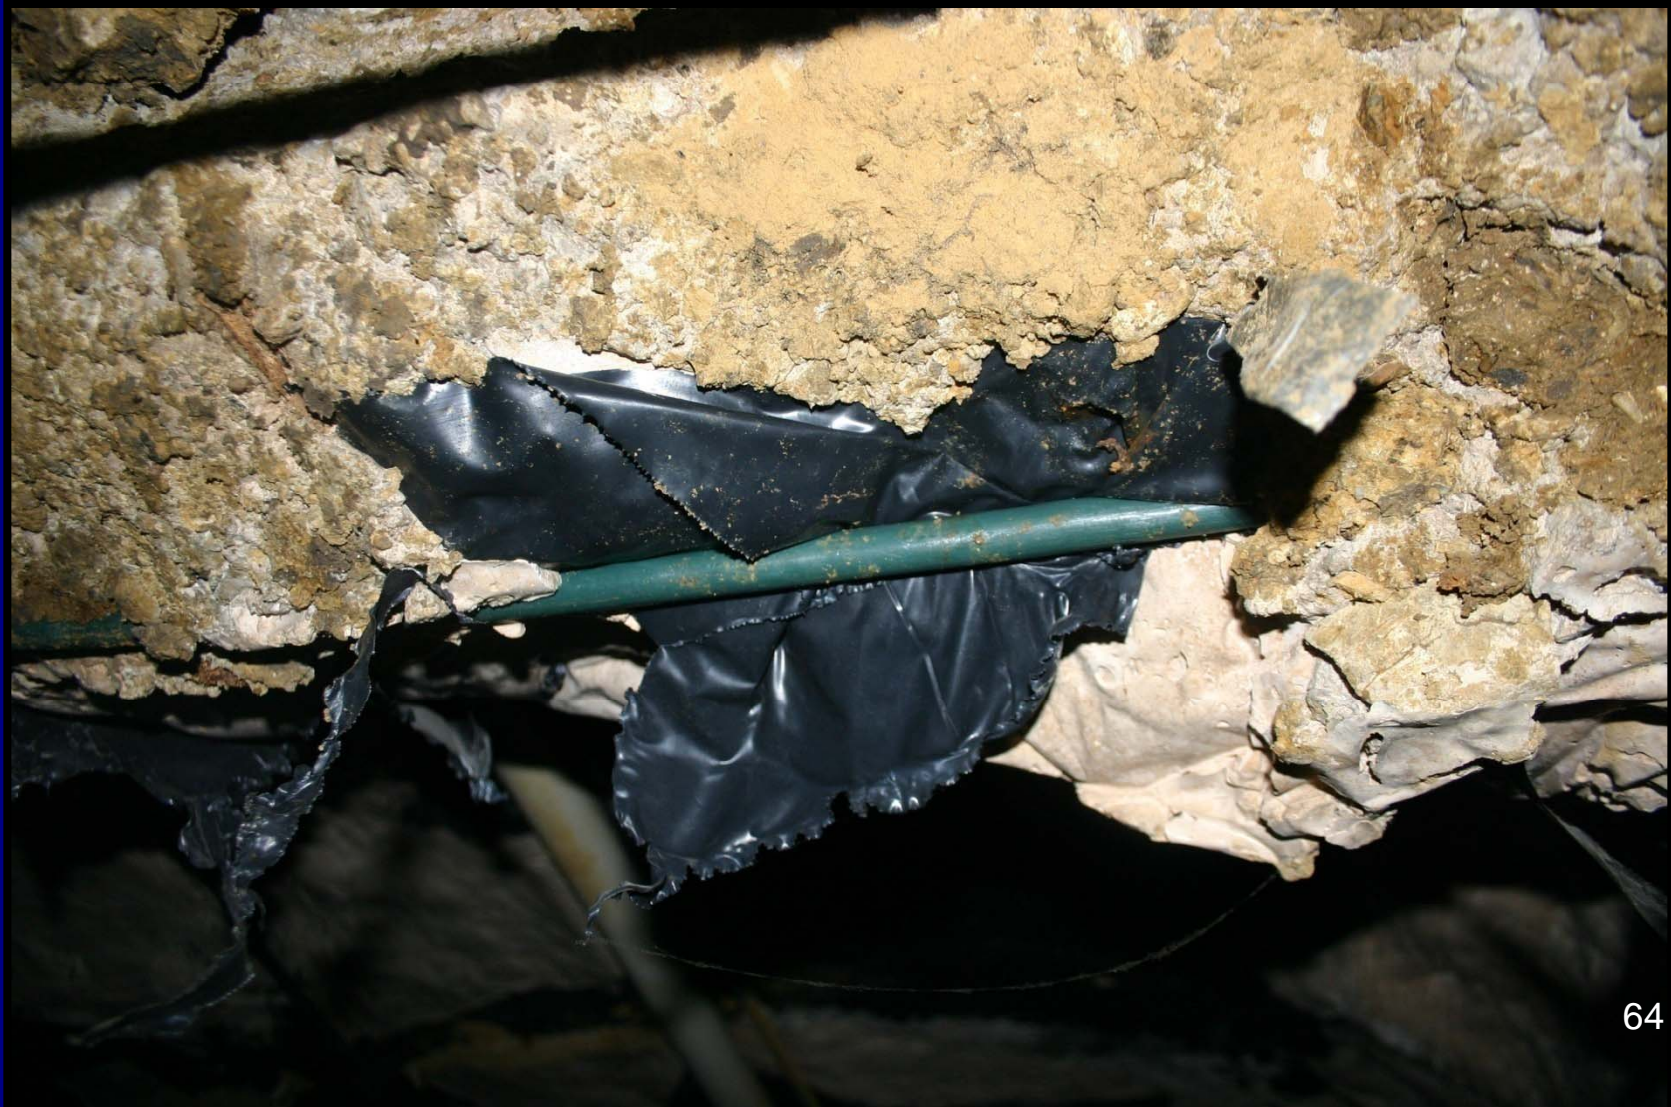
Exposed Cable—Poor Construction/Inspection

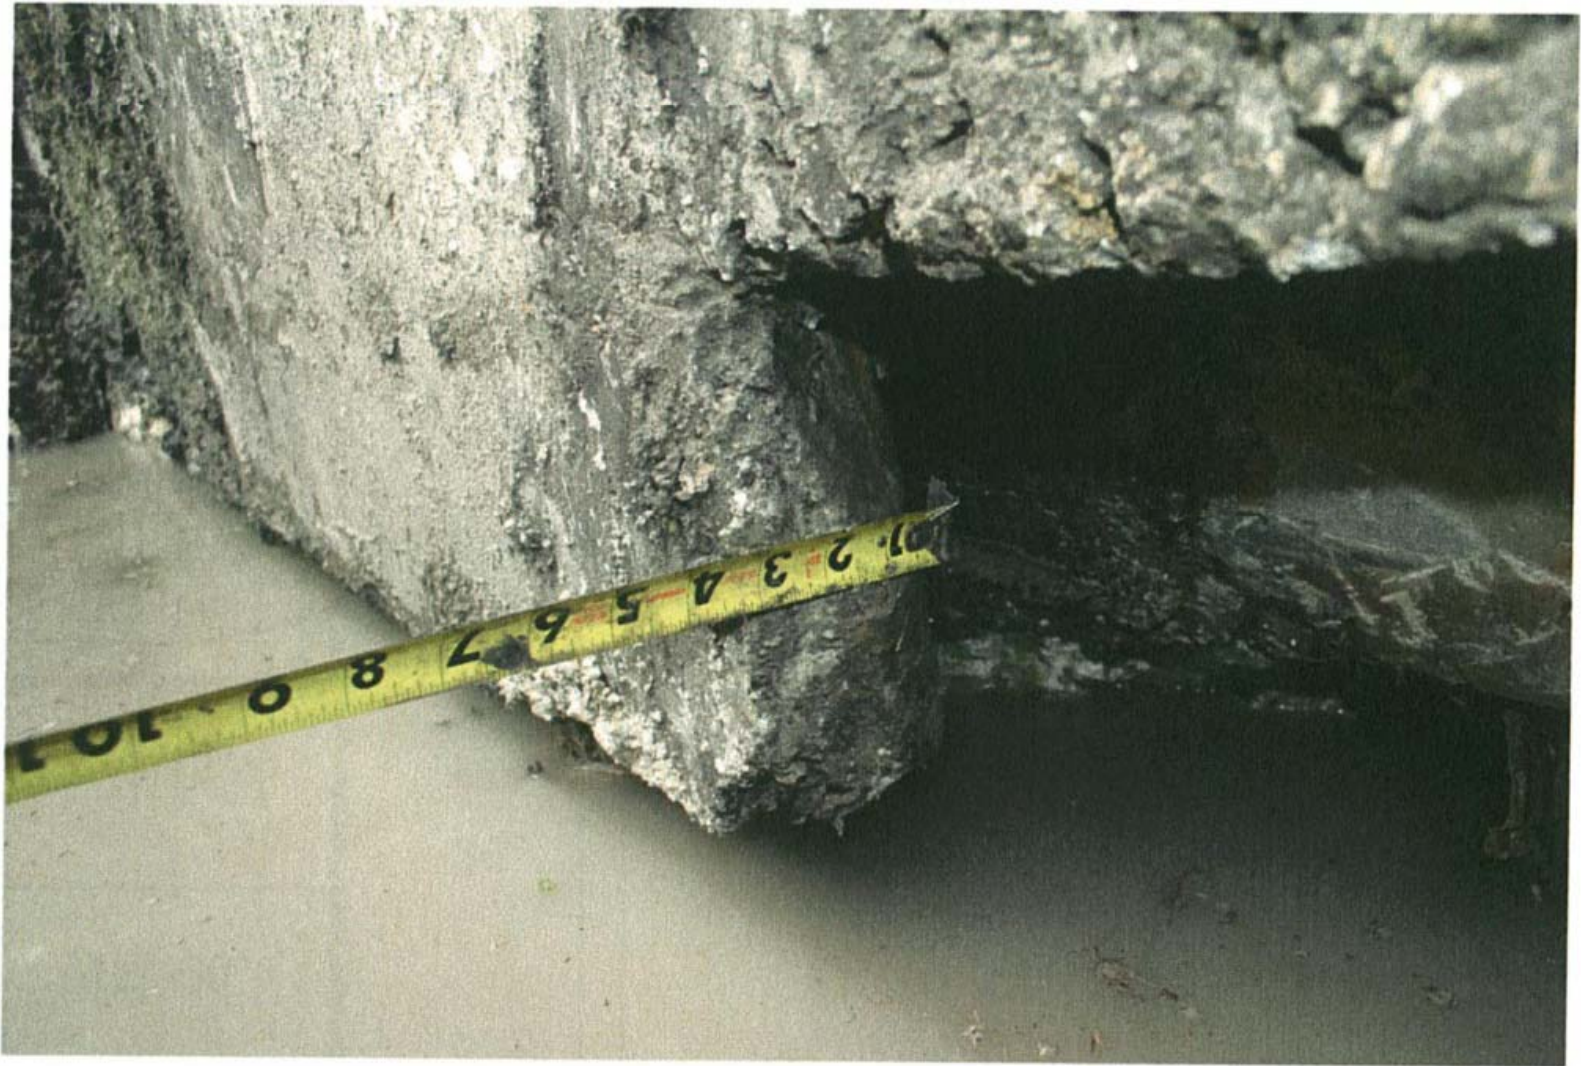
Test Pit #1: Two carton forms. Inside collapsed. Outside left 3.5" concrete in contact with clay.

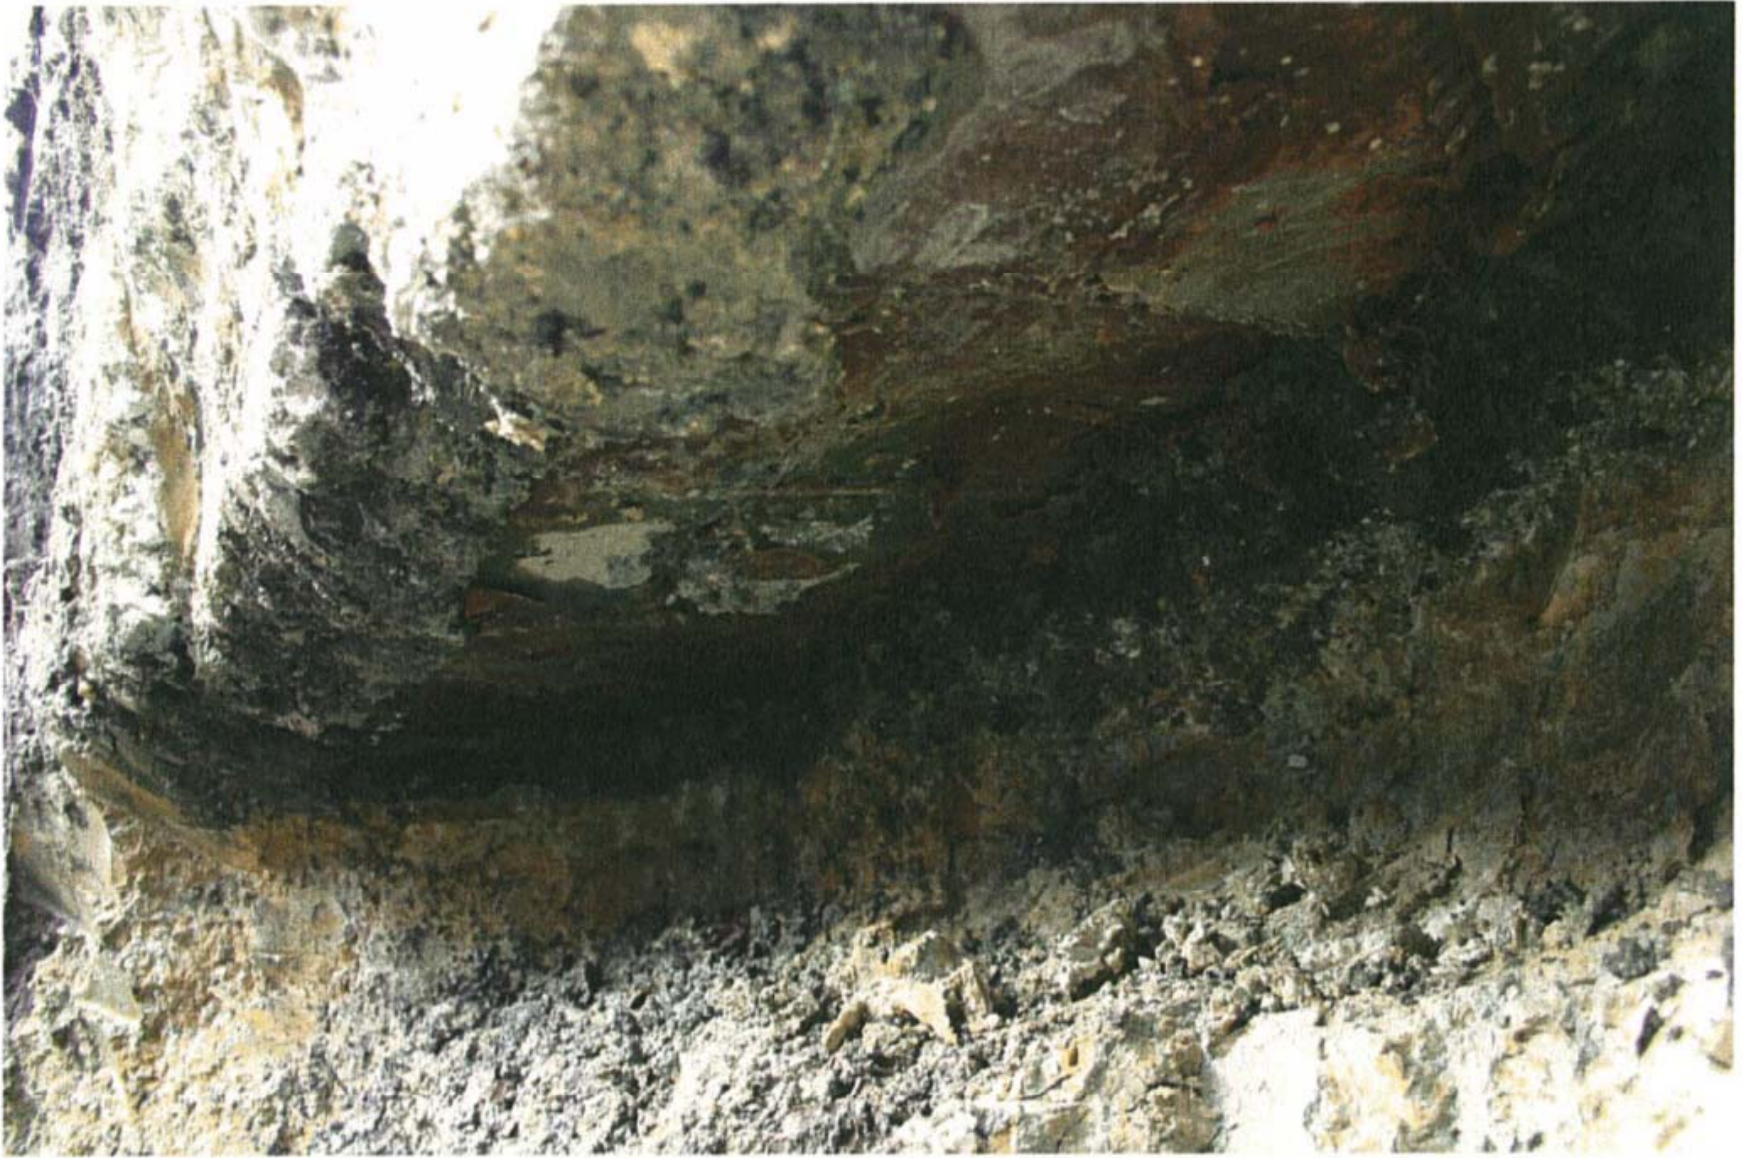
Test Pit #3, no void, carton form collapsed.
