# Concrete Floor Covering Failures

*B. Lee Lawrence, P.E.*

*Wiss, Janney, Elstner Associates, Inc.*

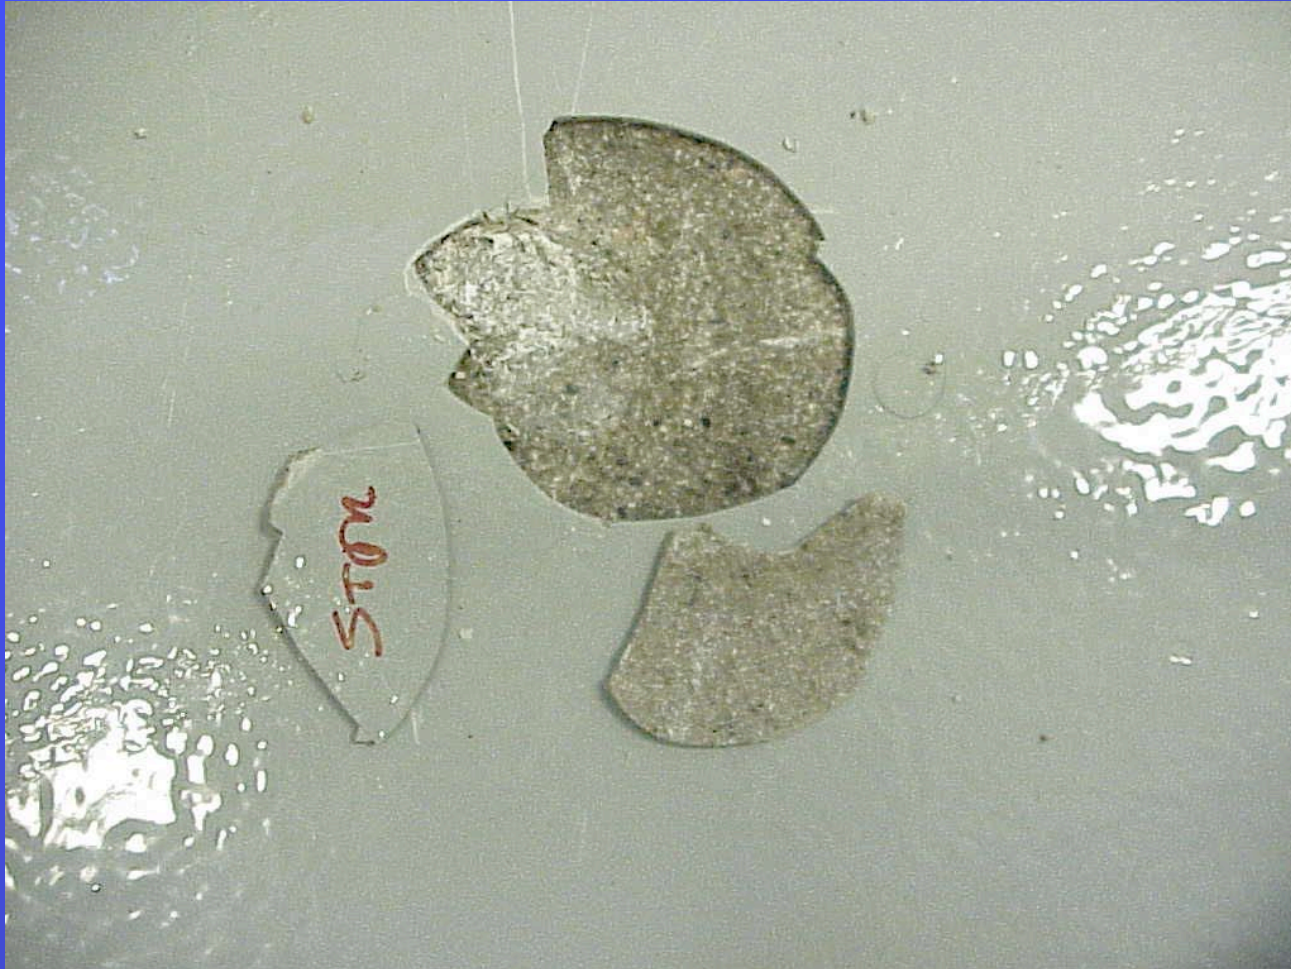
- *Epoxy coating applied on a two-year-old concrete slab with vapor barrier underneath*
- *Scaling and blistering observed within several months of application*
- *Cores were taken and examined petrographically*
- *Concrete was of good quality*
- *Near-surface ASR was identified involving fine rhyolite particles*
- *No ASR detected at the interior of the concrete*

## Region of debonded epoxy

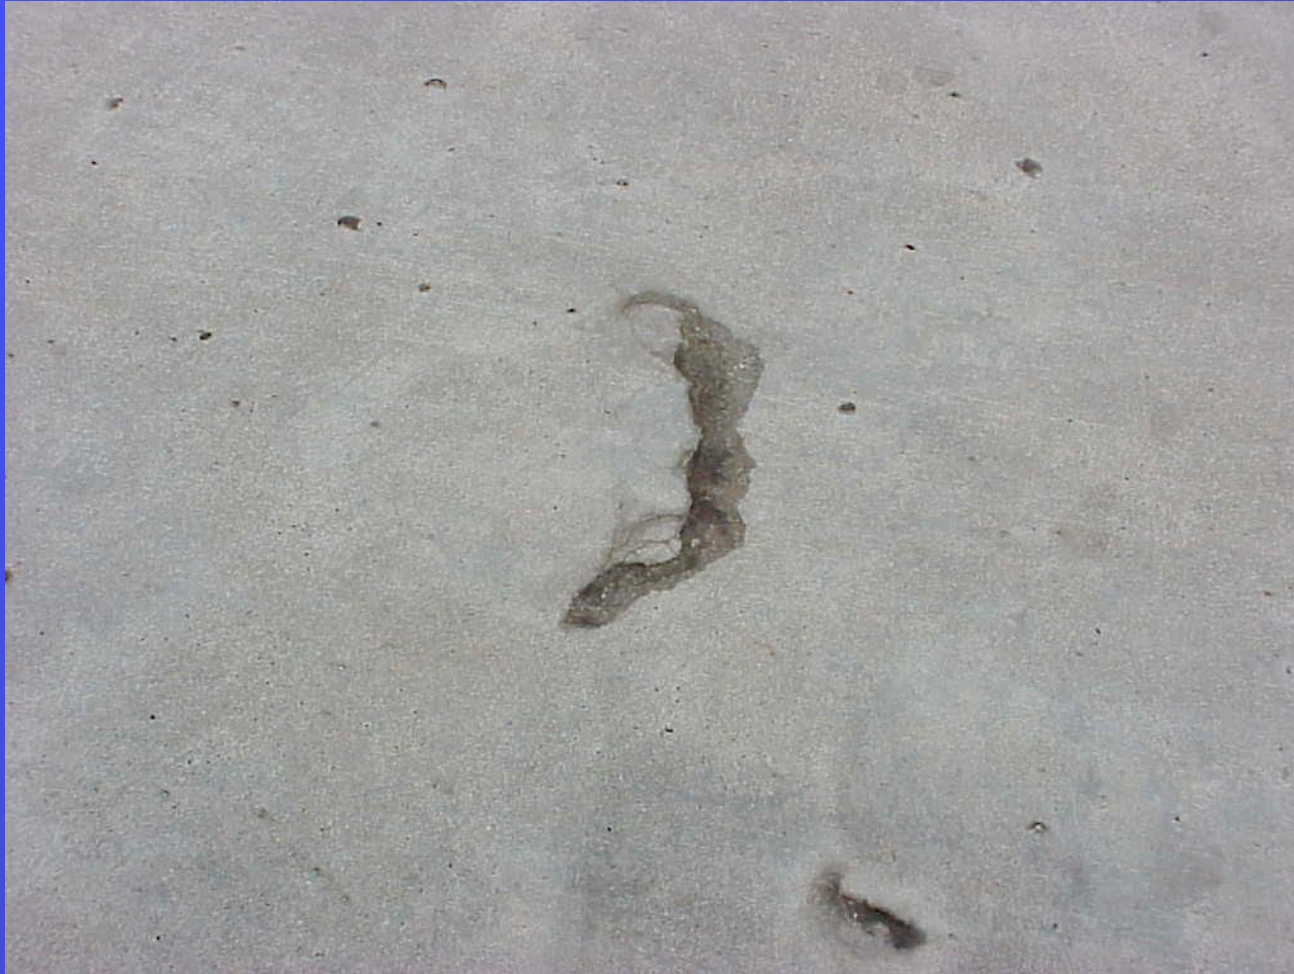
## Typical surface scaling in exterior concrete

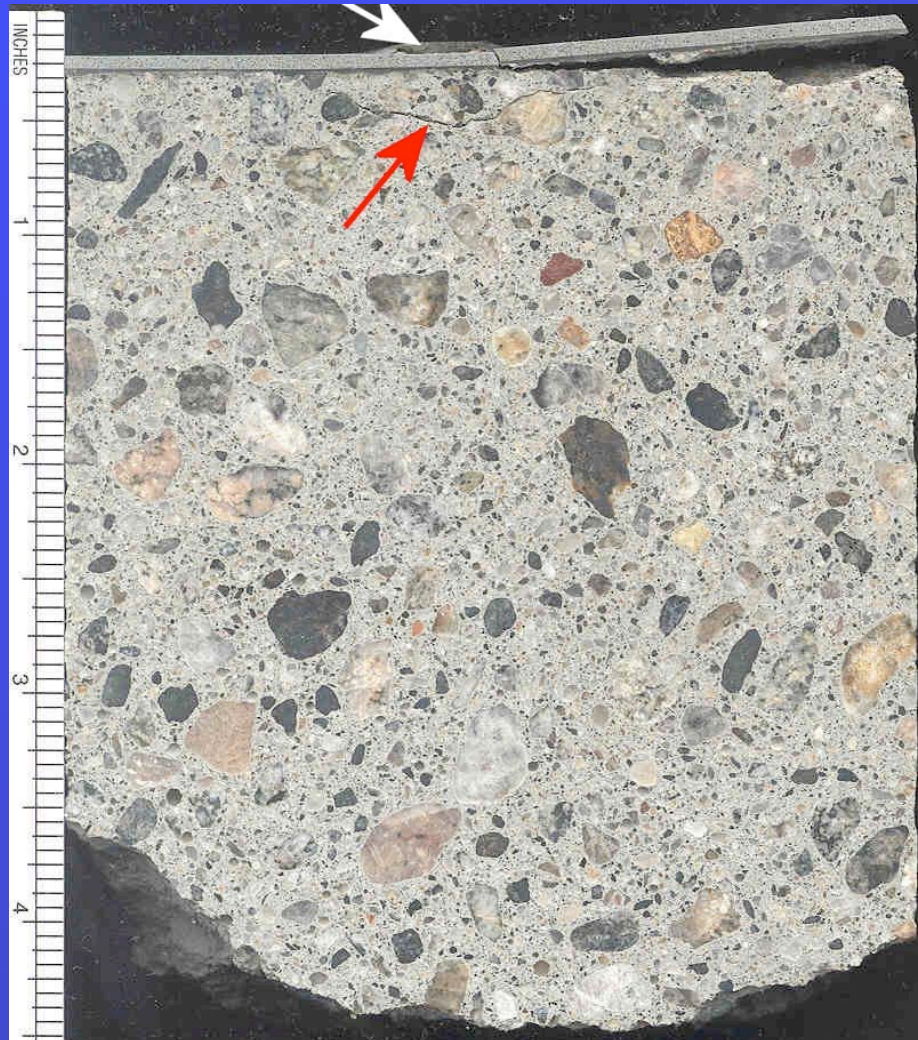
## Sample cross-section at disbonded area

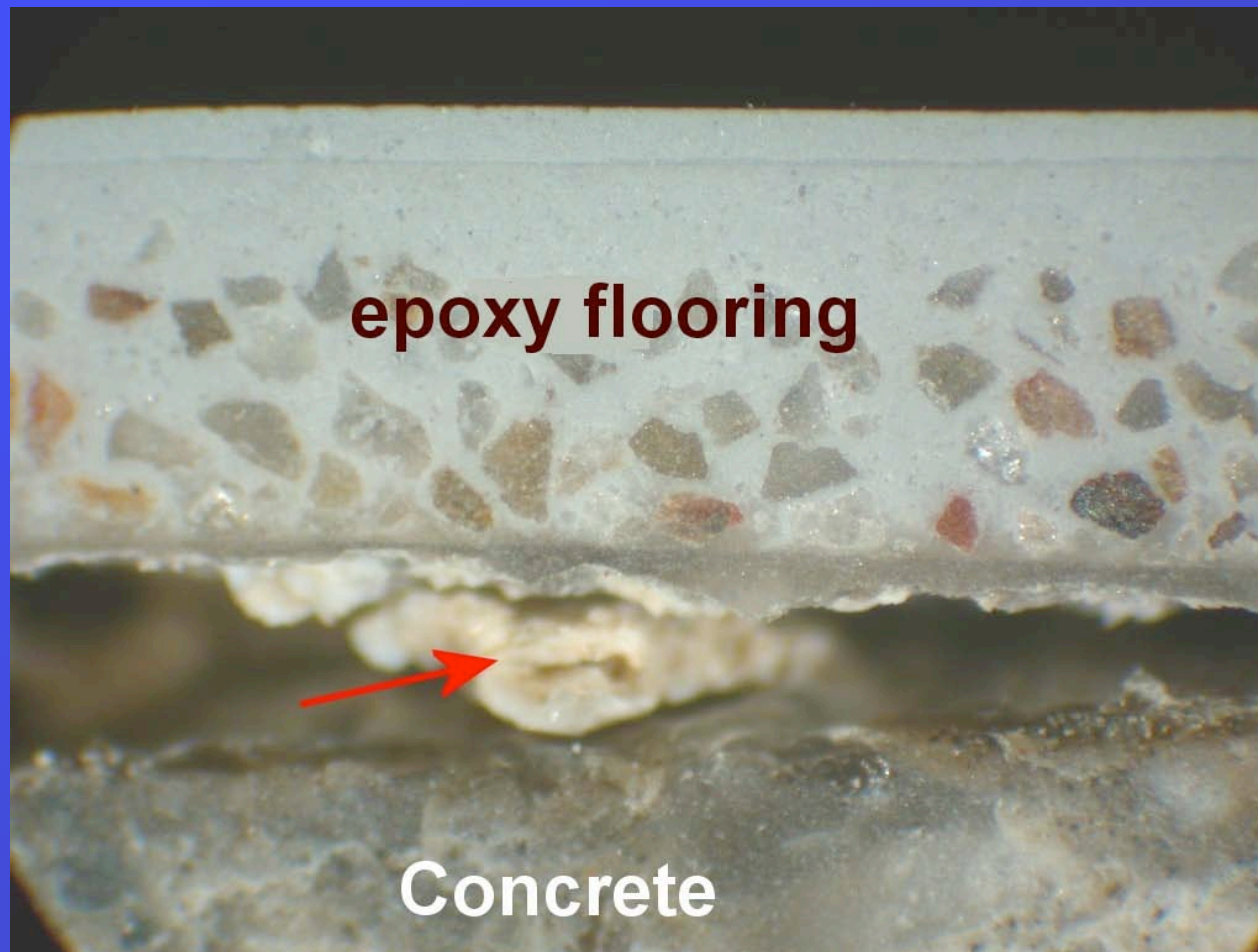
## ASR gel at interface

- *Segregation resulting in reactive aggregate concentrated only in the near-surface region*
- *Significant moisture gradient with high near-surface moisture content*
- *Alkali gradient*

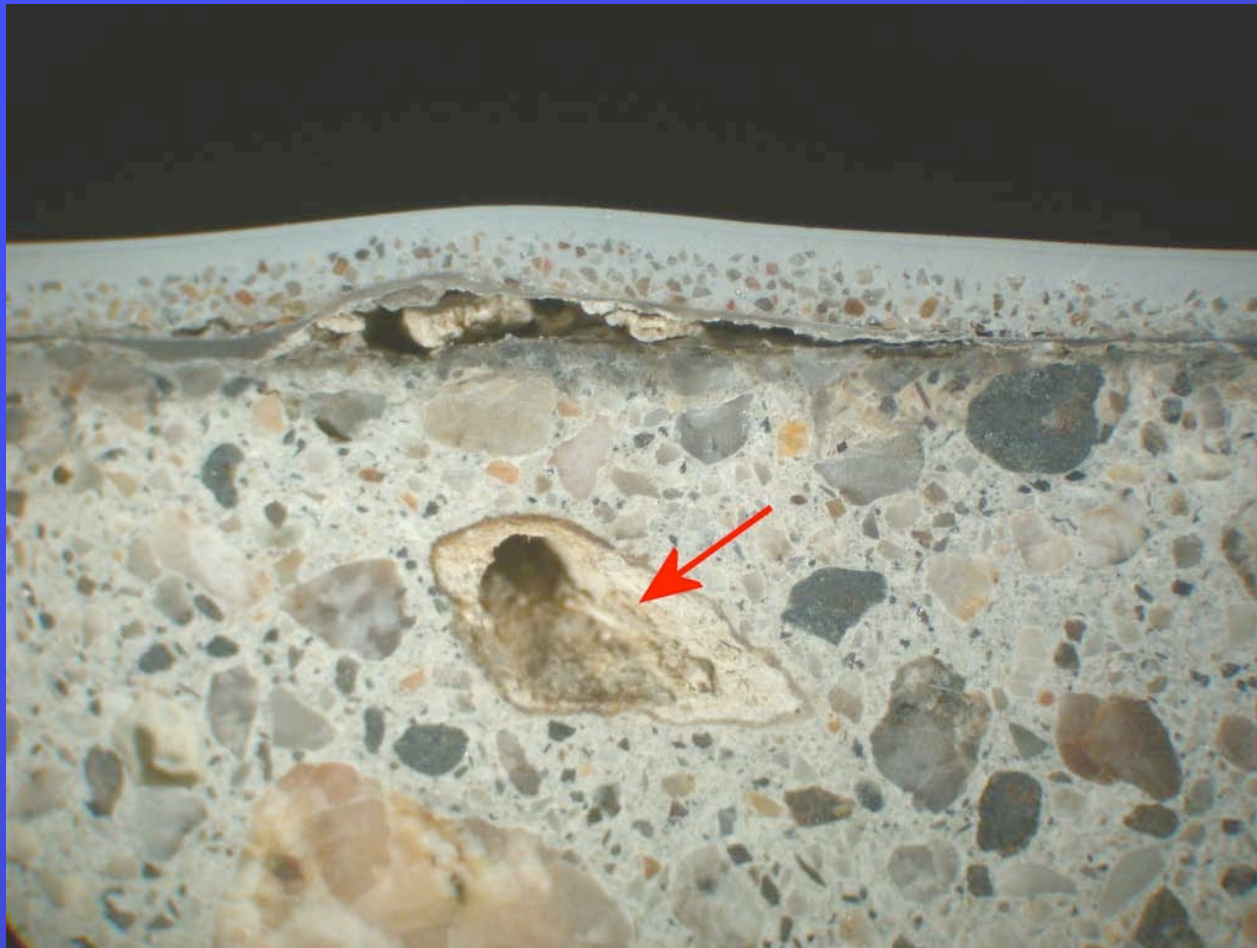
## Reactive aggregate near surface

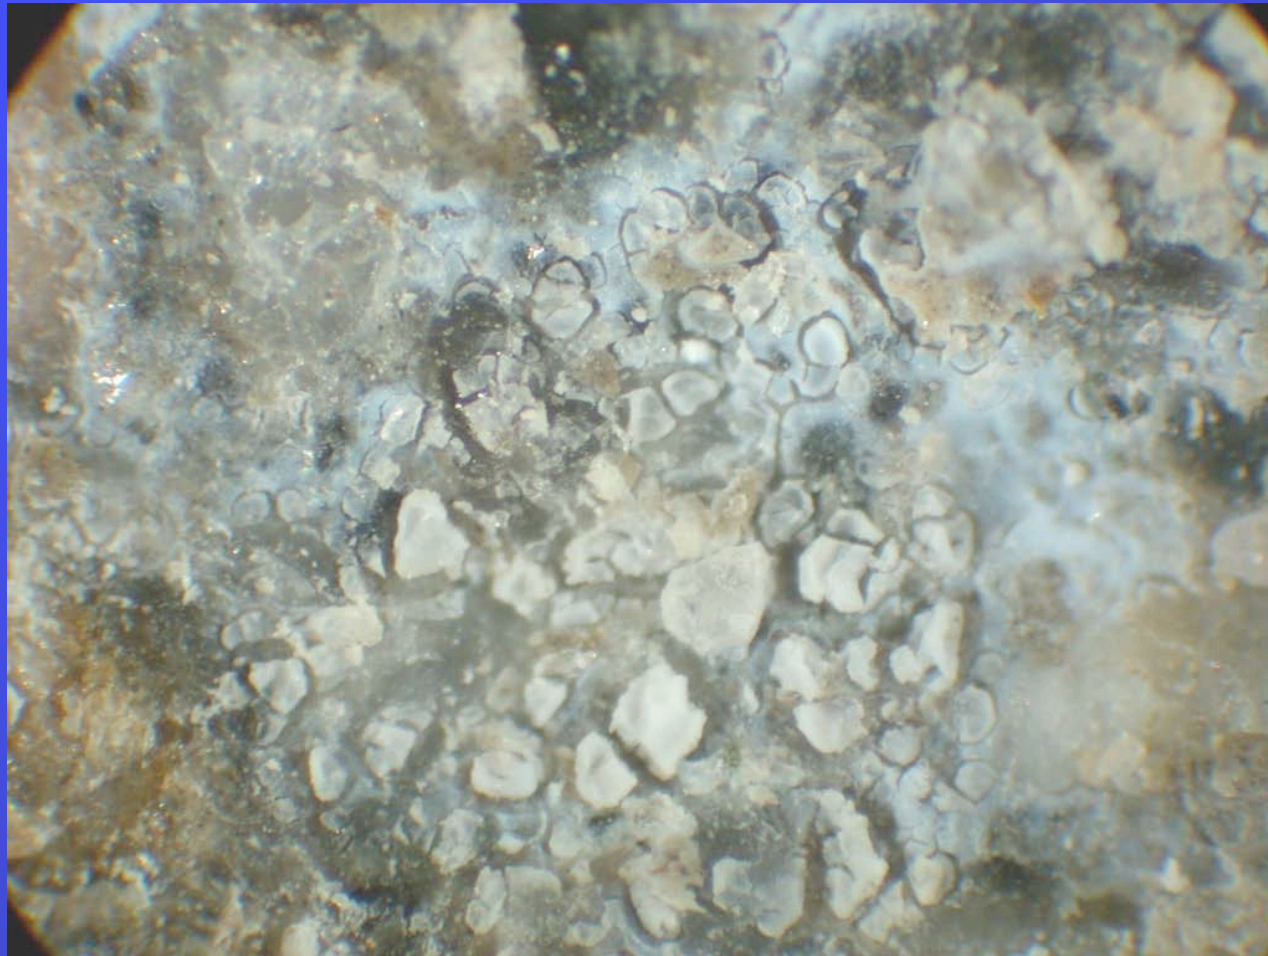
## ASR gel on concrete surface

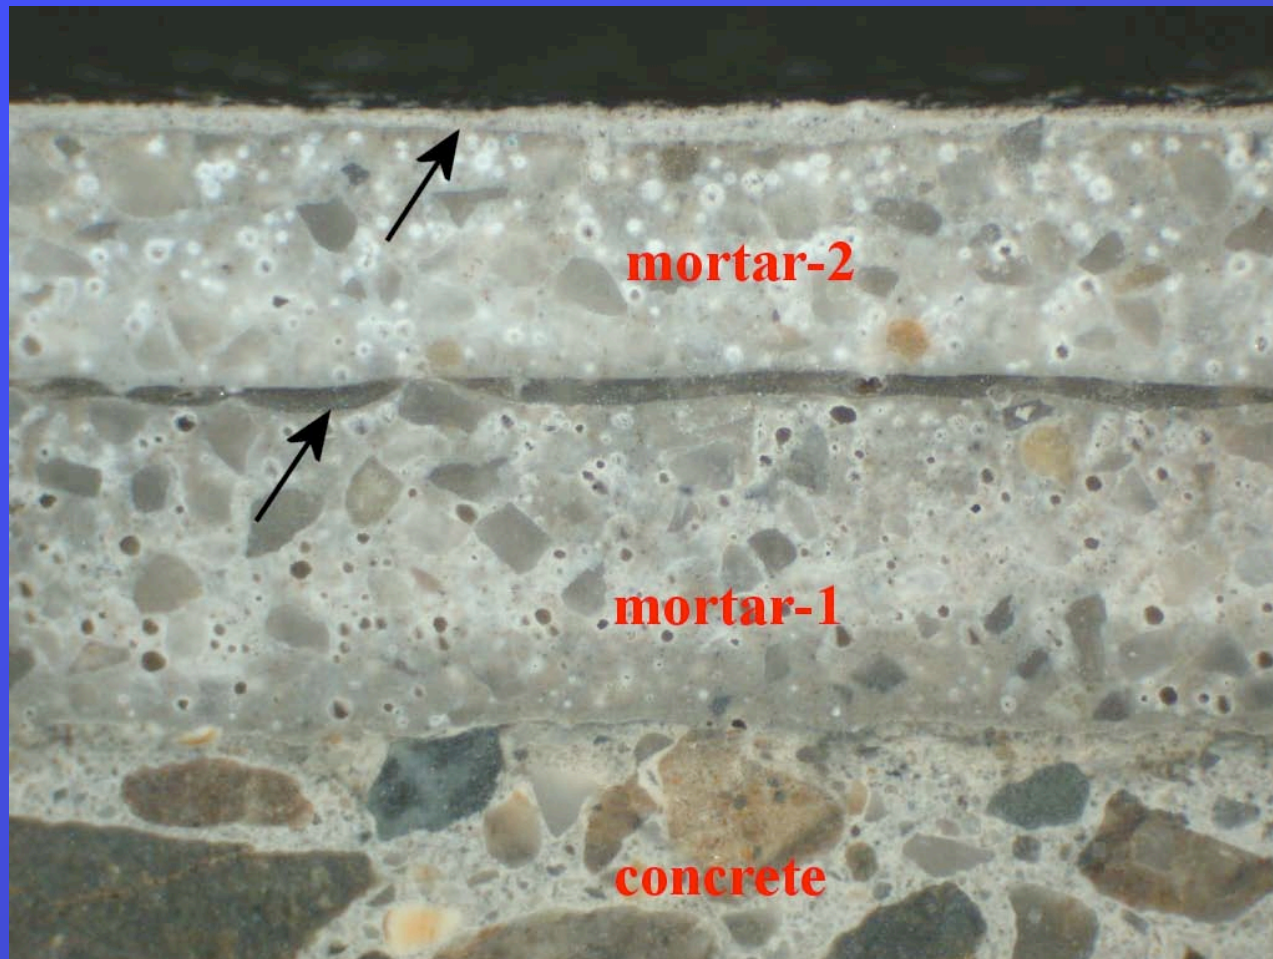
## Multiple layers of leveling mortar

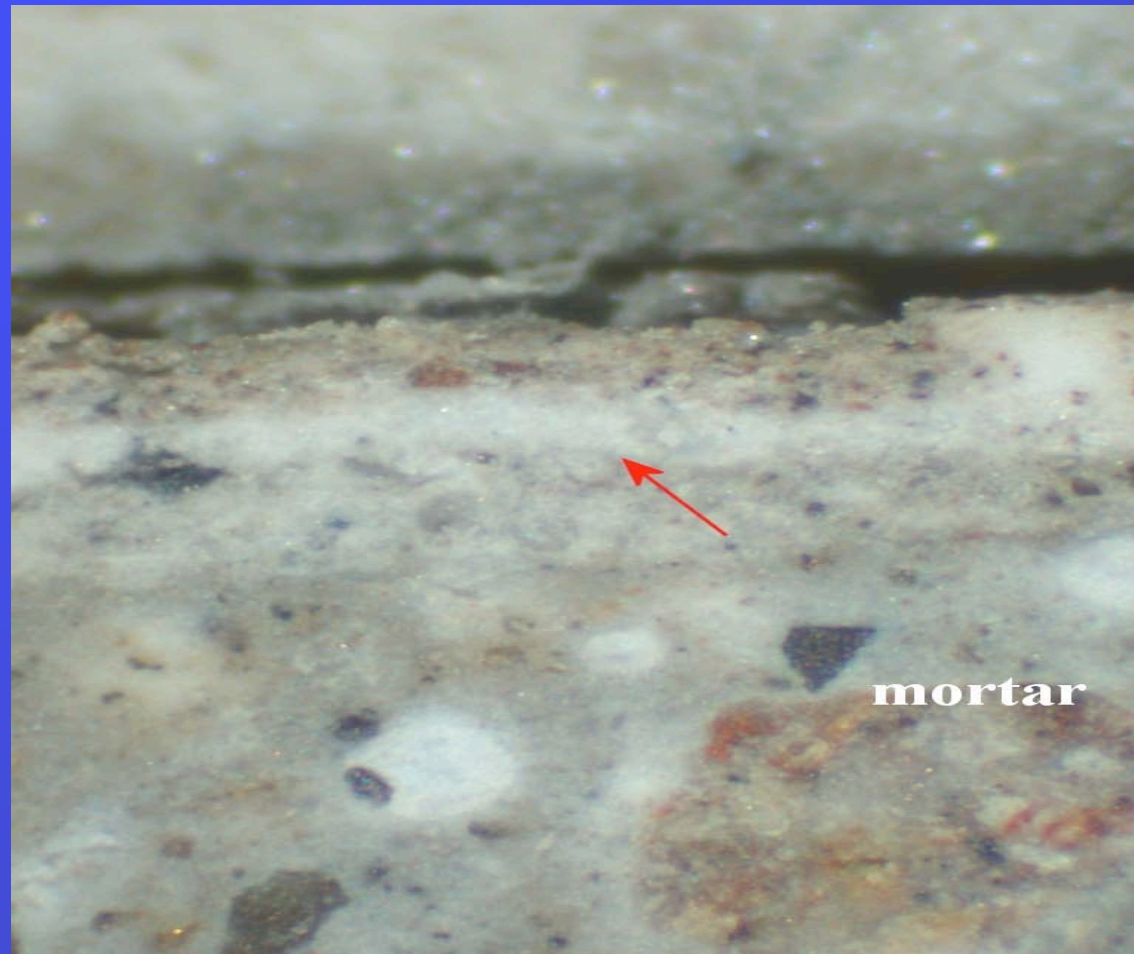
## Band of ettringite in leveling mortar

- *The shrinkage compensating mortar contained abundant calcium aluminate and calcium sulfate*
- *Moisture in the adhesive resulted in dissolving and reprecipitation of these components, forming ettringite in the interface*
- *The resulting internal sulfate attack caused the debonding of the vinyl flooring*

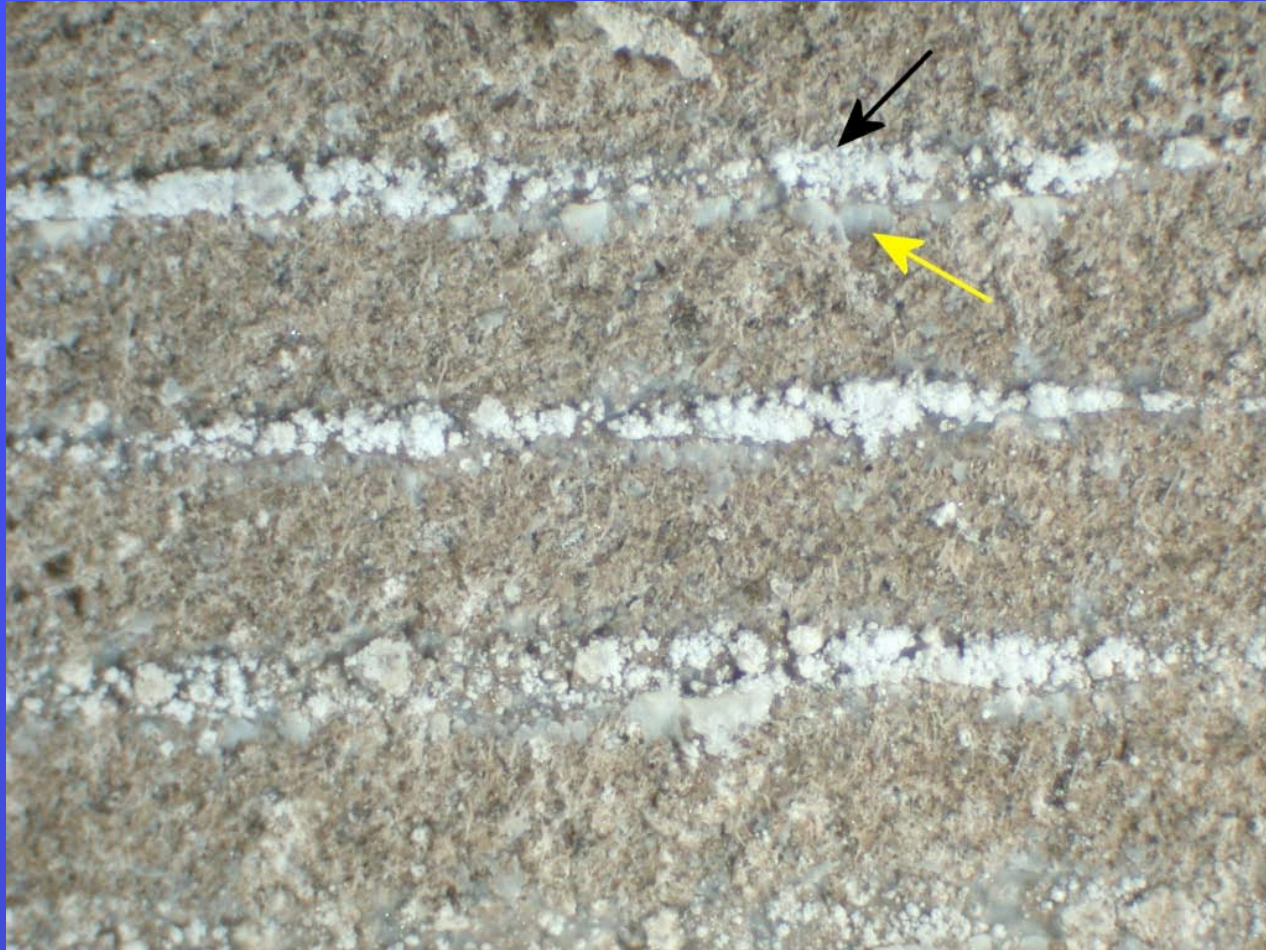
## Ettringite along adhesive strips

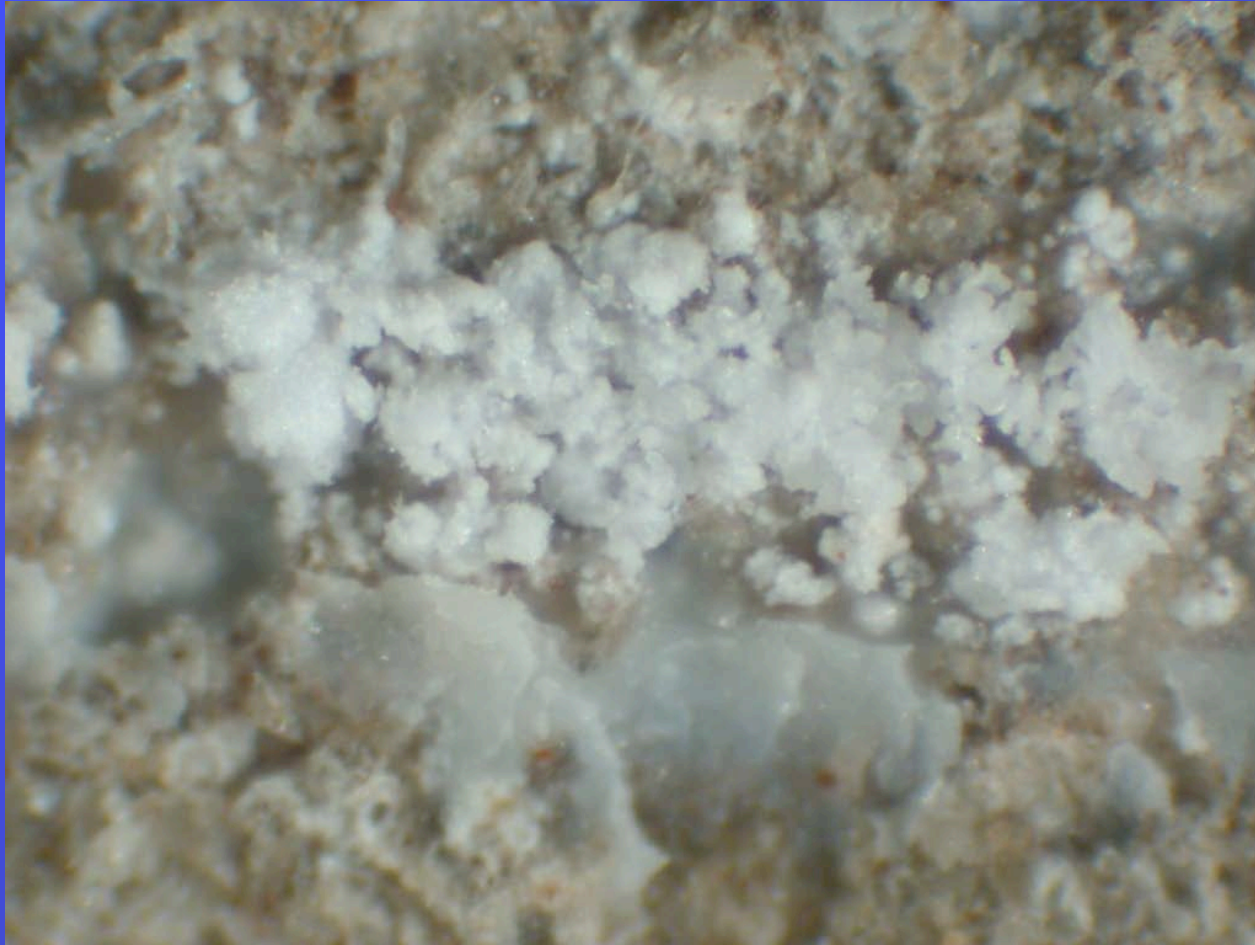
## Ettringite and adhesive

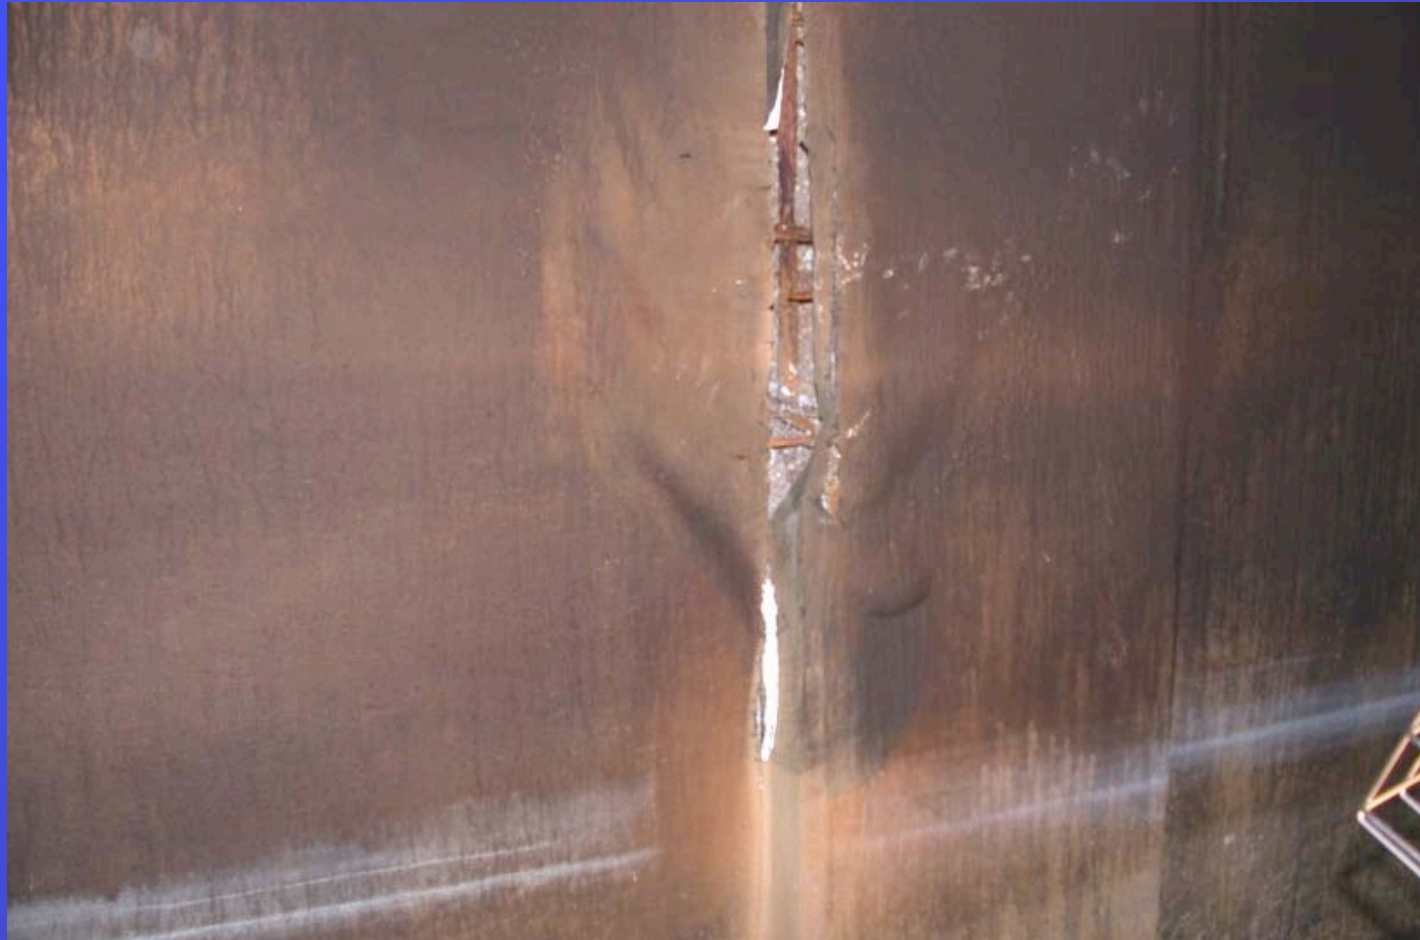
## Breach of coating

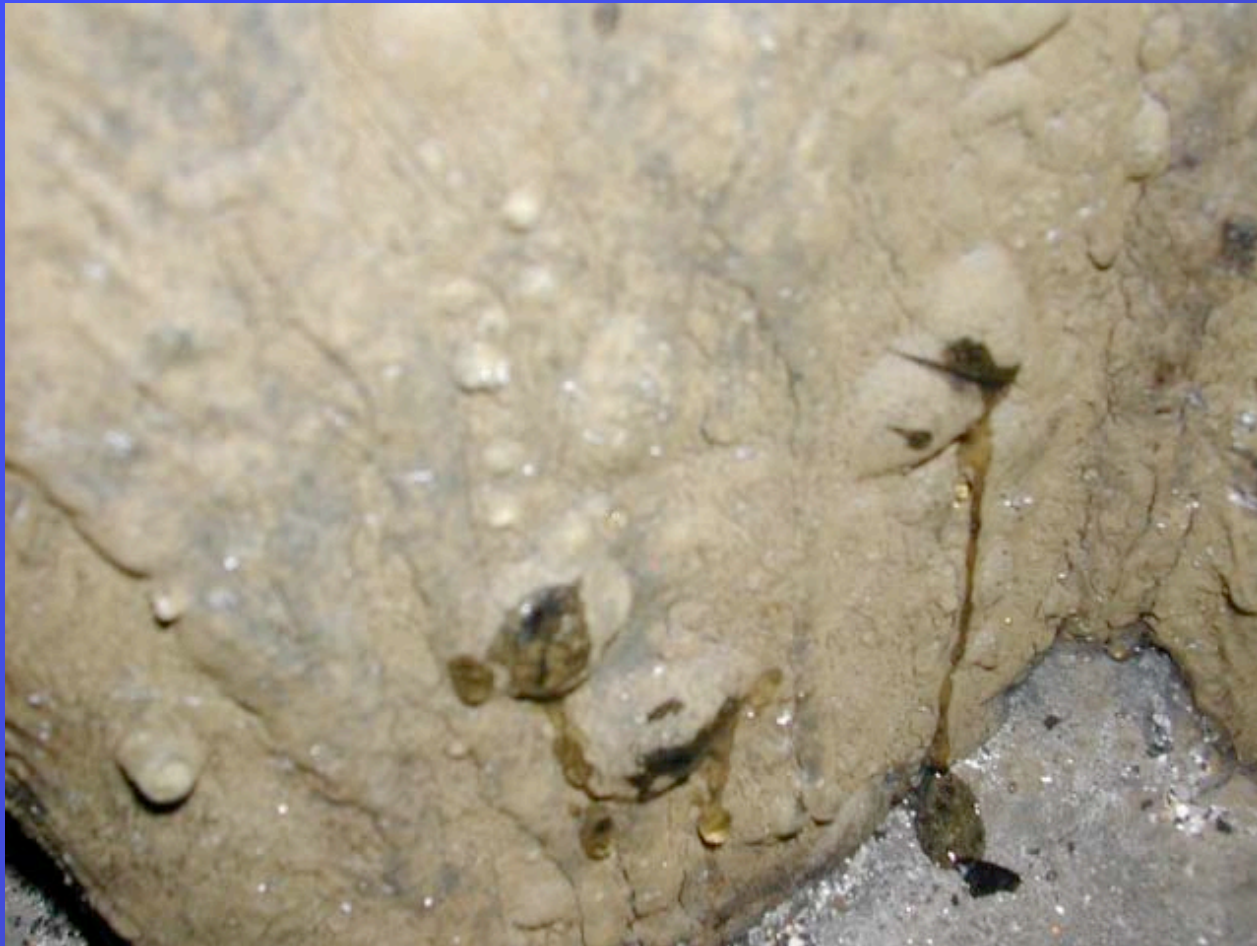
- *Application followed all other manufacturer's recommendations*
- *Petrographic examination indicated that the concrete was of good quality*
- *Blisters were often fluid-filled and under pressure*
- *Disbondment observed between epoxy base coat and concrete and between top coat and epoxy base coat*
- *Indication of possible formulation problems*

## Typical fluid-filled blisters

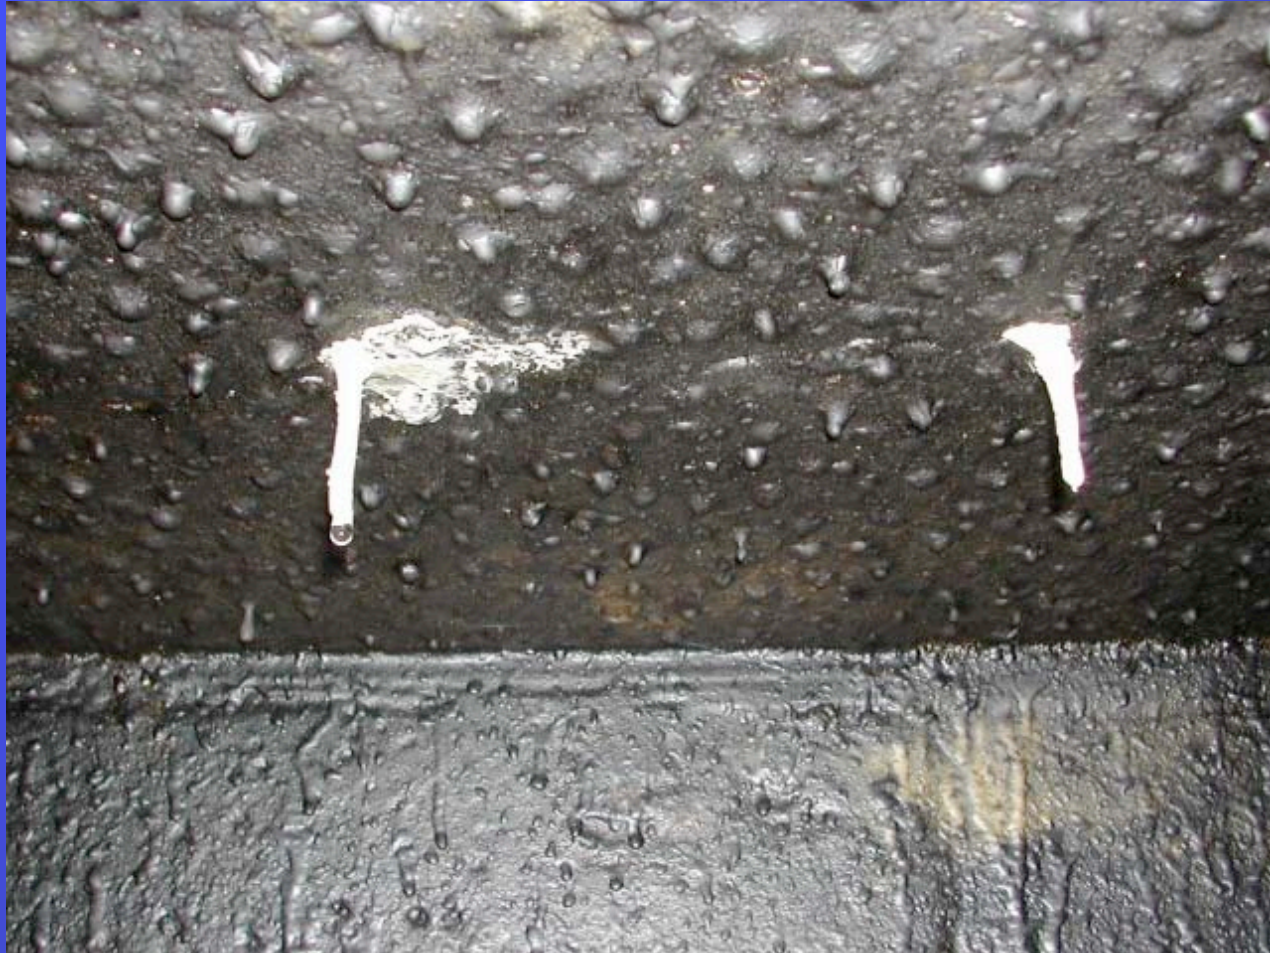
## Blisters under the ceiling

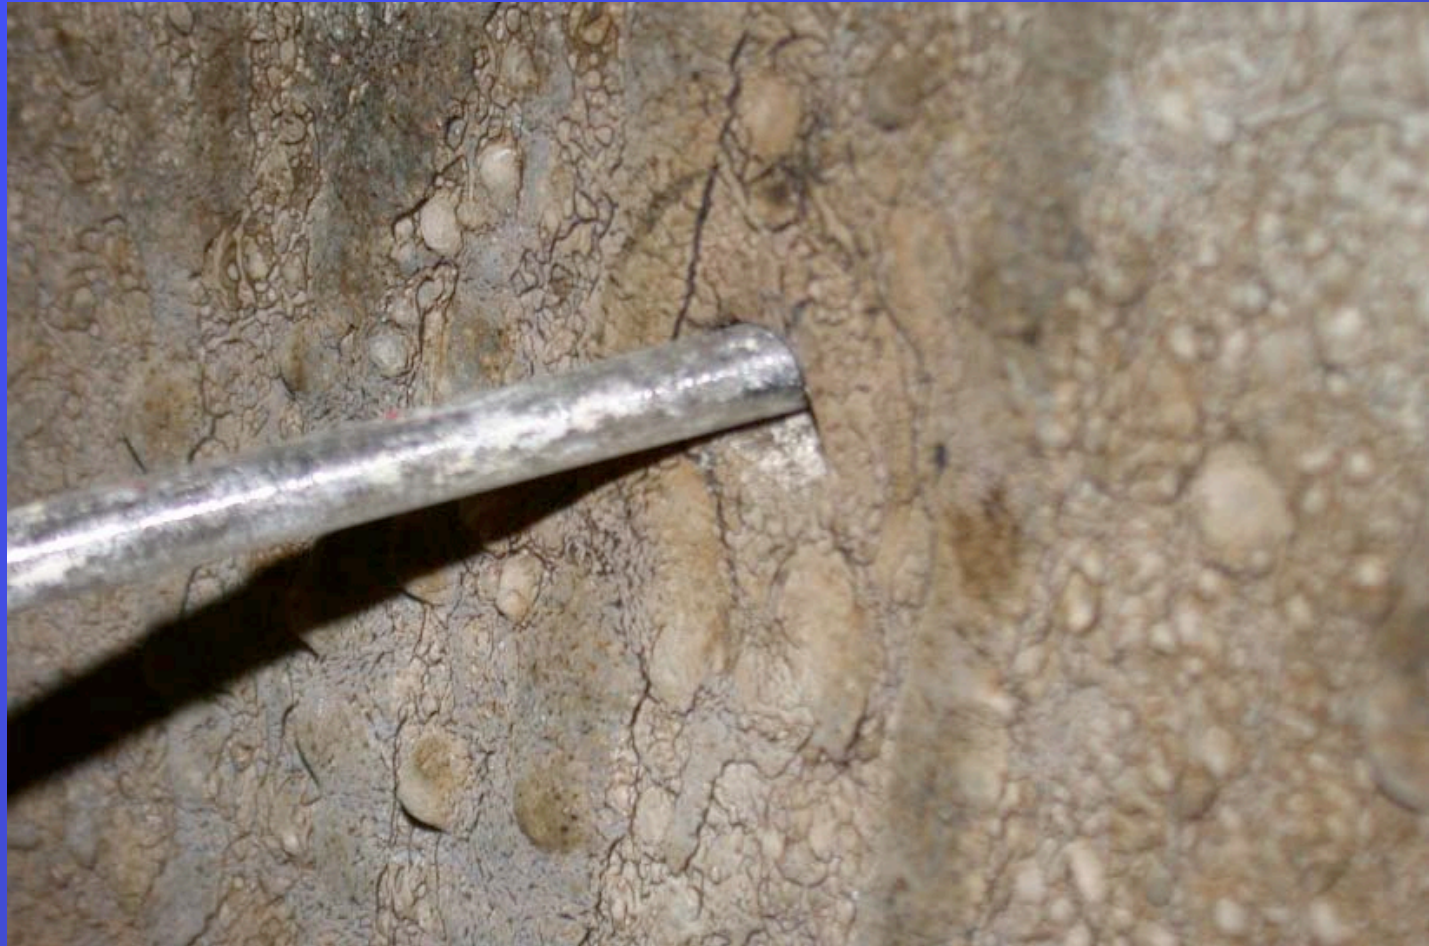
## Holidays below the coating

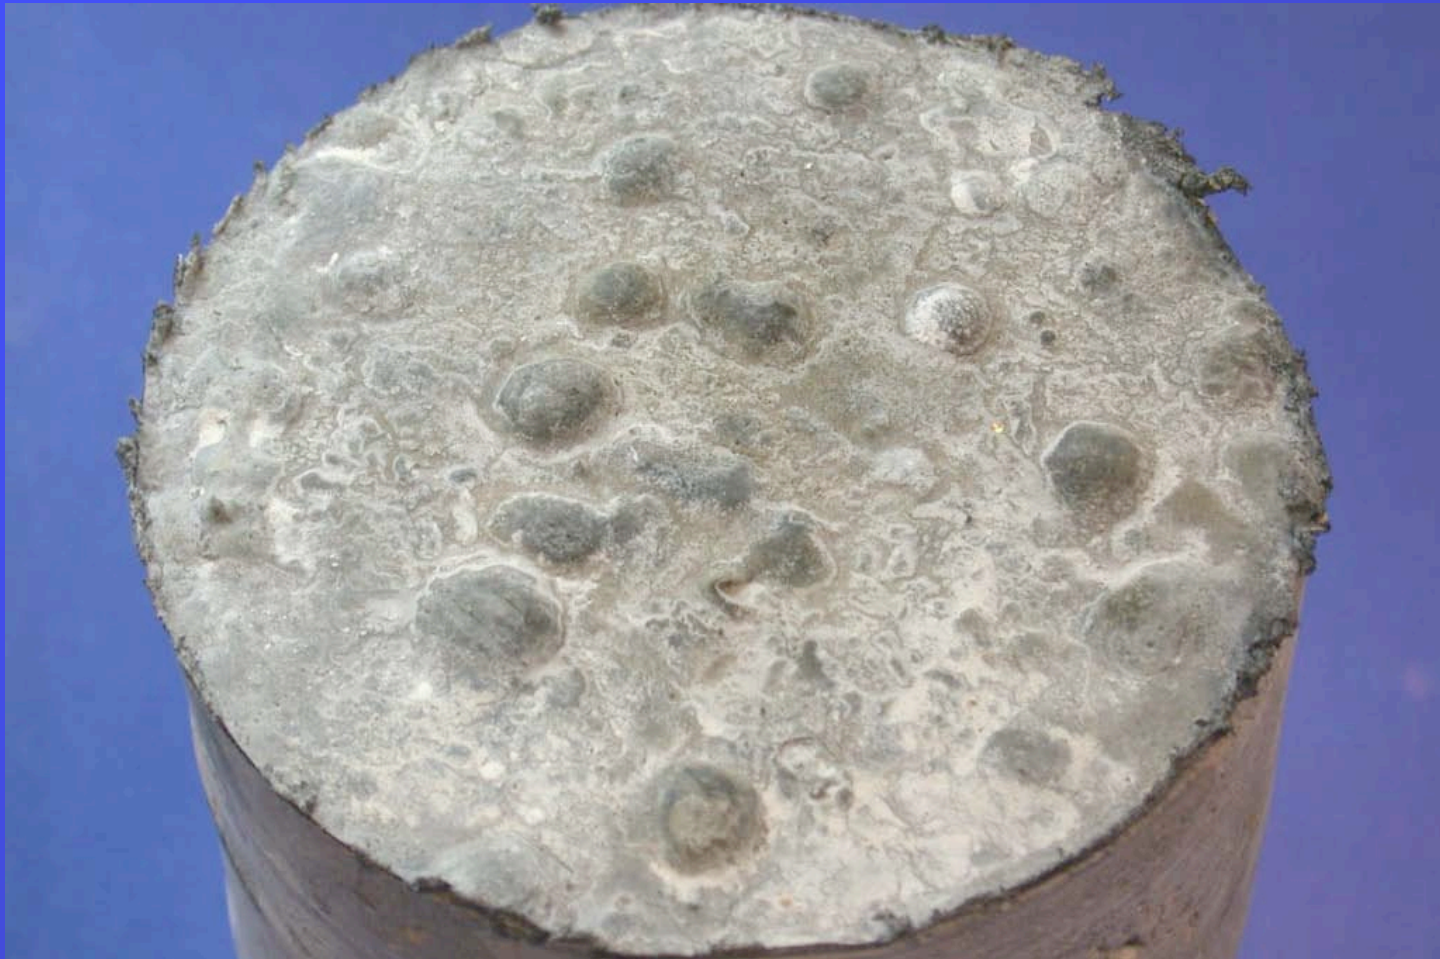
## Blister on a core from the floor

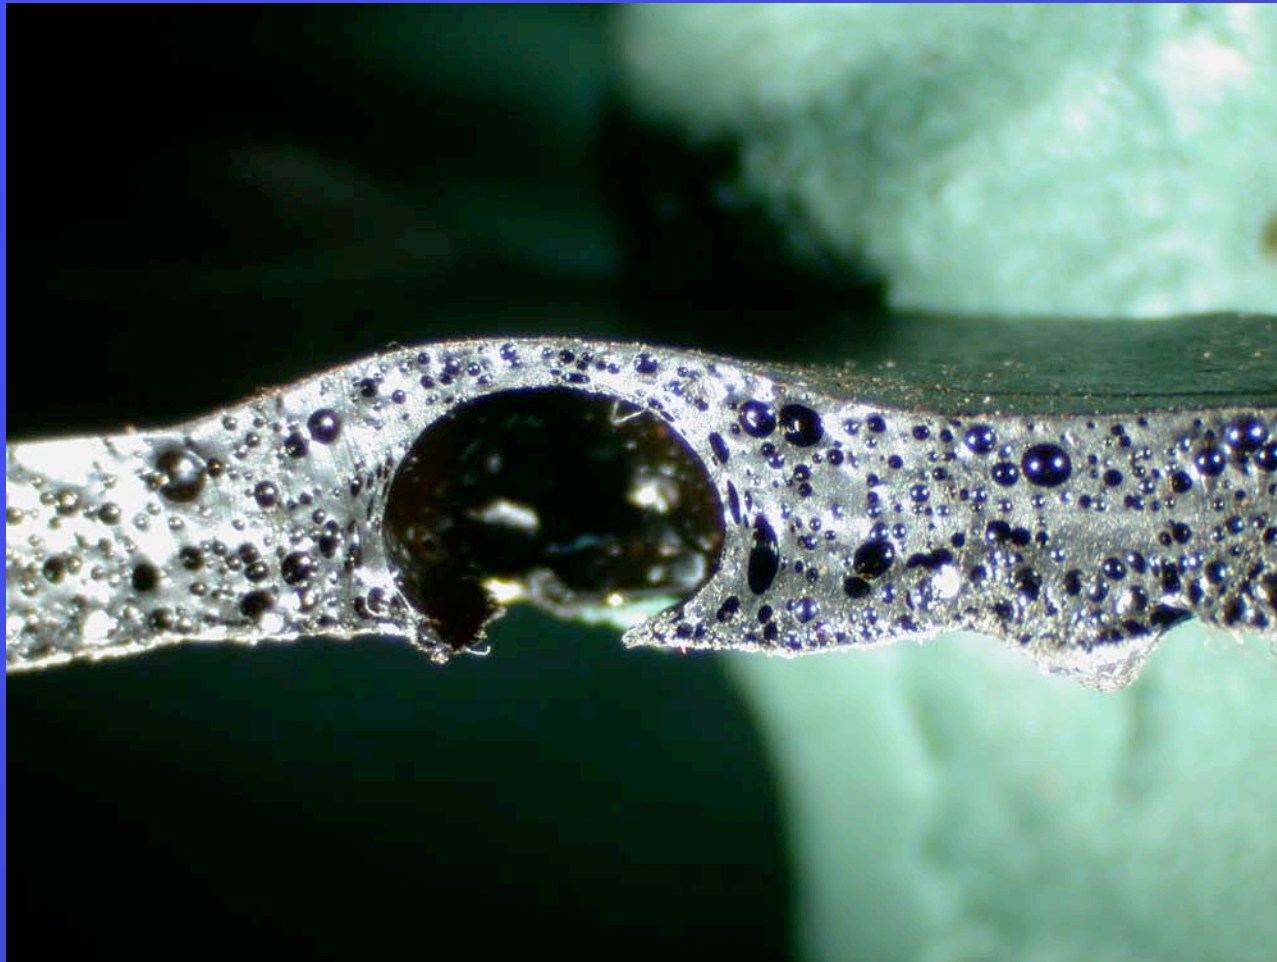
## Voids in coating indicating possible material problem

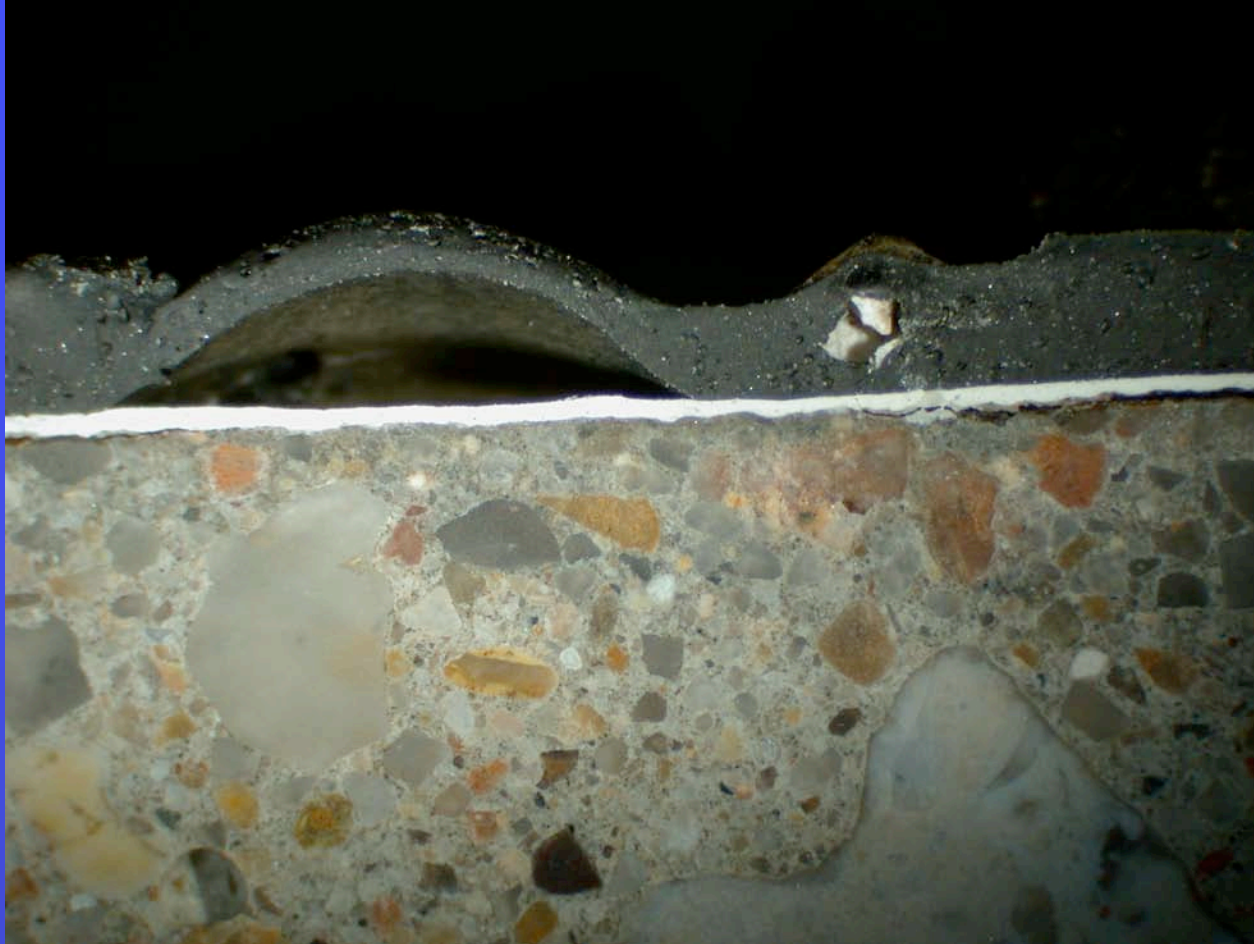
## Blister between top coat and epoxy base coat

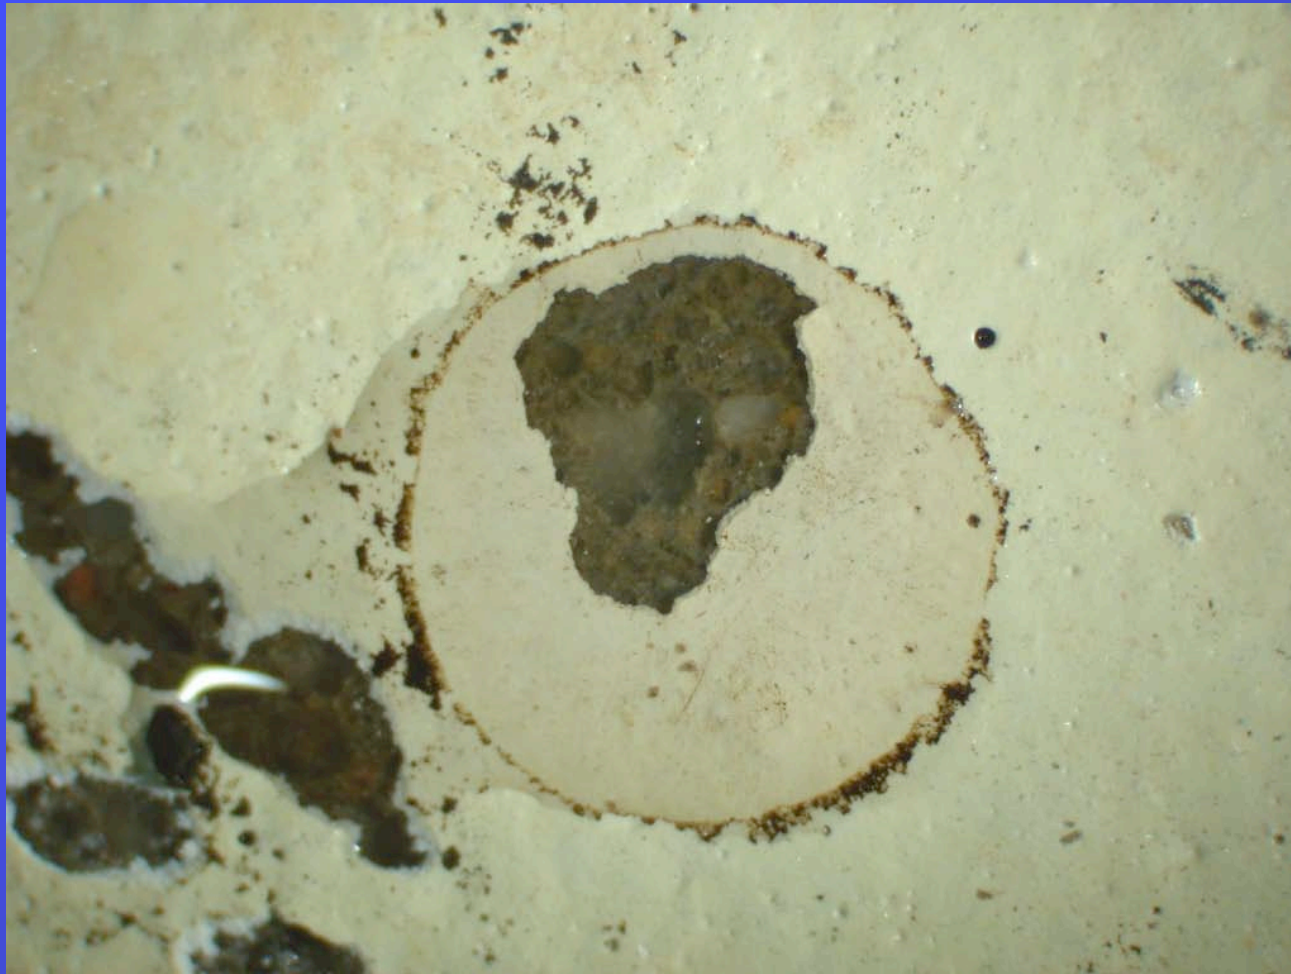
## Liquid from blister
