# Concrete Floor Covering Failures

*B. Lee Lawrence, P.E.*

*Wiss, Janney, Elstner Associates, Inc.*

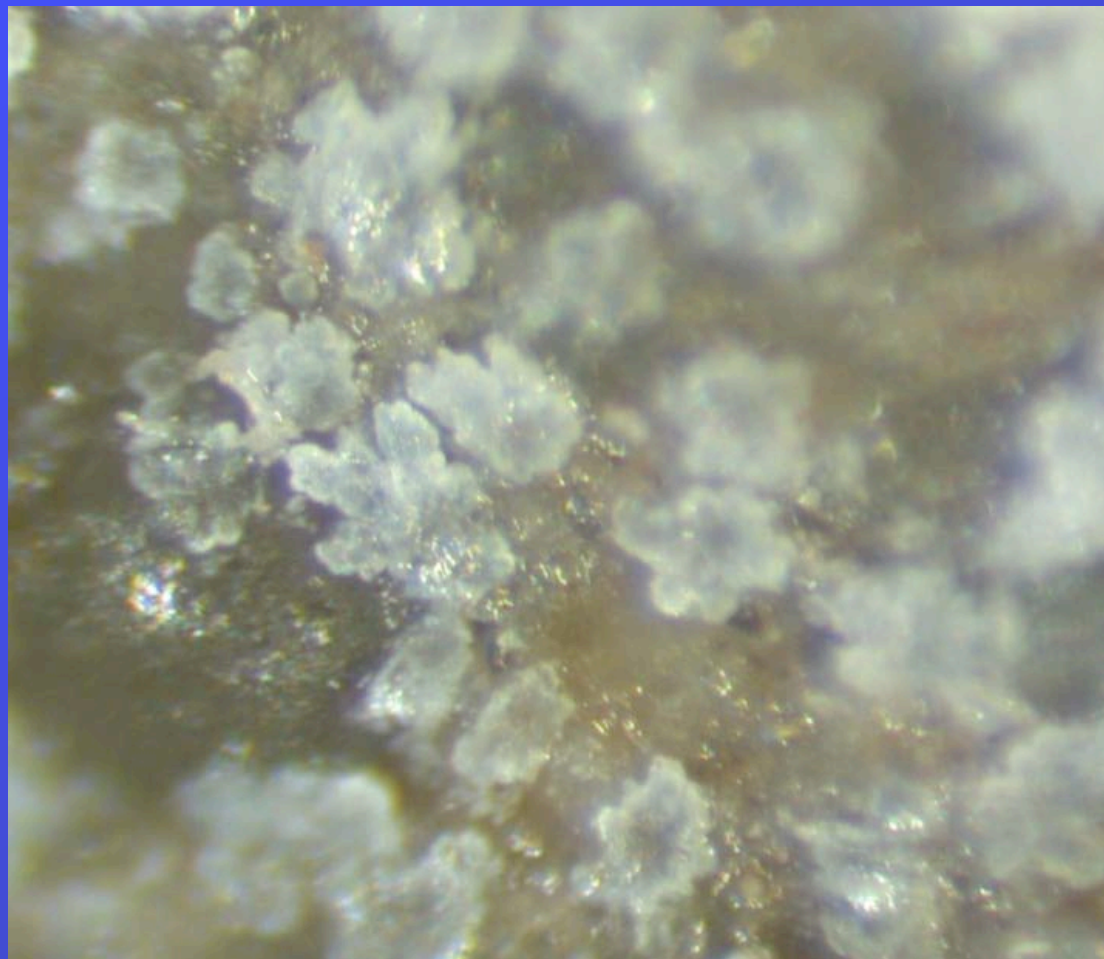
## Crystals from evaporated blister fluid

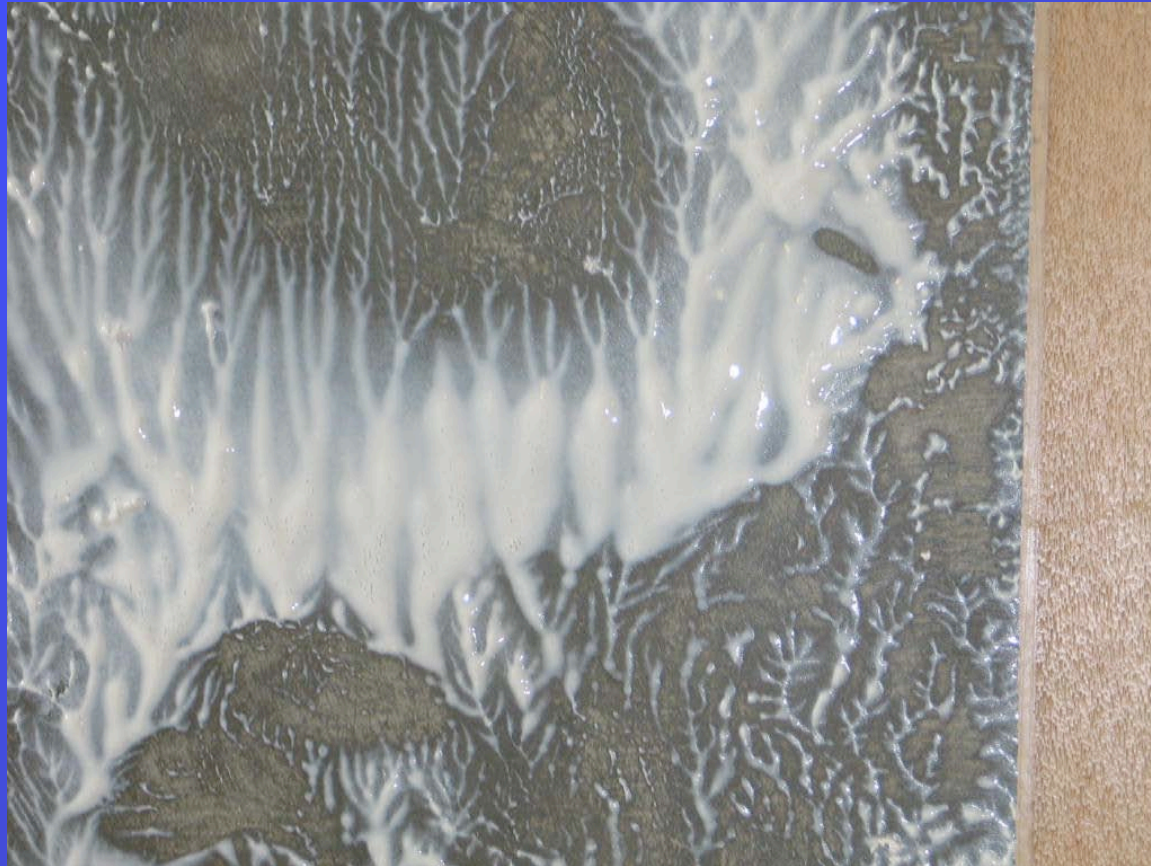
- *Laminated rubber-like sheet installed with a water-based adhesive;*
- *A relatively new installation (less than one year)*
- *The slab was directly underlain by a layer of sand with 6 mil vapor retarder located beneath the bed of sand*
- *The sand had an approximate 11 percent moisture content; and*
- *When removed, adhesive was found to have liquidized due to a high moisture and alkali condition causing saponification of vinyl acetate-based polymer and phthalate ester plasticizing components in the adhesive*

## Liquidized adhesive
