Settlement of Foundations on Expansive Clays
Due to Moisture Demand of Trees
Technical Presentation at November, 2001 Meeting
Foundation Performance Association
Kenneth E. Tand, P.E.

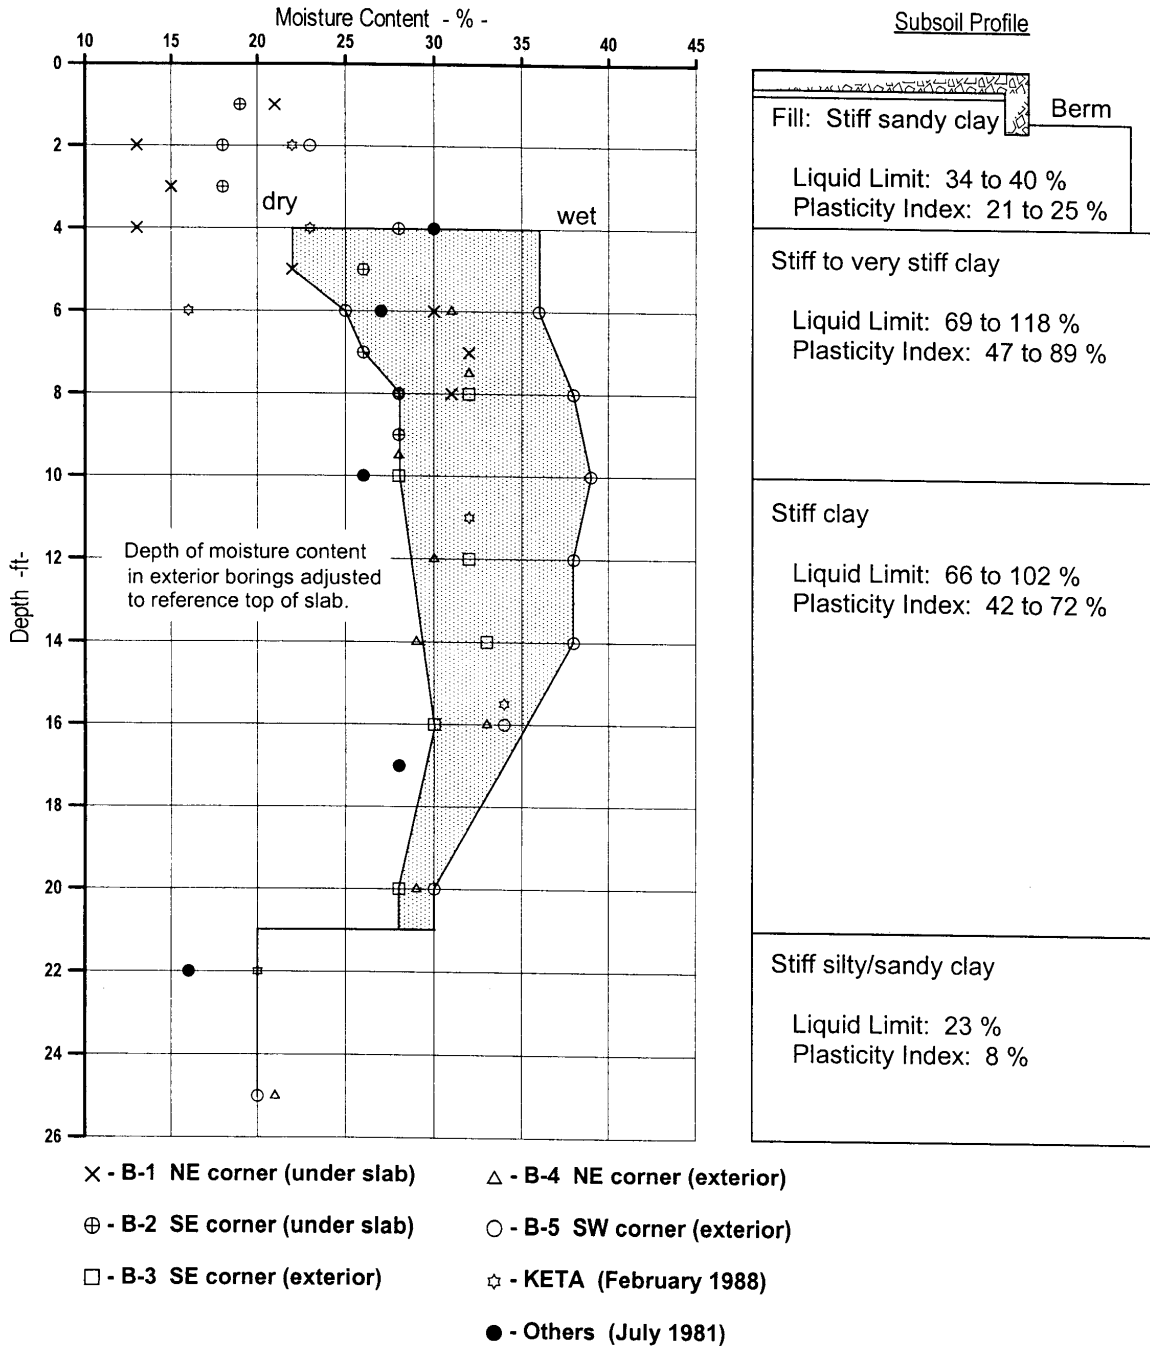
Figure 3
Subsoil Moisture/Profile
Site 1

Shown on Figure 3 is a plot of moisture content with depth. Analysis of the data indicates that the difference in moisture content is **very** high near the surface, and that it is about 20 feet below exterior perimeter grade.

I found feeder and fine roots in the soil samples from the surface to 10 feet (depth of borings) inside the building. Also, I found both fine and feeder roots to a depth of 15 feet in the boring near the southeast corner, and found one 1/32 inch diameter live root in the soil sample at a depth of 18 to 20 feet. Thus, it appears that the depth of the feeder roots is below 20 feet. The roots found in the borings under the floor slab are beyond the drip line which is commonly assumed to be the major zone of root growth. Along the south wall near the southeast corner, we found one 1/2-inch diameter root at the surface which was about 17 feet beyond the drip line of the 32-inch oak tree near the southeast corner.

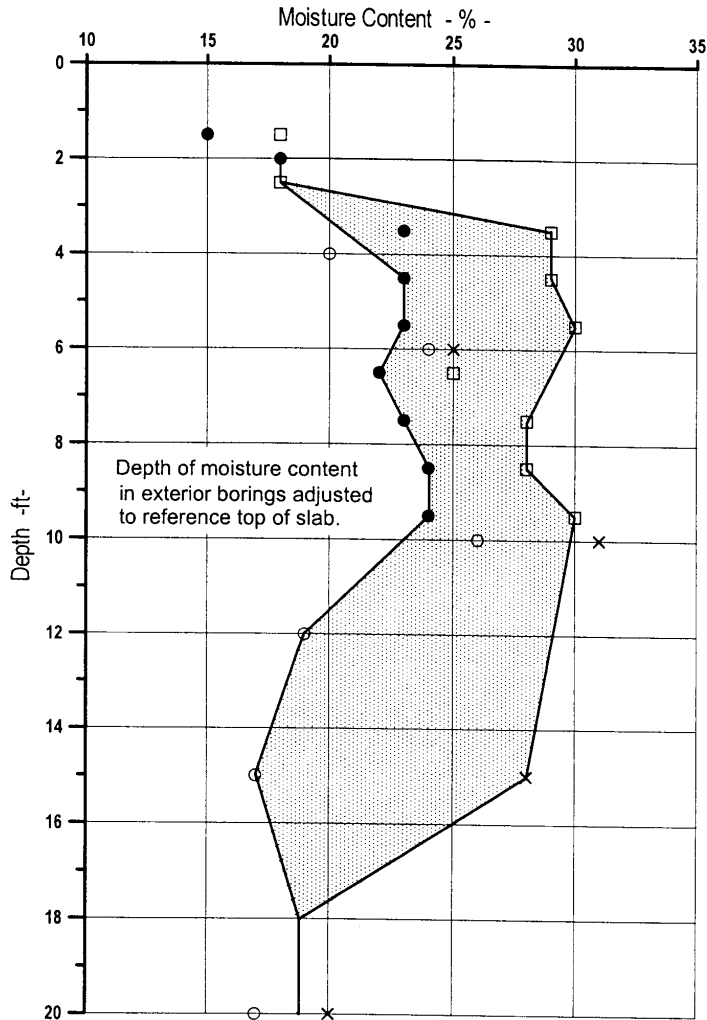
Figure 4
Subsoil Moisture/Profile
Site 2

Feeder roots were observed in the soil samples to a depth of 10 feet at boring B-2 where the maximum settlement had occurred, but no roots were observed in boring B-1 where little settlement, if any, had occurred.

Shown on Figure 4 is a plot of moisture content with depth. The depth of moisture change appears to be greater than 20 feet. However, this assumption is based on limited test data from two borings drilled at the perimeter of the building. Boring B-3 was drilled at the drip line of an oak tree, and boring B-4 was drilled in a lawn area about 70 feet east of boring B-2 where no trees were present. The pocket penetrometer tests at 18 to 20 feet were very similar at these two borings suggesting that the moisture content is reasonably similar. Thus, the difference in moisture content could be due to material changes and the depth of moisture change could be between 15 and 18 feet. For purpose of this report, a depth of 18 feet is assumed.

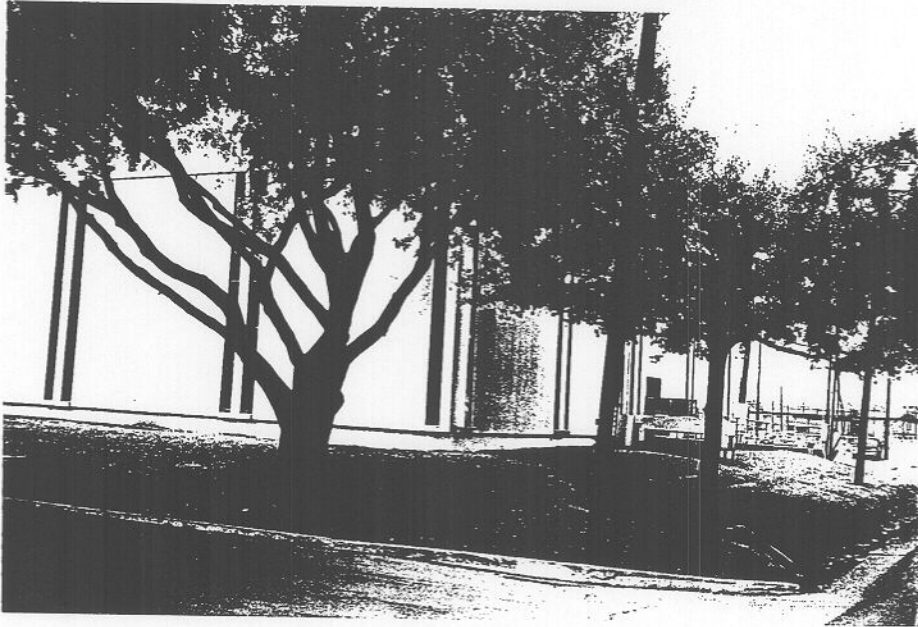
There are two large trees close to the northeast corner (Photo 1) that range in diameter from 18 inches (oak) to 42 inches (ash). The branches of the ash tree had to be pruned so that they did not rub against the east wall. There are two oak trees about 30 feet east of the east wall near the southeast corner (Photo 2) that range from 20 to

32 inches in diameter. The drip line of the trees is within 6 feet of the east wall. There are large roots at the ground surface around the trees and indications of root thrust under the asphalt parking lot on the east side of the building.

Photo 1
Ash & oak trees near NE corner of building

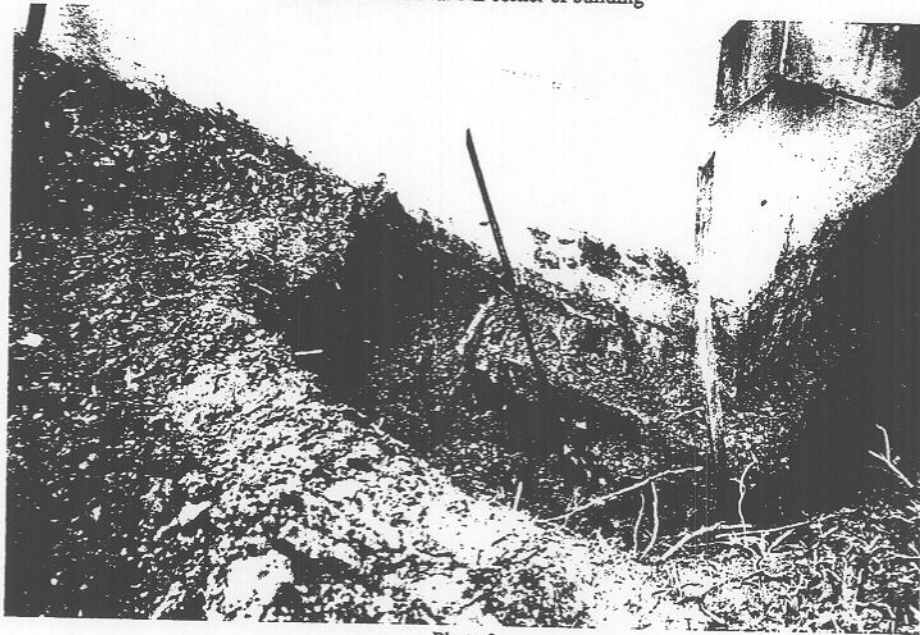
Photo 2
Root penetrating below slab at NE corner of building

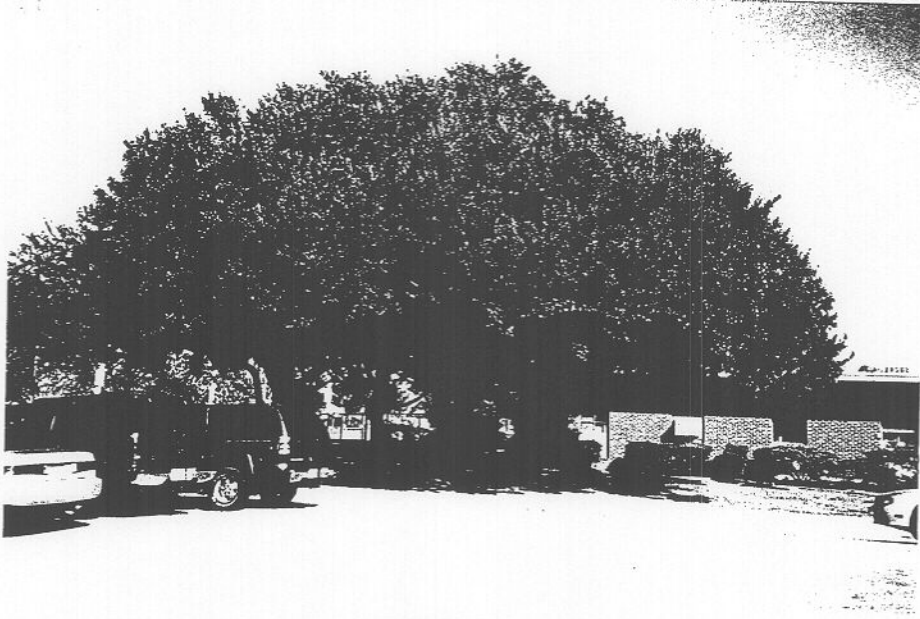
Two oak trees varying from 28 to 30 inches in diameter (see Photo 3) had been planted close to the area where the maximum amount of settlement was observed. The drip line of the trees was at the edge of the roofline. There were 4 inch diameter roots at the ground surface that were heading straight for the building.

**Photo 3
Oak trees near NW corner of building**

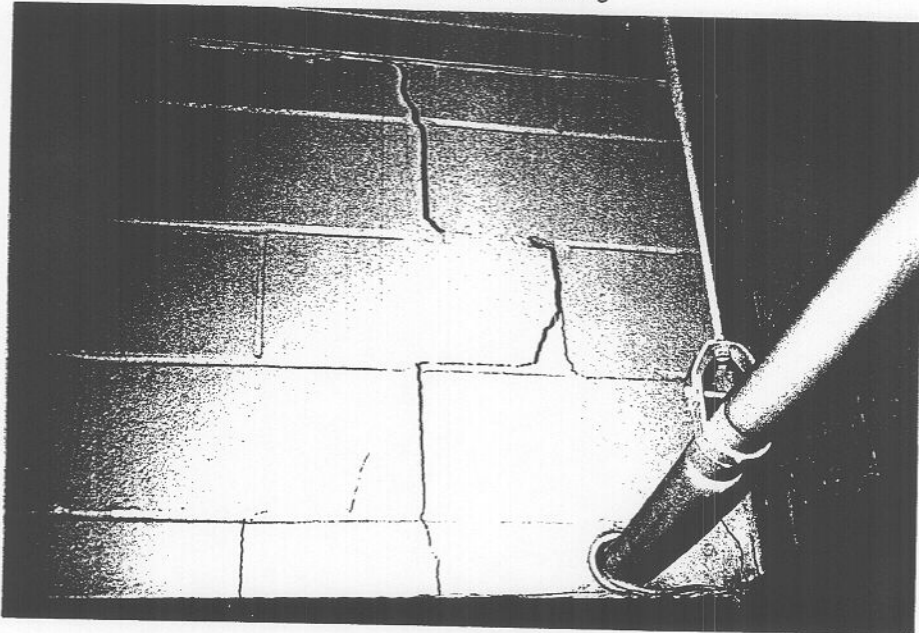
2000 the client authorized geotechnical studies to evaluate the cause of settlement at the west wing. Large cracks in the interior CMU walls (see Photo 4) occurred due to settlement. Settlement also occurred in other parts of the building, but geotechnical studies were not performed in these areas.

**Photo 4
Typical cracks in interior CMU walls**
