CASE STUDY OF THE PAVEMENT DISTRESS AT A SERVICE STATION

By Hsienjen Stephen Tien, Eng.D.¹ and David A. Eastwood, P.E.²

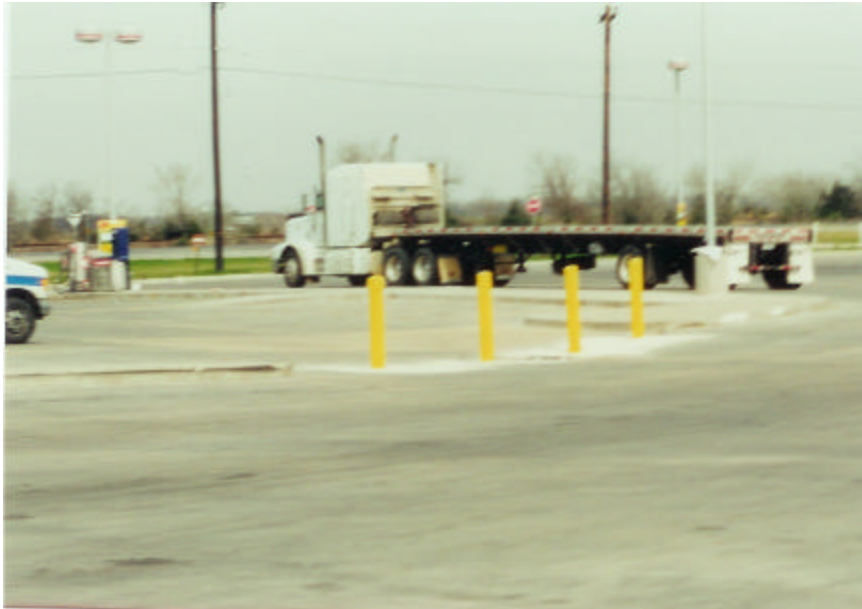
- The property is about 2- to 4- ft above the surrounding area. Fills have been placed on this property.
- Some steel poles were added to the site, at the passenger vehicle parking lot located to the east of the food mart building, to prevent 18-wheelers from crossing to the passenger vehicle parking lot. A picture taken at this location is presented in Figure 2.

Figure 2. A View of the Steel Poles Located to the East of the Food Mart (Between Areas V and VIII); These Poles Preventing 18-wheelers from Crossing to the Passenger Vehicle Parking Lot

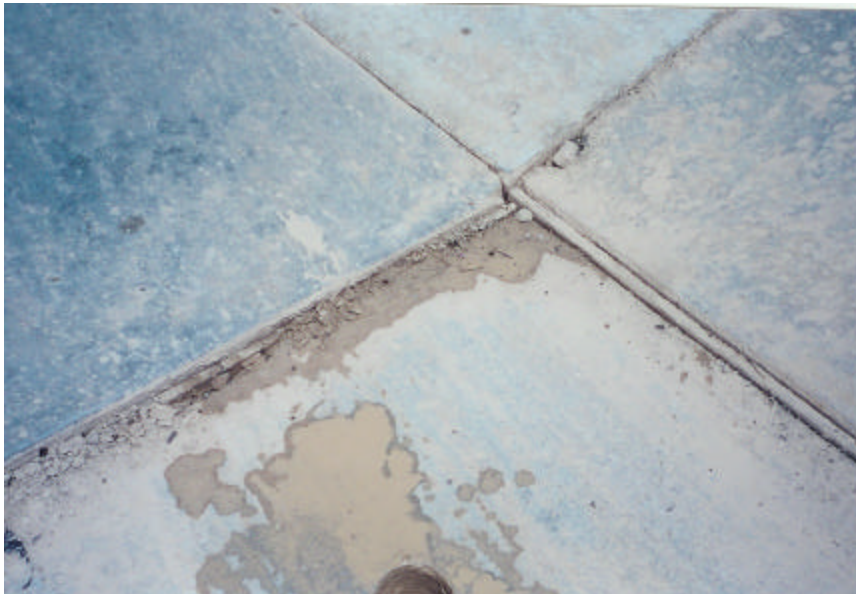
- The observations of the concrete paving at Area III (7-inch thick concrete) indicate an expansion joint with missing joint sealant and deteriorated wooden insert located to the southeast of the RV service islands. Subgrade fines mixing with water were pumped out when heavy trucks passed by. A picture taken at this location is shown in Figure 3. The similar failure was observed at a control joint located to the southeast of the food mart at Area V, and an expansion joint located at the service station exit to the country road at Area VI. This type of failure suggests that the pavement is losing the subgrade support underneath the concrete.

Figure 3. A View of the Expansion Joint with Missing Sealant and Deteriorated Wooden Insert Located to the Southeast of the RV Service Island (Subgrade fines mixing with water were pumped out when heavy trucks passed by.)

- Old, deteriorated sealant in the top of the joint needs to be resealed using liquid field-molded sealants as specified for new construction, such as AASHTO M173 and ASTM D 1190 that include hot-applied thermoplastic asphalt-rubber compounds (Ref. 3). Deteriorated sealants should be repaired immediately to prevent more surface water seeping into the subgrade soils.

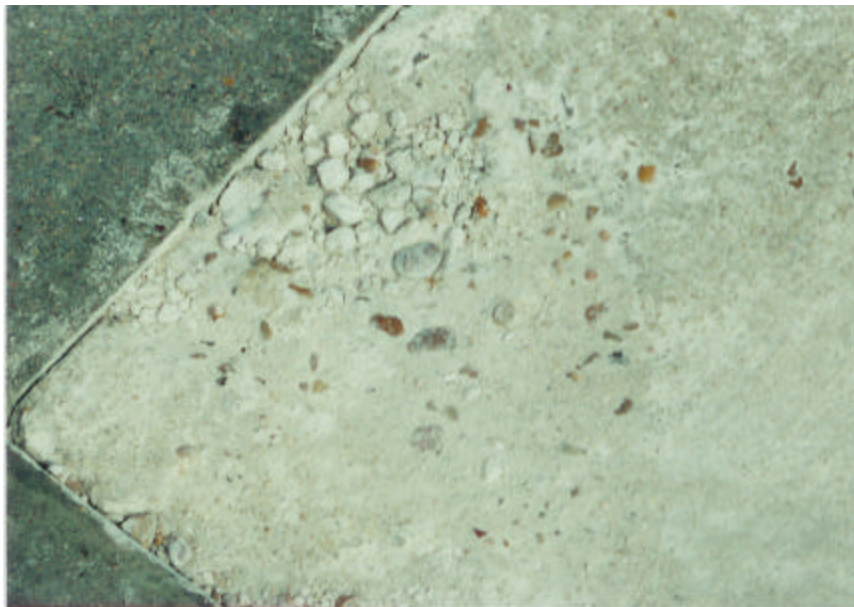
Figure 5. A Close-up of the Concrete Patch Located to the South of the Food Mart (The concrete is cracking and spalling, and aggregates are falling apart.)

- In the areas where significant cracking is occurring, these areas should be removed, using saw-cutting techniques and replaced with new pavement. The subgrade soils in the new pavement area should be lime stabilized to a depth of six-inches with 5% lime by dry weight. Texas Department of Transportation (TxDOT) Specifications, Items 260 and 264, can be used as a procedural guide for placing, mixing, and compacting the stabilizer and the soils. Alternatively, the top six-inches of subgrade soils can be replaced with six-inches of crushed limestone. The limestone base should be compacted to 100% modified proctor density, according to ASTM 1557, with moisture contents within $\pm 2\%$ of optimum moisture contents. All of the sands should be removed in the area that pavement saw cutting takes place.

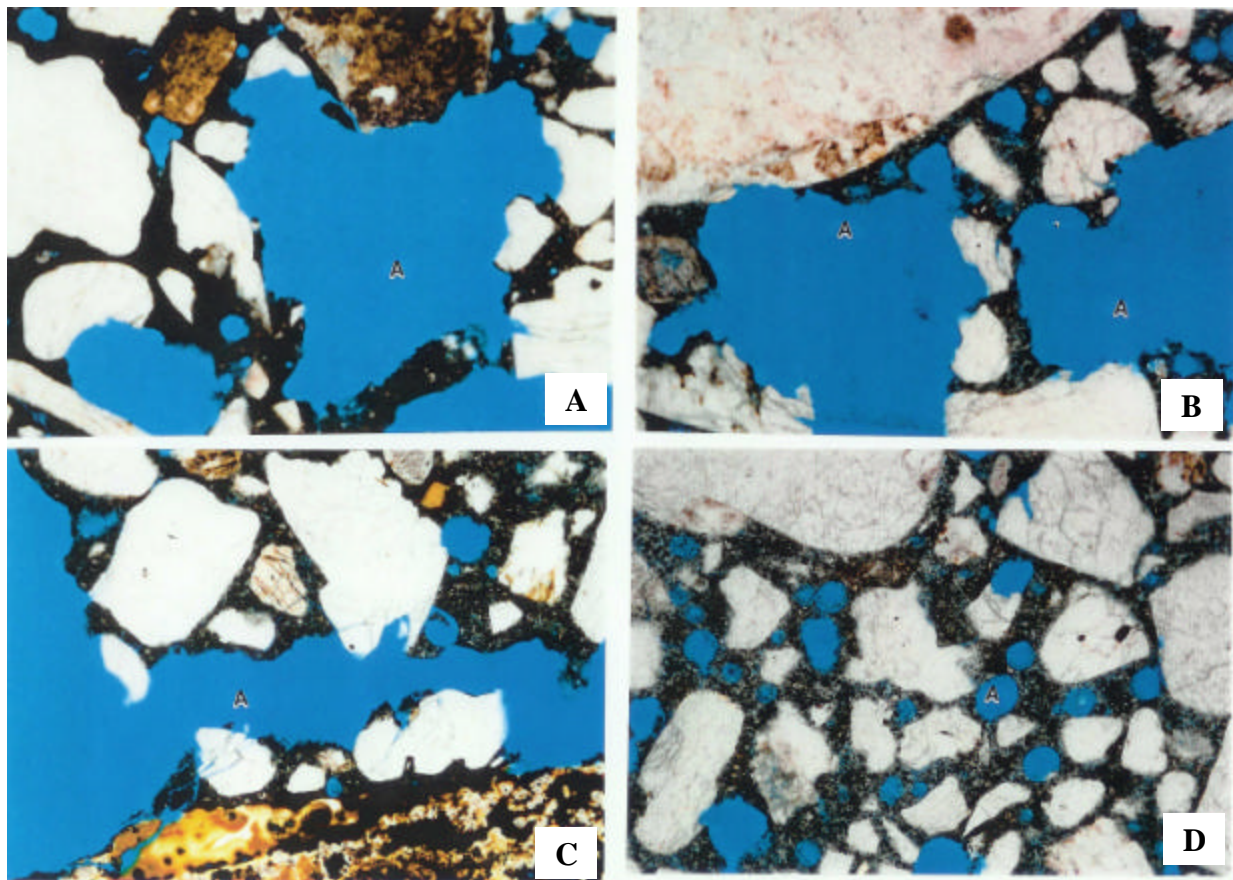
The petrographic analysis of Core B-12 indicates only a few vertical microcracks observed, however, excessive amount of voids were present in the upper part of the core (see Figure 10) due to improper mixture of water and concrete, or delayed placement of concrete mixture. Furthermore, unhydrated cement particles and marginally hydrated cement grains were found in Core B-12 which showed incomplete hydration of the concrete. Core B-12 showed the concrete at its adjacent area may not be in a fully serviceable condition.

- One of the concrete cores obtained at the bad concrete area of the project site (Core No. B12) was examined using the petrographic analysis. The analysis results indicate that this concrete core contains an exceptionally high amount of voids which can result from either that the concrete mixture was not mixed properly before it was placed or an attempt was made to place the concrete that had already began to harden. The testing results of this concrete core show that some of the pavement concrete may not be in a fully serviceable condition. Furthermore, its strength is likely to be affected.

Figure 10. Small to Coarse Air Voids (Blue Areas) Observed in the Concrete Core Obtained at Boring B-12 Location

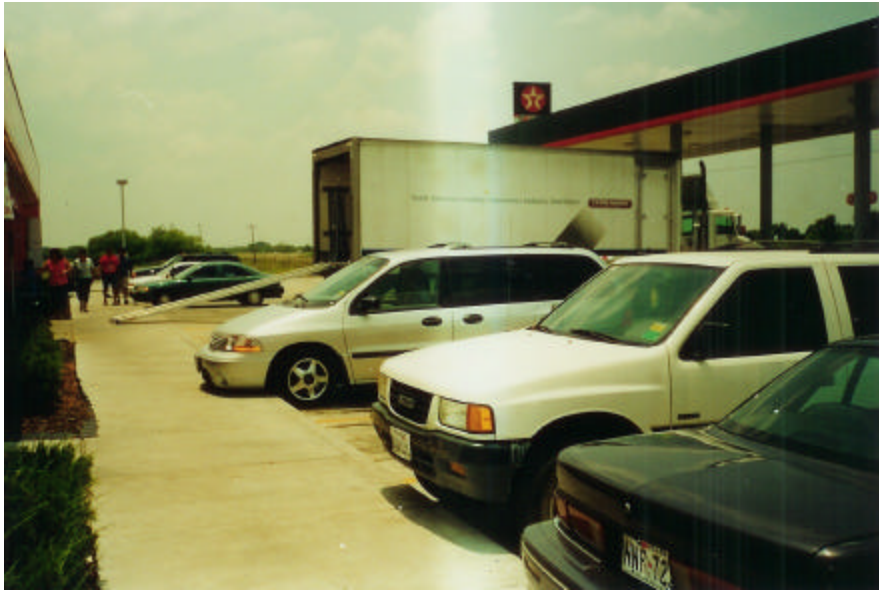
Our traffic study has two different stages. The first stage is observing the traveling routes of the 18-wheelers in the Texaco Food Mart site. In general, the five-inch concrete areas (i.e. Areas VII & VIII) are set up for light-weight passenger vehicles. However, 18-wheelers were often observed traveling and parking at these areas. Our two-day Phase I traffic study indicates that more than 40% of 18-wheelers took the routes through the five-inch concrete areas, and resulted in premature failure of the five-inch concrete pavements.

- During various site visits, 18-wheelers were observed running through the areas designed for light-weighted passenger vehicles and RVs (*Areas VII and VIII*). Heavy trucks traveling on thin pavements usually lead to extensive cracking and significant shorten the service span of the concrete paving.
- According to the traffic studies, the existing pavement thickness of 5- and 6-inches at *Areas I, II, VII and VIII* is not appropriate for the current traffic load. This results in a shorter pavement life expectancy. Instead of the 20-year life span described in the contractor's warrantee, the 5- and 6-inch pavement structures would have lasted for only 56 days and 4.3 years respectively, after the service station started to operate.

Figure 11. A View of an 18-wheeler Unloading Merchandise at the Front Entrance of the Food Mart (Area VIII)

- Construct a designate truck route with 8-inch thick concrete for 18-wheelers to replace the existing truck route, and impede the heavy trucks from entering the thin pavement areas by using barriers or directional signs. For the new constructed truck route, the subgrade soils should be lime-stabilized, or replaced with crushed limestone as discussed above. Concrete flexural strength should be at least 500 psi at seven days and 3,000 psi at 28 days. This paving should be reinforced with No. 4 rebars at 18-inches

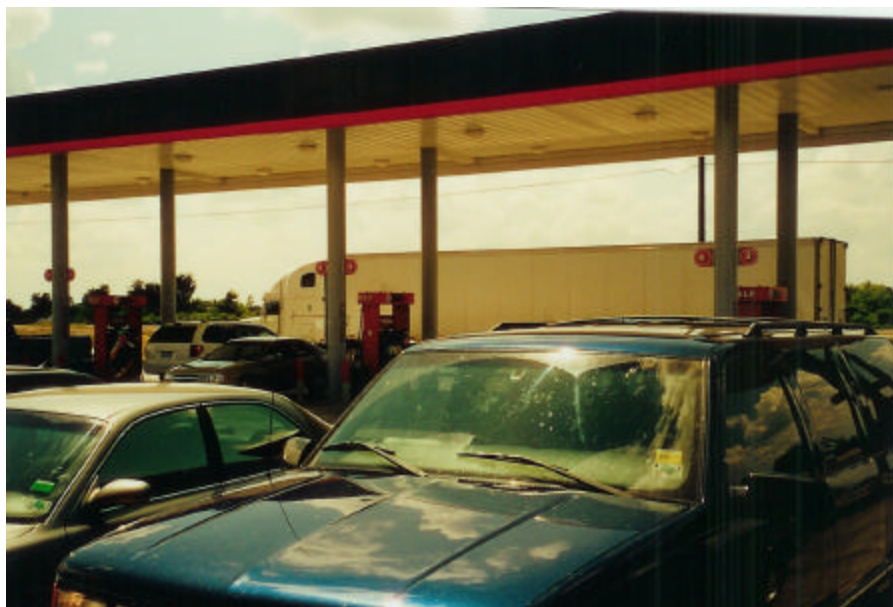
Figure 12. A View of an 18-wheeler Travelling Through the Passenger Vehicle Area (Area VIII)
