CASE STUDIES OF RESIDENTIAL FOUNDATION MOVEMENTS IN SOUTHERN HOUSTON AREA

By H. Stephen Tien, Ph.D., P.E.¹ and David A. Eastwood, P.E.²

ABSTRACT

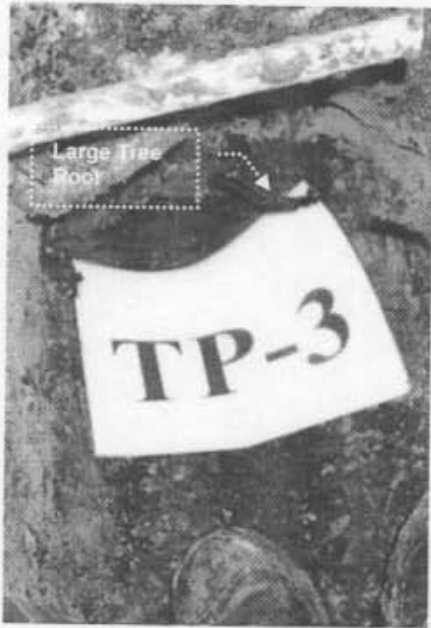
Our test pit excavations indicated a significant amount of root fibers under the grade beams, such as the large tree root found in Test Pit #3, as shown in Figure 2(a). Furthermore, perch water was observed behind/under the grade beam while digging the test pits. Figure 2(b) shows the perched water condition in Test Pit #4. Soil samples obtained from the interior borings showed that sands were mixed with clays and used as fill materials (see Figure 2(c) and 2(d)).

Figure 2. Test Pit Excavations and Soil Sampling at the Clear Lake Residence:
(a) Large Tree Root Found in Test Pit No.3, (b) Perched Water Observed Under the Grade Beam at Test Pit No. 4 Location, (c) Clay and Sand Mixture Soils Found at the Depth of 1- to 2-ft in Boring C-1, and (d) Clay and Sand Mixture Soils Found at the Depth of 0- to 1-ft in Boring C-2

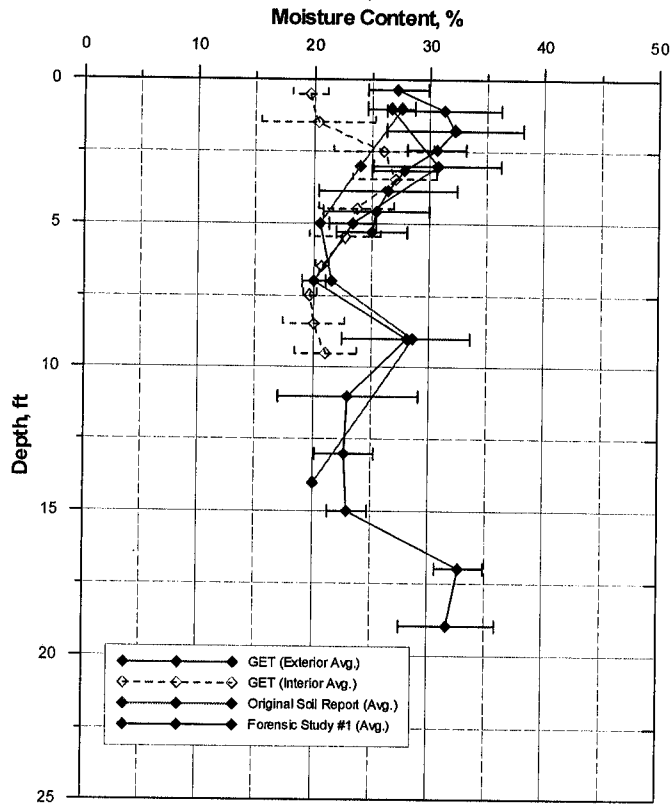
Figure 3. Average Moisture Content and Standard Deviation versus Depth at the Clear Lake Residence

It is seen from Figure 3 that in general the moisture contents obtained after the residence was built are higher than those measured before the construction, since the project site was heavily wooded. In the other words, the moisture contents in the subsoils increase after the trees at the project area were removed.

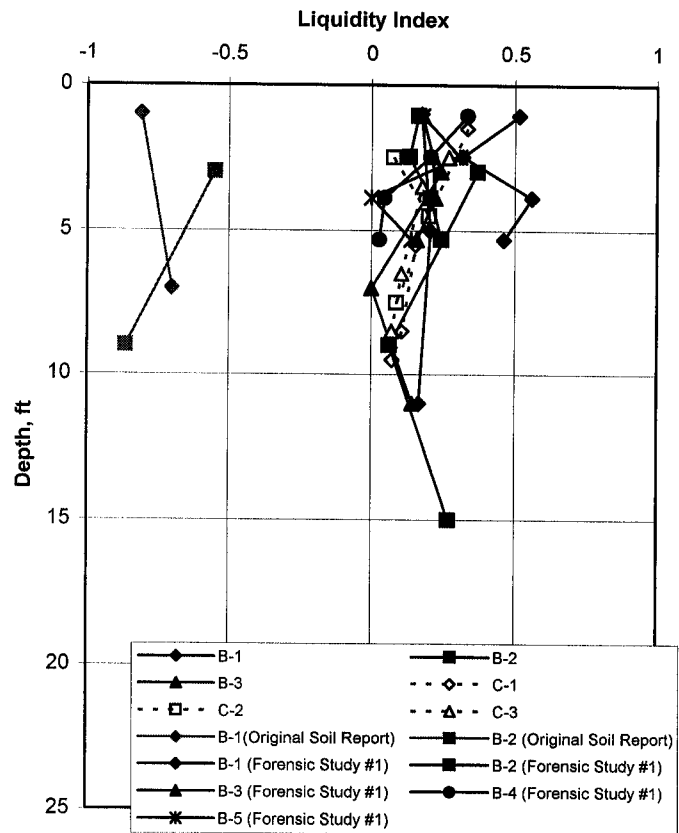
Figure 4. Liquidity Index versus Depth at the Clear Lake Residence

The liquidity index relates the subsoil moisture to the liquid and plastic limits. The liquidity index profile for all the borings is shown in Figure 4. In addition, the liquidity index profiles generated from the data of previous field explorations are also presented in the chart. A review of these data indicates that the subsoils had mostly positive (wet) liquidity index values after the residence was built (i.e., trees were removed), and subsoils had negative (dry) liquidity index values prior to the construction of the residence (heavily wooded condition).

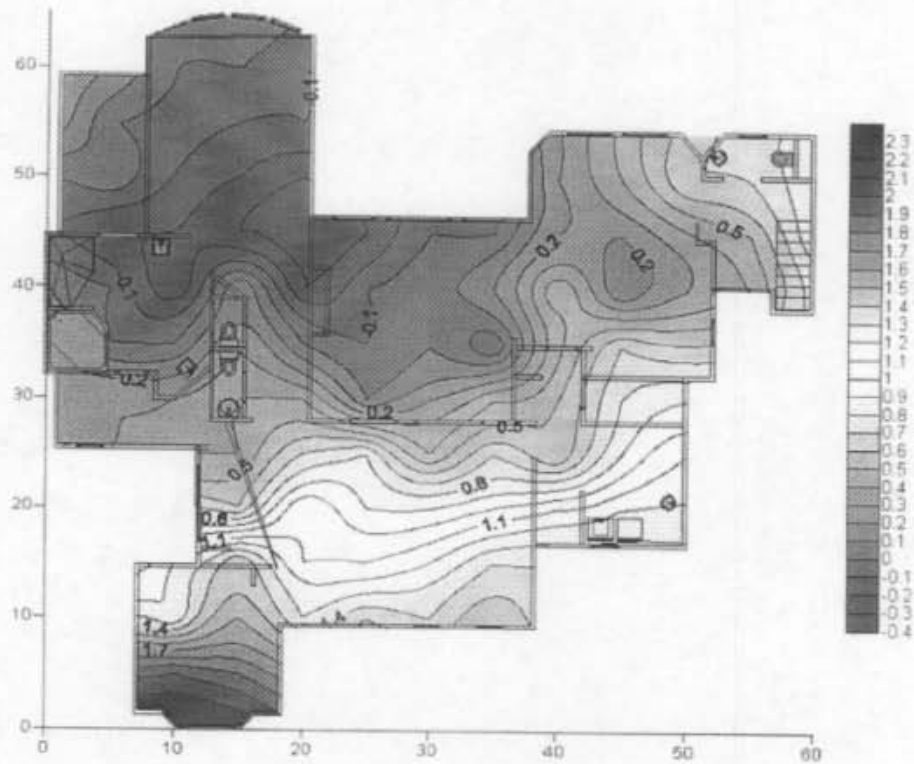
Figure 6. Floor Slab Micro-Elevation Survey at the Clear Lake Residence (performed on December 26, 2002)

Our review of the previous micro-elevation data indicates an elevation differential of about 2.3- to 2.6-inches in the subject residence. The data indicates floor elevations are high at the edge and low at the center (edge lift). The high areas are at the western portion of the residence (west wall of the study and the west wall of the dining room). The low area is at the northeast corner of the house (inside the master bedroom). Our micro-elevation data are presented in Figure 6, and show an elevation differential of 2.6-inches. Our measurements and previous micro-

elevation data indicate the elevation measurements from different engineering companies are consistent and all lead to an edge-lift case at the subject residence.

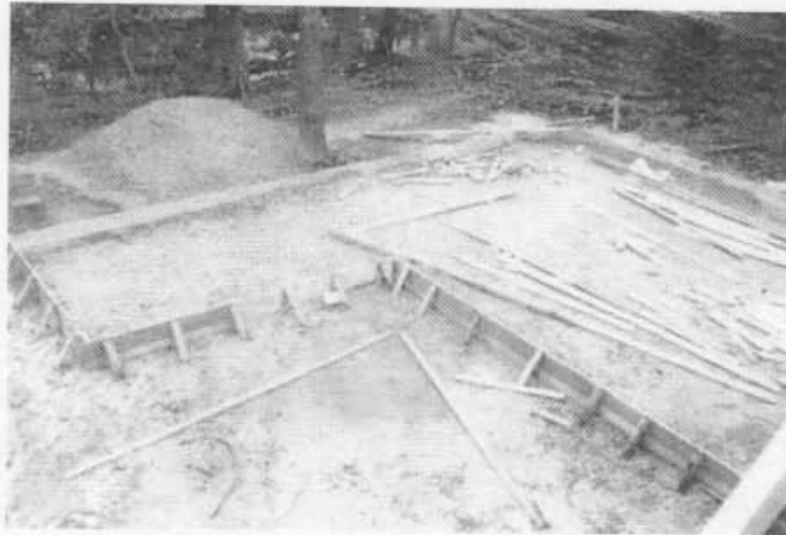
Construction Problems. Standing water was observed around the construction pad in the project site pictures taken during construction (see Figure 7(b)). In accordance with our review of the rainfall data for the Year of 1996 in Houston, Texas, published by NCDC, Asheville, NC, the total rainfall during the month of August in 1996 was about 10.58-inches (the month with the most rainfall amount during that year). Since the foundation was constructed in August, 1996, a lot of rainwater could have infiltrated the building pad prior to floor slab pour.

Poor Materials. Our review of the construction photo shown in Figure 7(b) indicated that significant amount of sandy soils were used for the construction pad. Our examination of the interior borings, C-1 through C-3, showed that silty sands and fat clay soils were mixed and used as fill materials on the site (see Figures 2(c) and 2(d)). In addition, the original soil report for the subject residence indicated that fill material within the building area should be lean clay having a plasticity index (PI) of 10 to 20 and a liquid limit of 28 or more. Among the three interior borings, Borings C-1 and C-3 have fill materials with plasticity indices (PIs) of 27 and 30 respectively, both over the required range. These sandy fill soils found in the interior borings, as well as in the test pit excavation next to the grade beams do not resist water to seep through these materials and travel under the foundation causing the expansive soils to swell and result in distress.

Figure 7. Project Site Conditions at the Clear Lake Residence: (a) Heavily Wooded prior to Construction and (b) Wet Ground Surface During Construction (prior to Concrete Pour)

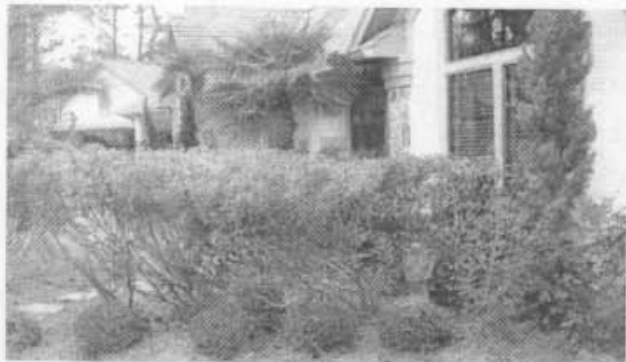
**Figure 9. Site Observations and Pier Exposure at the Friendswood Residence:
(a) Planter Area with Trees Adjacent to the South Side of the Residence,
(b) Cracks within the Pool Deck, (c) Perched Water Observed at Pier
Exposure Site No. 4, and (d) the Root System Found at Pier Exposure
Site No. 4**

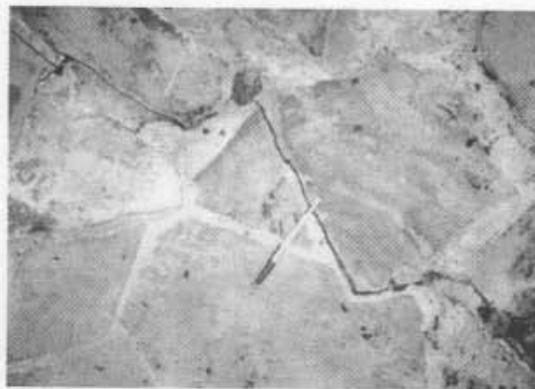
(b)

Our field exploration program consisted of conducting four (4) drilled footing exposures, concrete coring inside the residence as well as four (4) exterior soil borings to 20-ft deep and four (4) interior soil borings to 10-ft deep. The location of the drilled footing exposures and borings are presented in Figure 8. Our observations during the field explorations indicated that planter areas were constructed around the residence except the front porch and the pool area. Figure 9(a) shows the planter area located to the south of the residence. Furthermore, several cracks were observed all over the pool deck area, as shown in Figure 9(b).

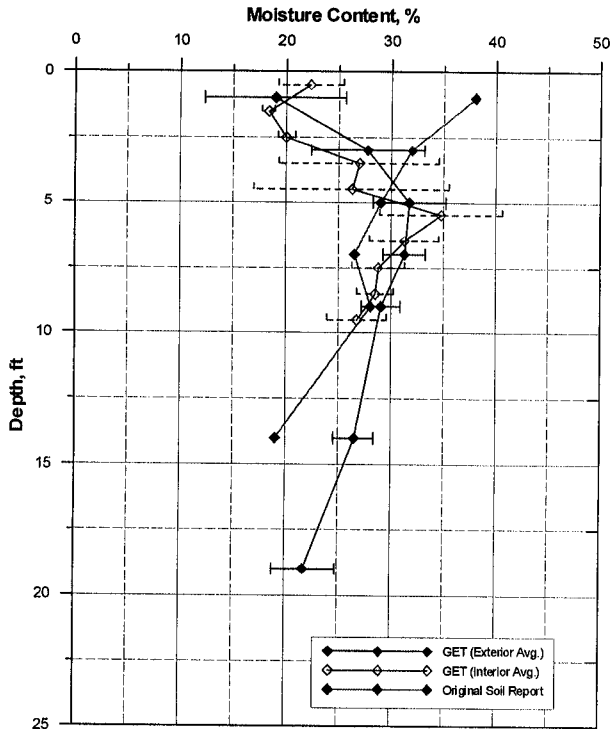
Figure 10. Average Moisture Content and Standard Deviation versus Depth at the Friendswood Residence

It is seen in Figure 10 that in general the moisture contents obtained after the residence and swimming pool were built are lower than those measured before the construction, above the depths of 5-ft, but higher below the depth of 5-ft. Namely, the moisture contents in the subsoils below the depth of 5-ft increased after the pool and house were constructed.

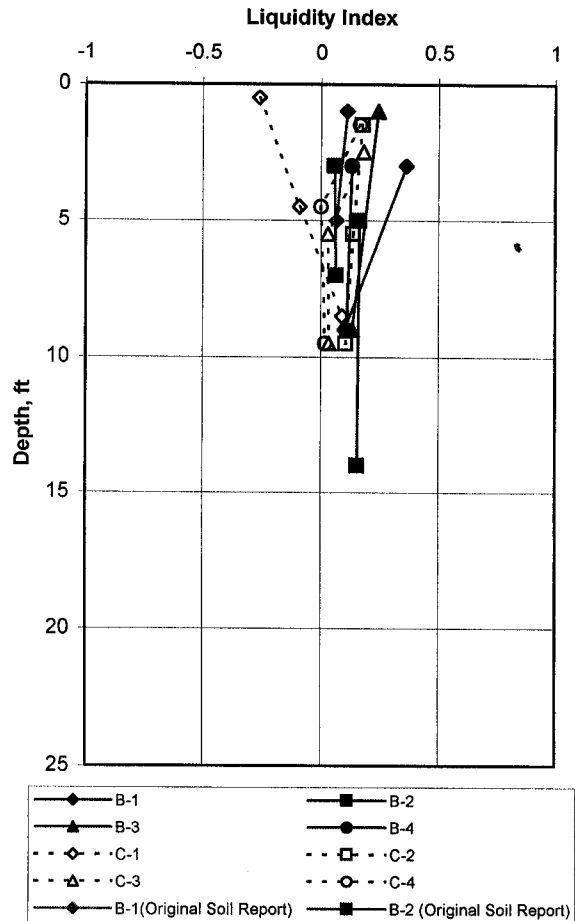
Figure 11. Liquidity Index versus Depth at the Friendswood Residence

Liquidity Index Profile. The liquidity index relates the subsoil moisture to the liquid and plastic limits. The liquidity index profile for all the borings is shown in Figure 11. Furthermore, the liquidity index profiles generated from the data of previous field explorations are also presented in the chart. A review of these data indicates that the subsoils had mostly positive (wet) liquidity index values. In addition, the subsoils from the interior soil borings had lower liquidity index values than those from the exterior borings in our field explorations.

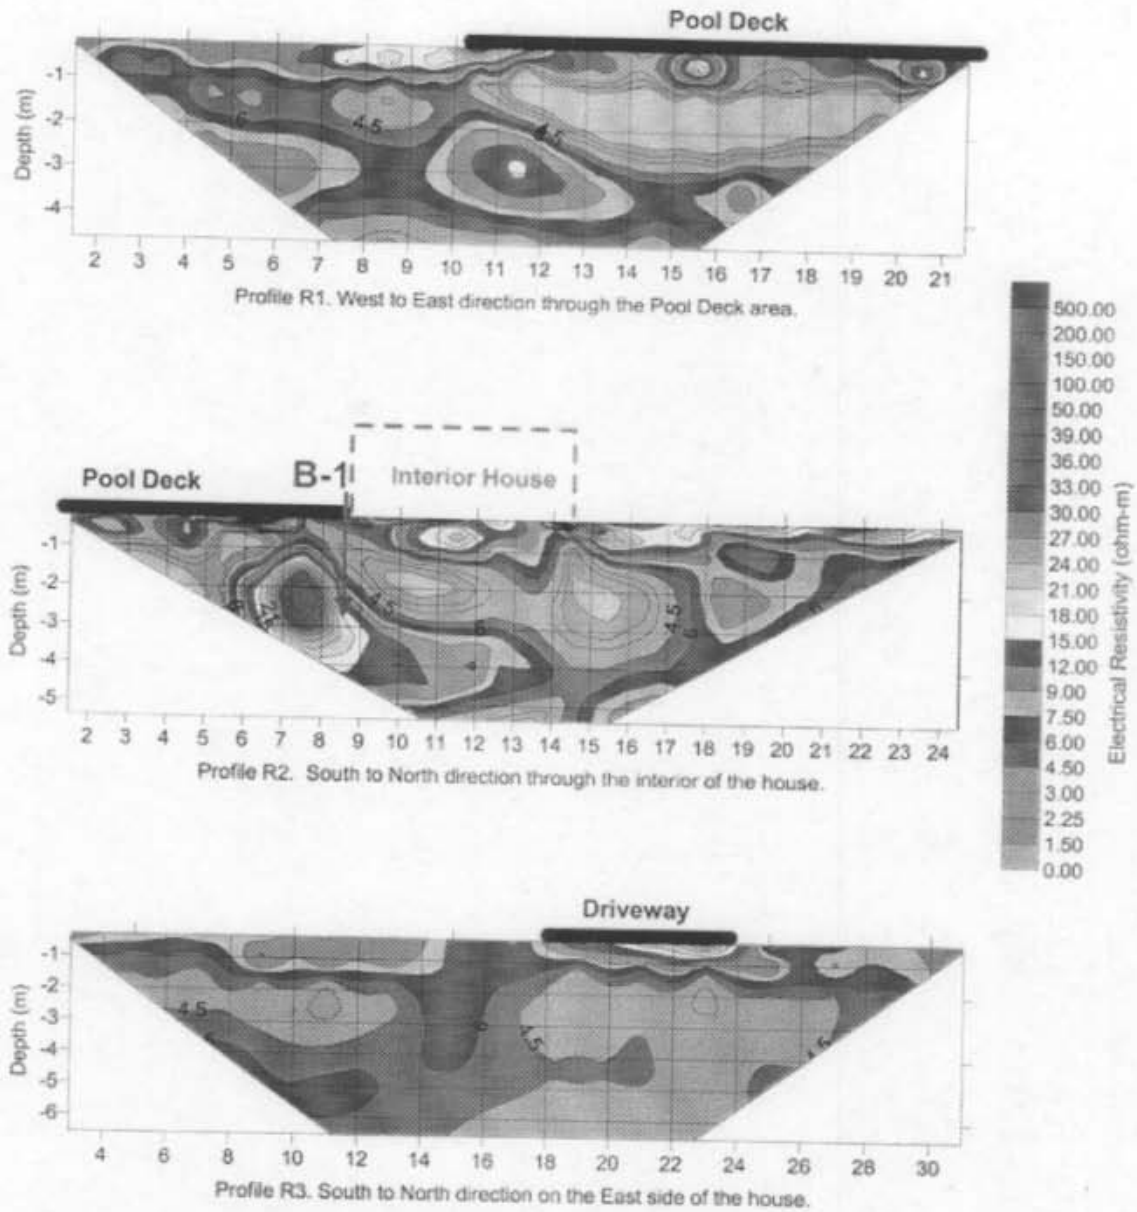
Figure 13. Geo-Electrical Moisture/Material Imaging Resistivity (GMMIR) Profiles at the Friendswood Residence

Geophysical Exploration and Analysis. Our geophysical information for the subject residence indicate that the majority of extremely low resistivity zones (resistivity values on the order of 3.0 ohm-m or less) were measured underneath or in the vicinity of the pool deck area. As shown in Figure 13, these extremely low resistivity zones distribute at the depth of around 2- to 8-ft in those profiles. The extremely low resistivity areas were summarized on the map shown Figure 14. Among the three resistivity profiles, the high moisture content soils (extremely low resistivity zones) were found under the pool deck, under a portion of the master bedroom and outside of the master bedroom, in the planter area (located to the east of the master bedroom). Two other spots of the extremely low resistivity zones were also documented in the planter areas next to the home office and front porch.

As to sandy fill soils, found in the exterior borings (Borings B-1 and B-2) as well as the pier exposure locations in the planter areas next to the grade beams, do not resist water to seep through these materials and travel under the foundation causing the expansive soils to swell and result in distress. The perched water found under the grade beams during our pier exposure indicated such water infiltration. Furthermore, the geophysical investigation also showed that sandy soils distribute on the ground surface to the depth of about 3-ft across the project site (see Figure 13, for soils with resistivity values 7.5 ohm-m and up).

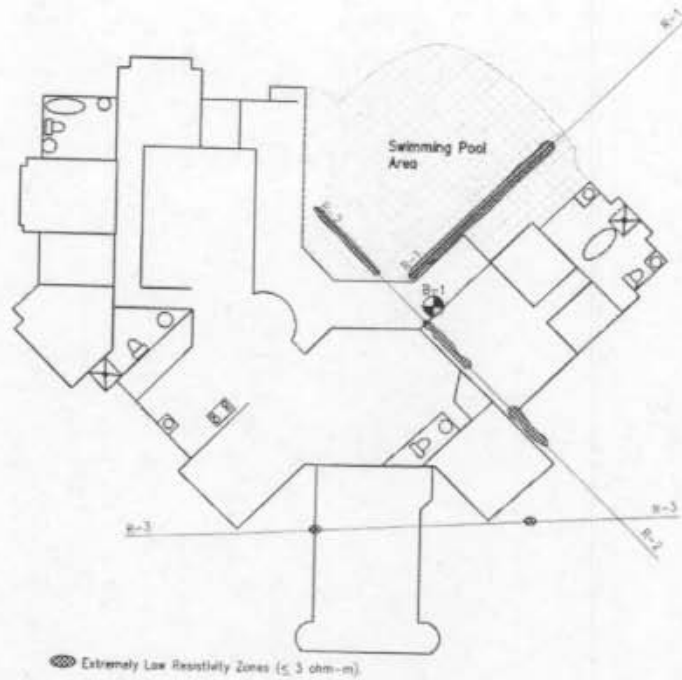
Figure 14. Extremely Low Resistivity Zones (High Moisture Content Soils) Found at the Friendswood Residence

Based on the geophysical information, the most probable sources of water at the project area are from the pool leak and the planter irrigation water. To further identify the major water source, it is our opinion that analytical chemistry tests should be performed to verify the chloride content in the water sample retrieved from the ground.

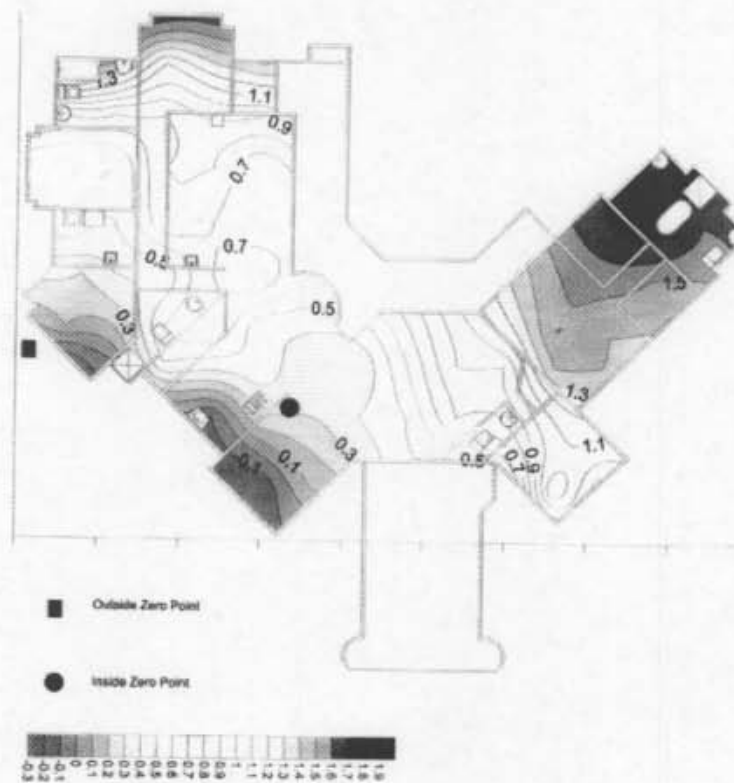
Figure 15. Slab Micro-Elevation Survey at the Friendswood Residence (Performed on April 30, 2003)

Micro-Elevation Data. Our review of the micro-elevation data performed on April 30, 2003 indicated that an elevation differential of about 2-inches in the subject residence, as shown in Figure 15. The high areas were at the walk-in closet of the master bedroom and the west wall of Bedroom #3. The low areas were at the dining room and Bedroom #1. Our review of this micro-elevation data suggested that the slab elevations were generally higher at the west side of the house which was the area close to the swimming pool.

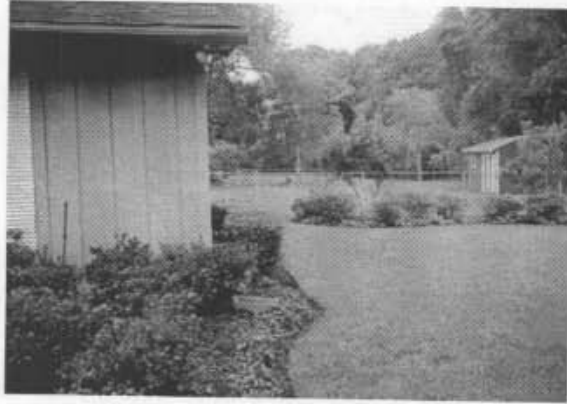
2. Planter areas with sprinkler systems were found all around the garage and add-on area (see Figures 17(a) and 17(c)). Planter areas were also found in front of the house and at the west side of the house (see Figure 17(b)).

Roof water drainage should properly discharged away from the foundation. Our site visit indicated the presence of guttering and downspout systems at various locations around the residence. However, there is no guttering system installed at the north and east sides of the add-on and the south side of the original structure. In addition, missing downspouts (Figure 17(a)) or

Figure 17. Site Observations at the League City Residence: (a) the Gutter System without Downspout located at the Northeast Corner of the Residence, (b) the Downspout Discharging Water next to the Foundation at the Southeast Corner of the Residence, (c) Sprinkler System and Planter Area adjacent to the East Side of the Residence, and (d) the Gap between the Grade Beam and Subgrade Soils due to Subsoil Shrinkage Found at the South Side of the House

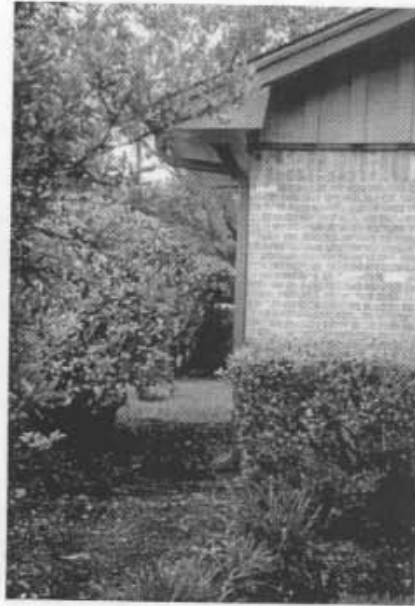
(b)

downspouts without extension pipes and draining water into the planter areas right next to the foundation (Figure 17(b)) were observed around the residence.

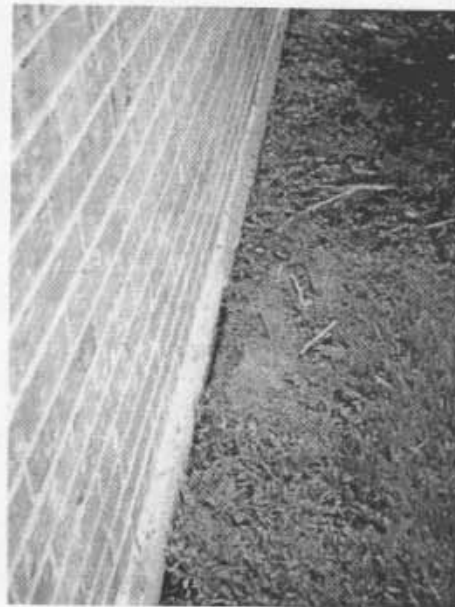
(d)

5. Our interview with the homeowner indicated that a large post oak tree at the back of the add-on (about 10-ft away) died in 1998.
6. Our observations of the soil conditions next to the foundation at the south side of the residence, Figure 17(d), indicated a separation between the grade beam and the soils. This separation was about 1-inch in width.
