# **TEST METHODS FOR EVALUATING EXISTING FOUNDATIONS**

**Document no:** FPA-SC-02

**Developed by:** FPA Structural Committee

**Presented to:** Foundation Performance Association

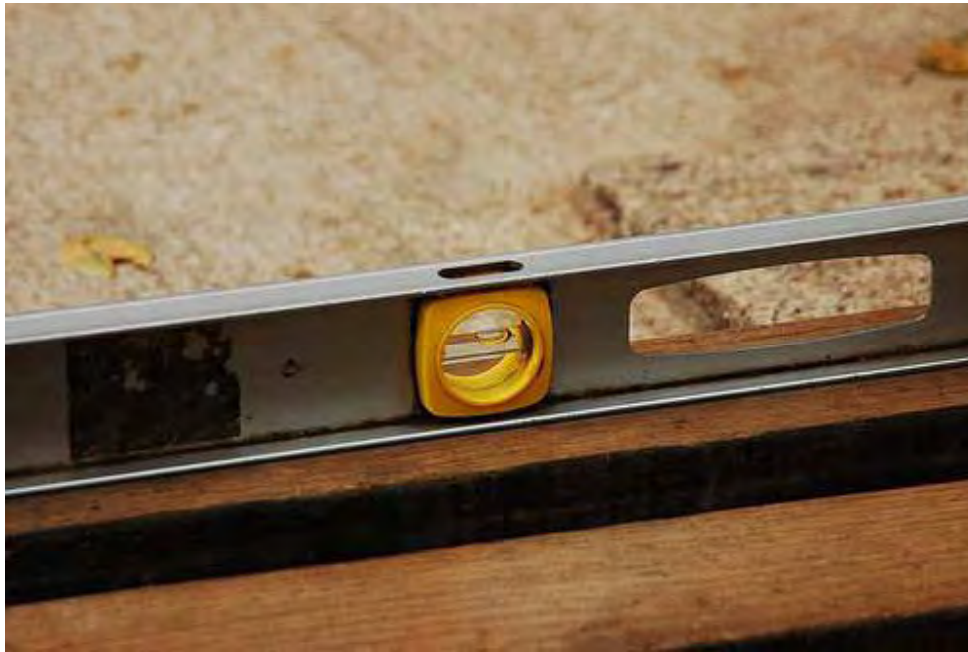
# Test Methods – Carpenter Level

- Confirm elevation survey
- Levelness
- Plumb

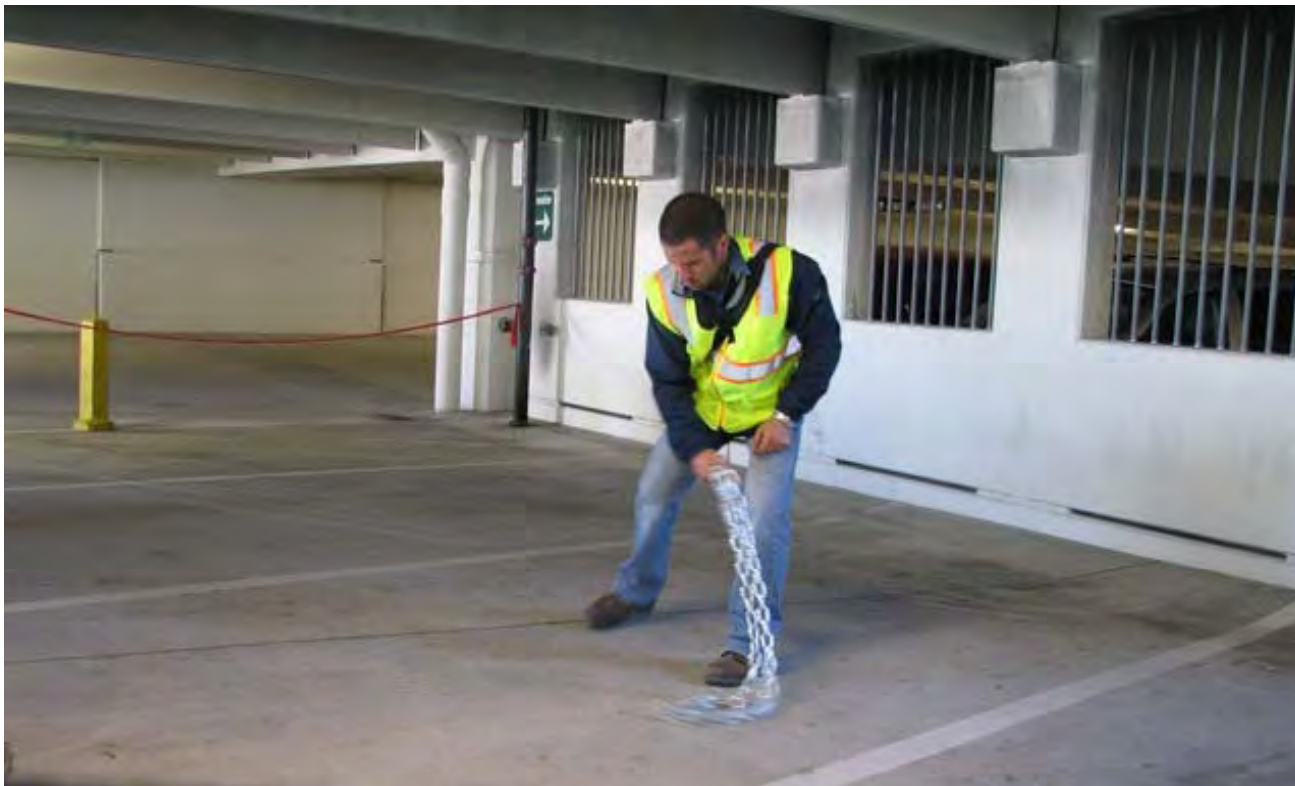
# Test Methods – Chain Dragging

- Estimate location and extent of delamination

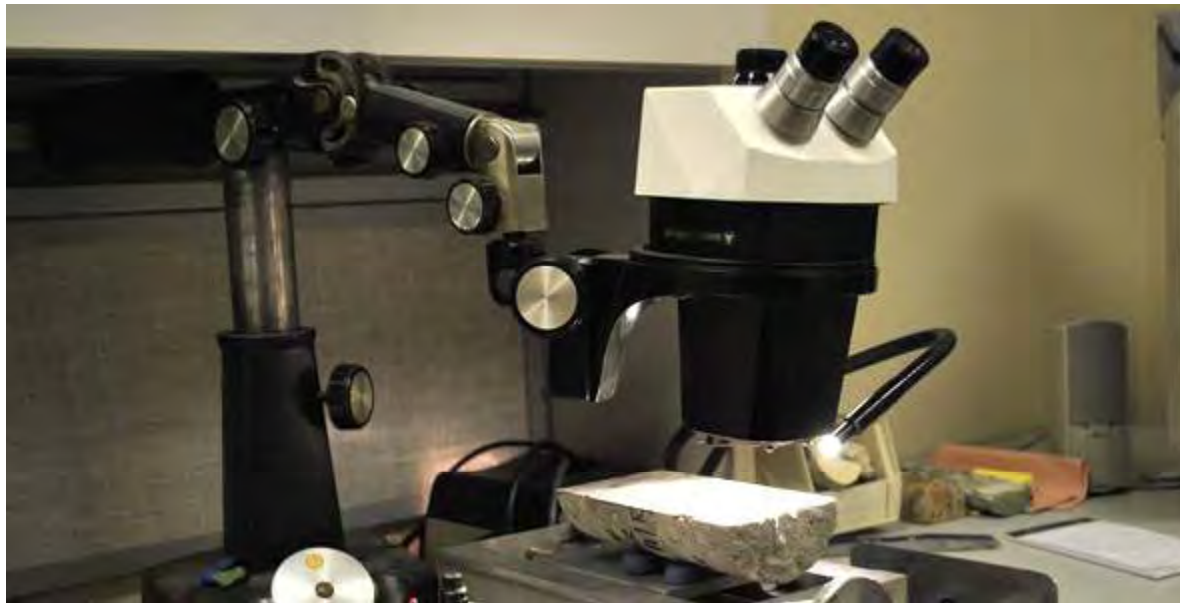
# Test Methods – Chloride Content

- Analyze for chlorides at the level of steel reinforcement

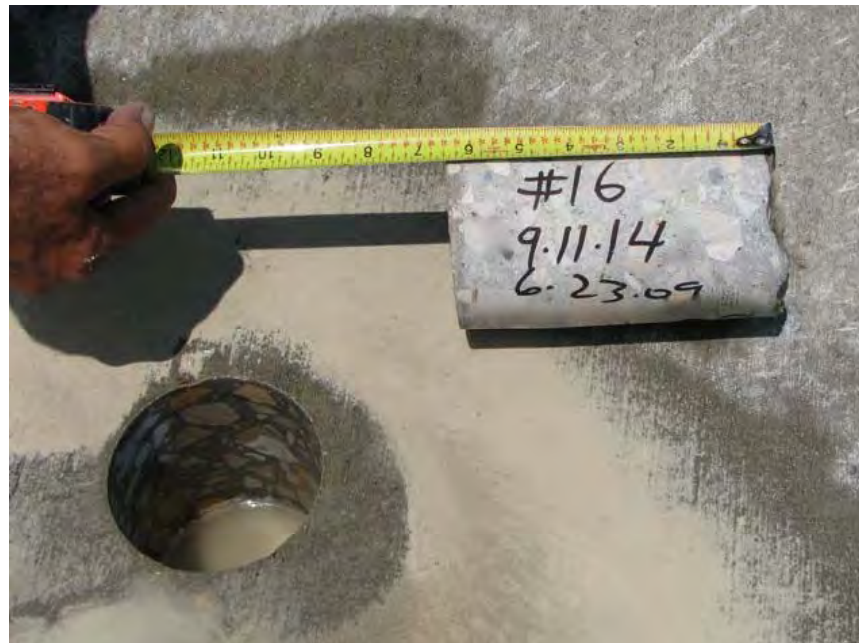
# Test Methods – Concrete Cores

- Testing - Compressive strength
- Confirm dimensions
- Petrographic analysis

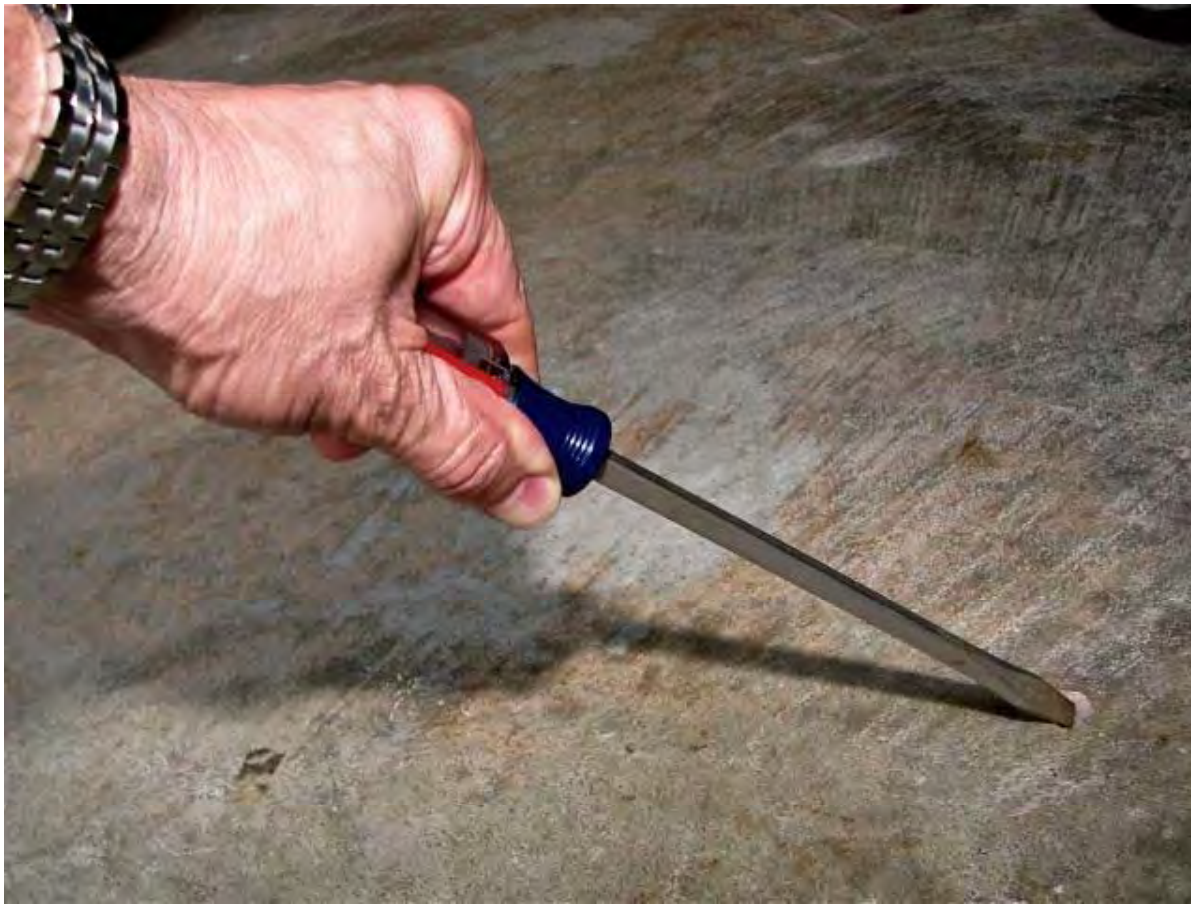
# Test Methods – Concrete Screwdriver Test

- Relative hardness and durability

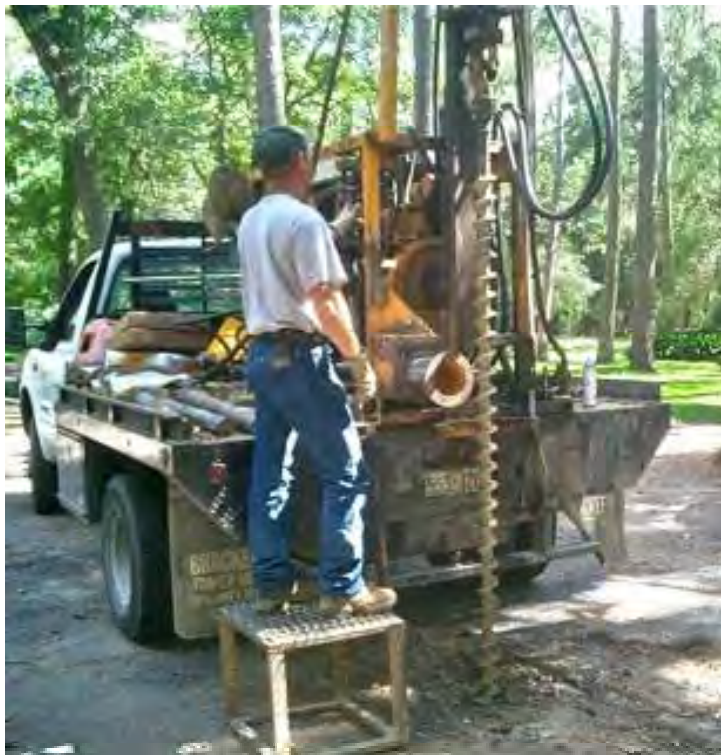
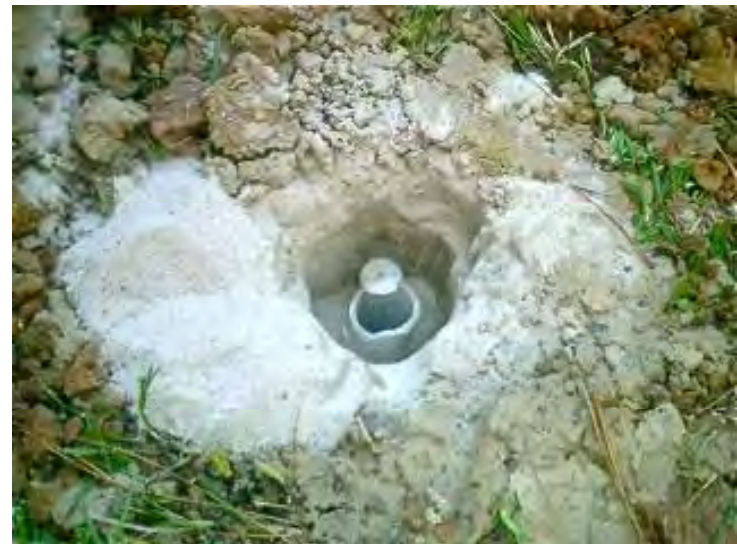
# Test Methods – Geotechnical

- Causes and extent of foundation movement

- Classify soil types
- Measure soil strength
- Report Atterburg limits
- Moisture content
- Ground water level
- Compaction
- Shear strength
- Active zone depth
- Swell potential
- Potential vertical movement (PVM)

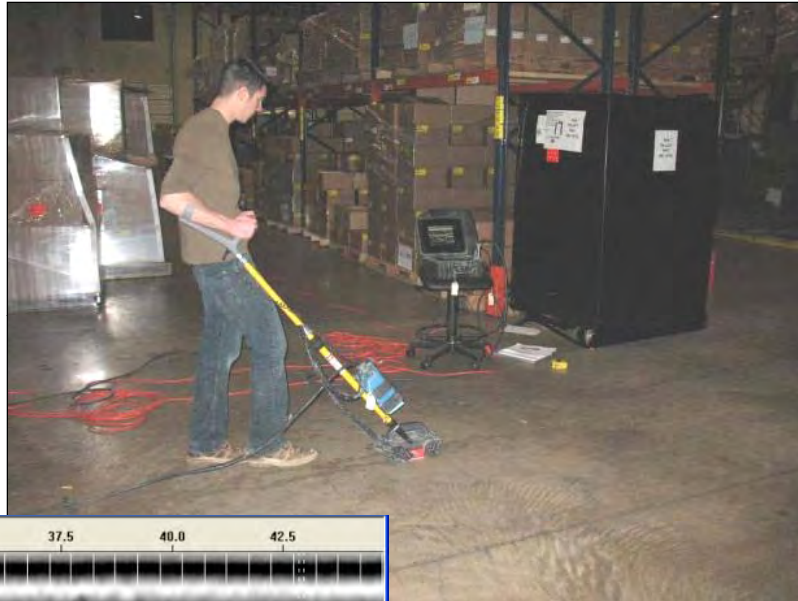
# Test Methods – Ground Penetrating Radar

- Location, depth, spacing of steel reinforcement
- Presence of utility lines
- Voids underneath a slab
- Delamination
- Slab thickness
- Soil strata

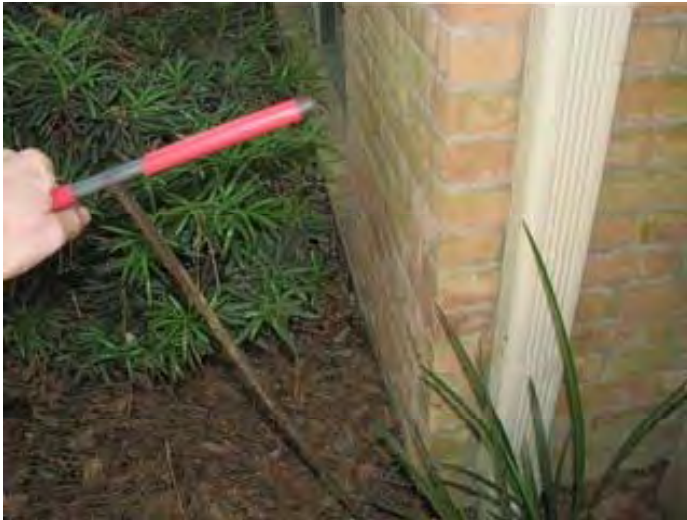
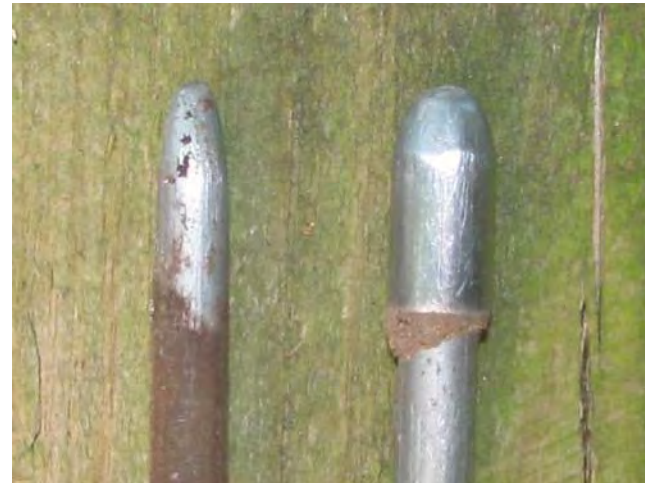
## Test Methods – Ground Probing

- Depth of perimeter grade beams
- Soil type and color
- Soil moisture condition
- Relative soil shear strength

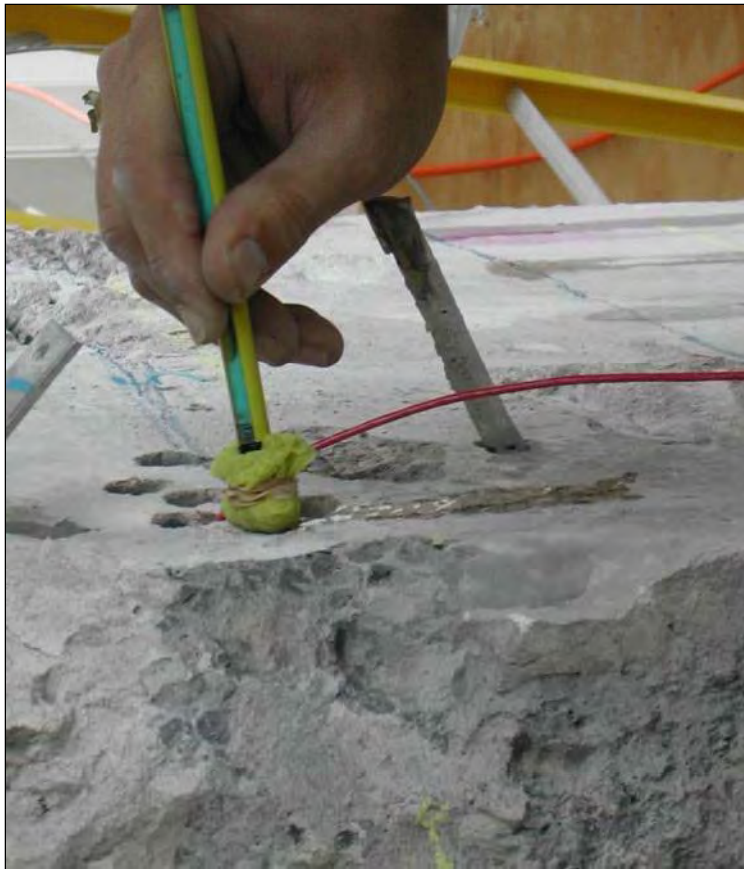
# Test Methods – Half Cell Potential

- Probability of steel reinforcement corrosion

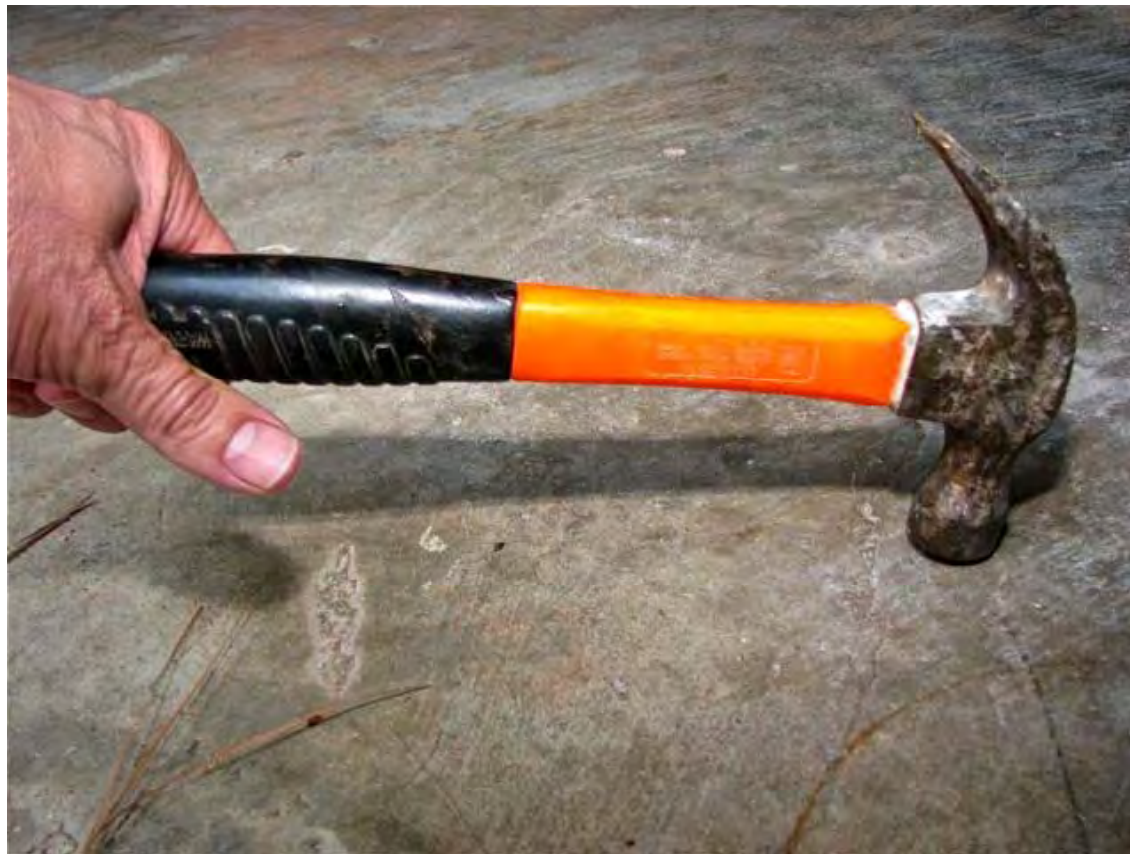
# Test Methods – Hammer Sounding

- Presence of delamination and voids

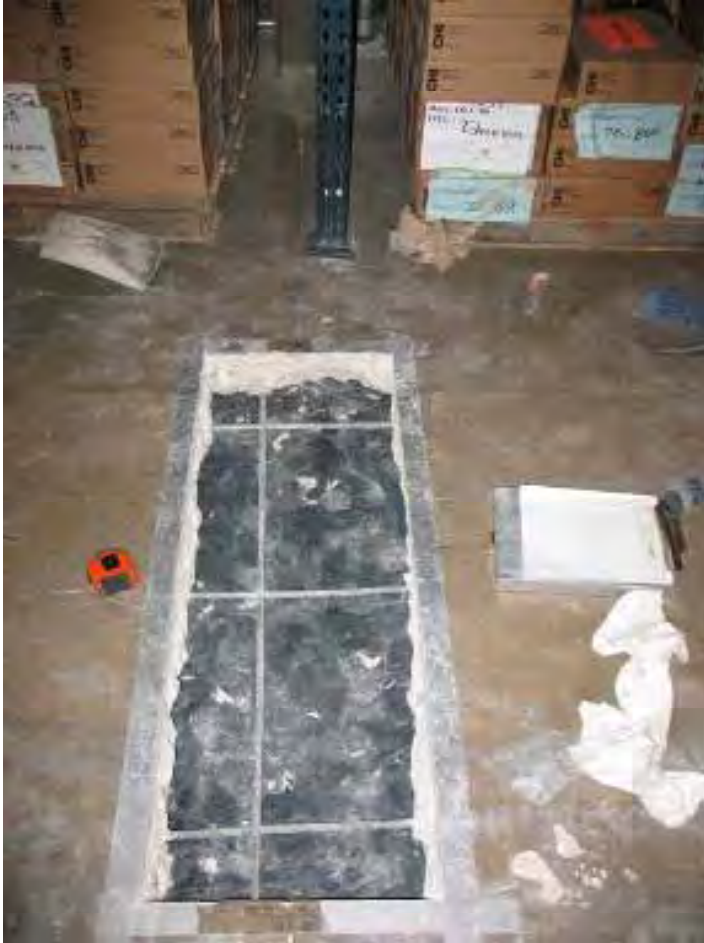
**Inspection opening**

- Inspection opening
  - Size and placement of steel reinforcement
  - Presence of vapor retarder below a slab
  - Slab thickness
- Excavations
  - Grade beam and bell pier dimensions
  - Presence of plumbing lines
  - Free water elevation and condition of fill

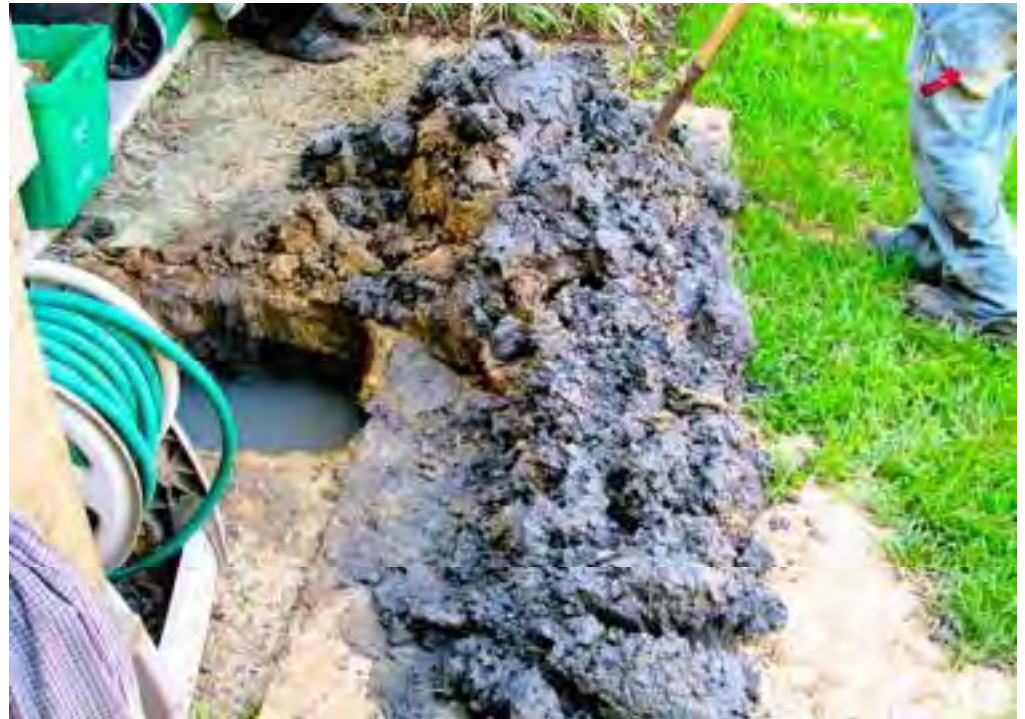
**Test pit excavation**

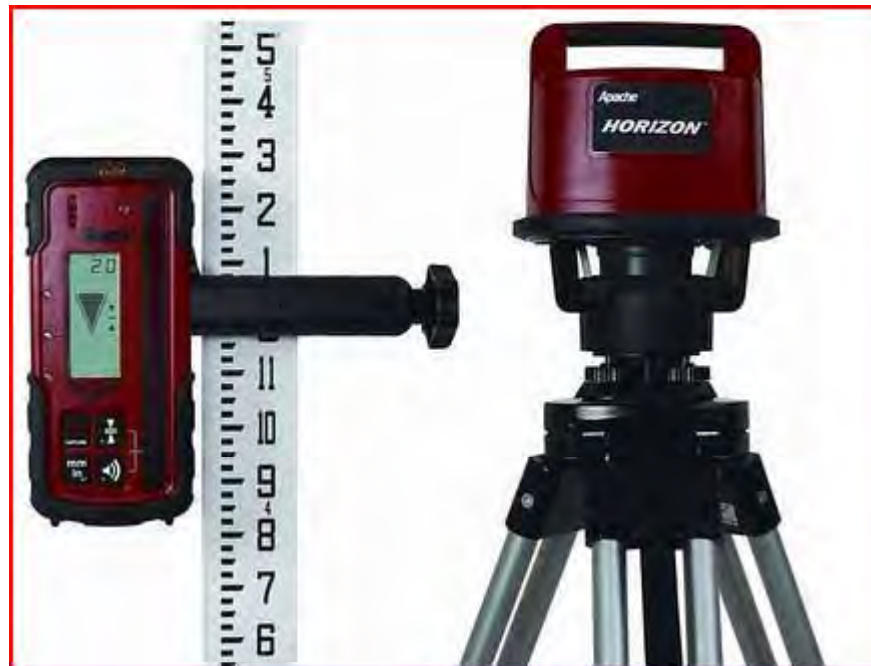
## Test Methods – Laser Level

- Floor elevations

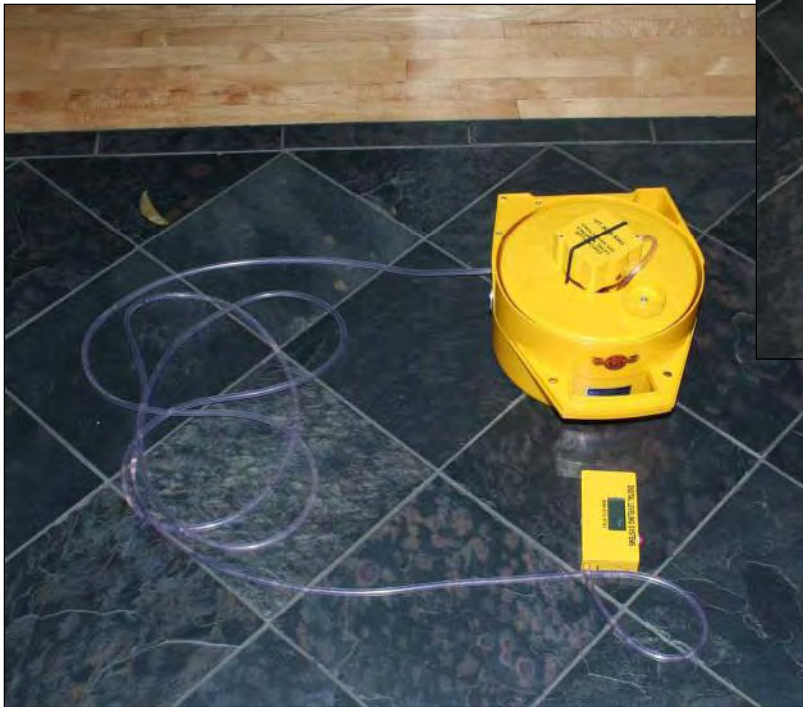
## Test Methods – Manometer

**Water**

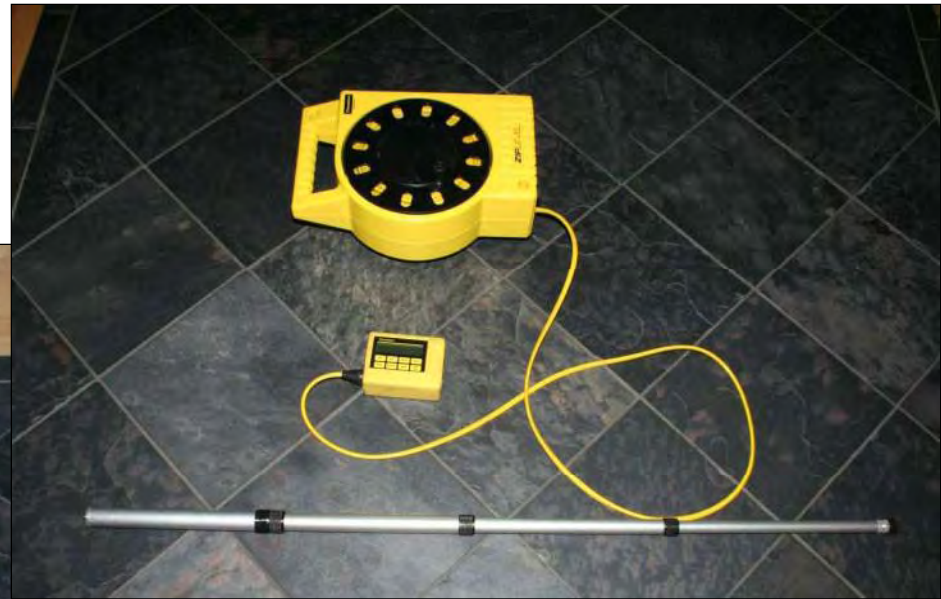
**Closed Liquid/Gas**

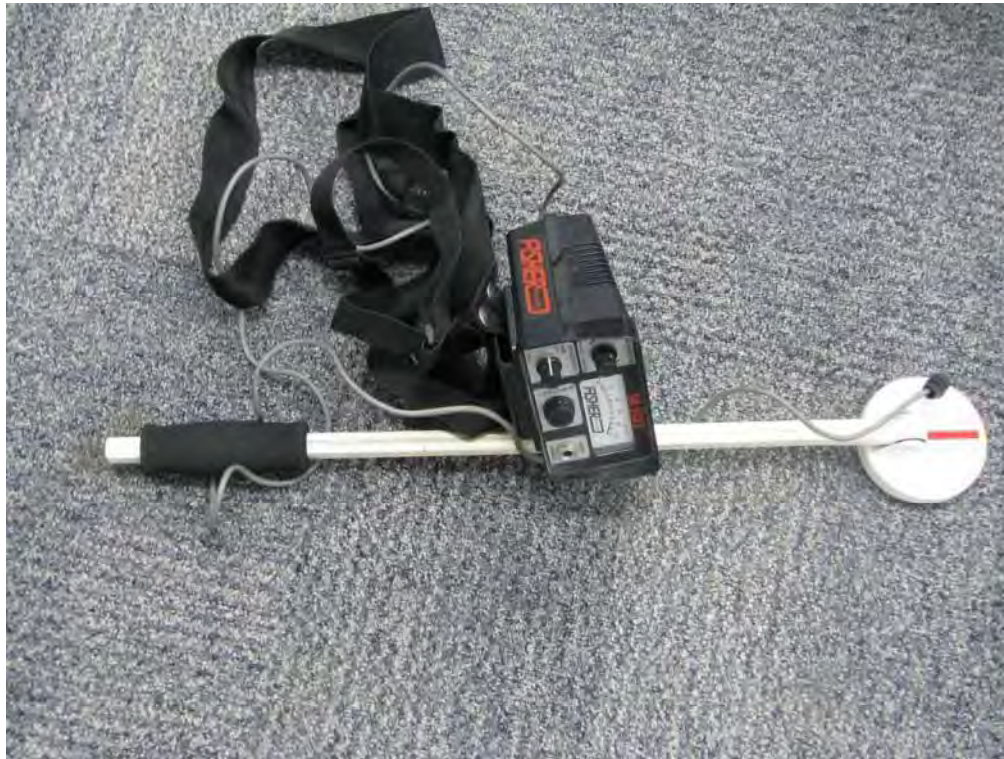
## Test Methods – Metal Detector

- Presence and general location of steel reinforcement

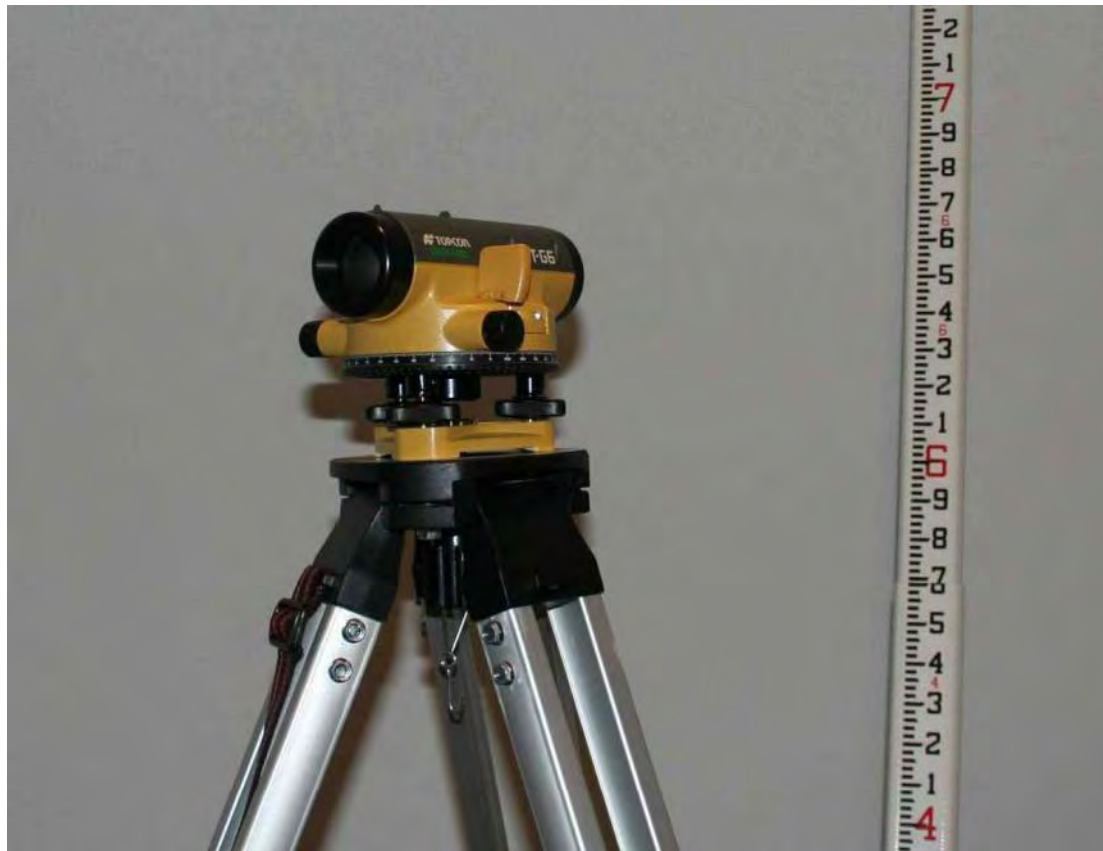
## Test Methods – Optical Level

- Floor elevation

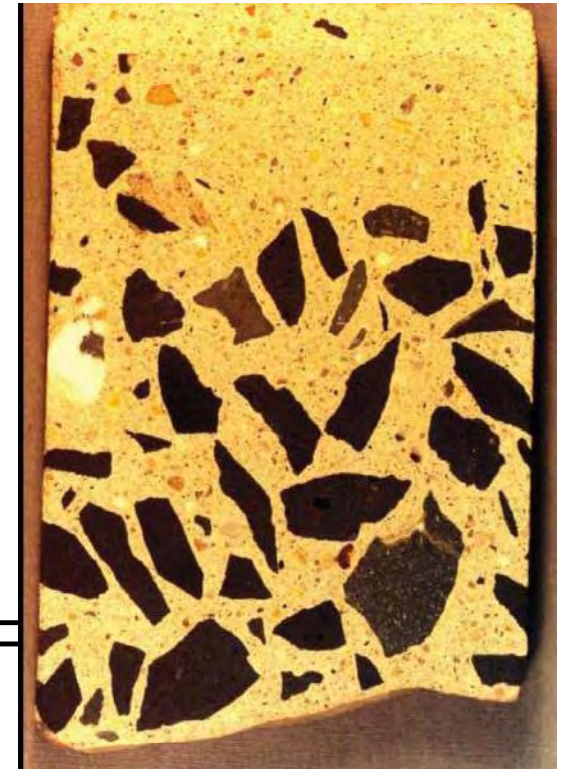
# Test Methods – Petrographic Examinations

- Coarse aggregate segregation
- Air voids
- Poor curing
- Relative water cementitious ratio
- Relative age of cracks
- Type of cracks
- Detrimental chemical reactions – ASR, DEF

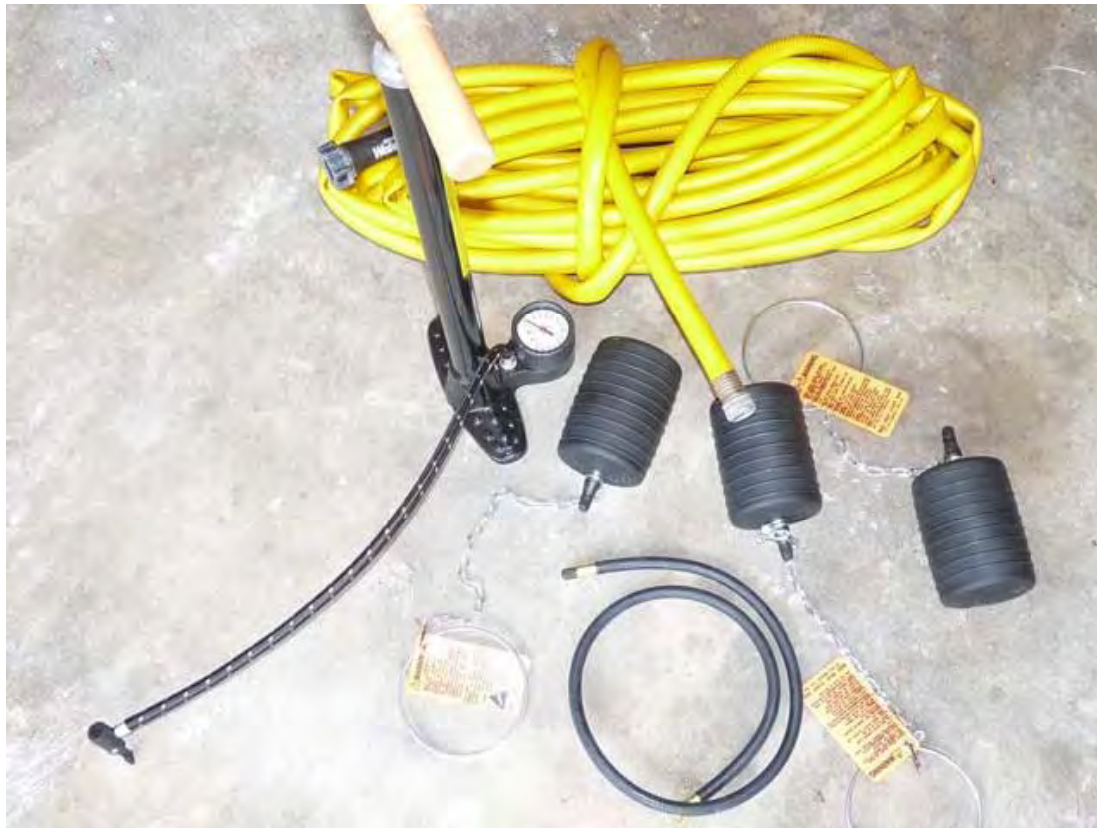
# Test Methods – Plumbing Leak Detection

- Foundation movement due to below slab water leaks

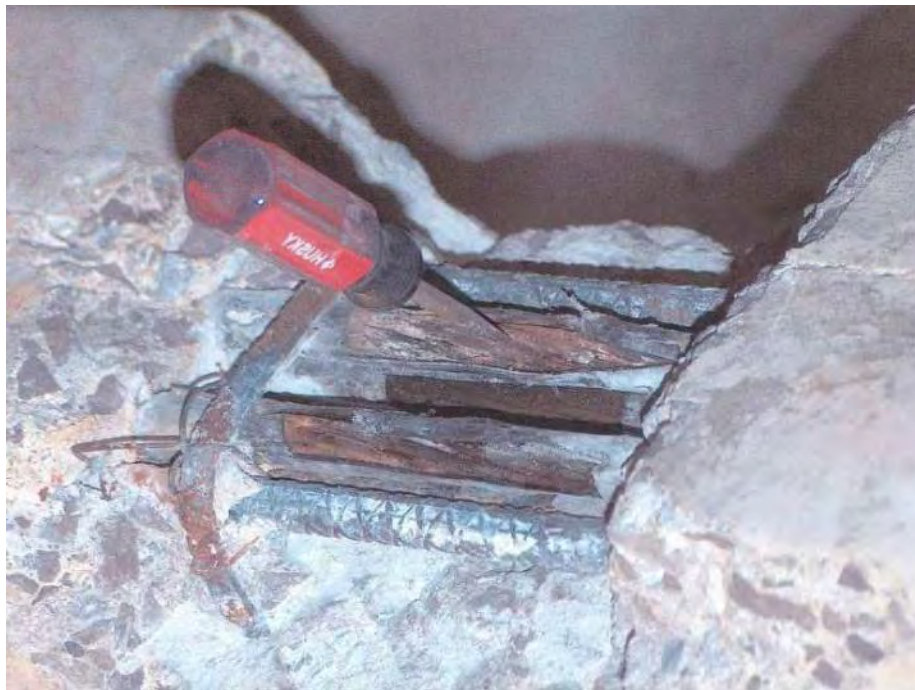
## Test Methods – Post-tension Screwdriver Penetration

- Evaluate presence of tension in post-tensioned tendons

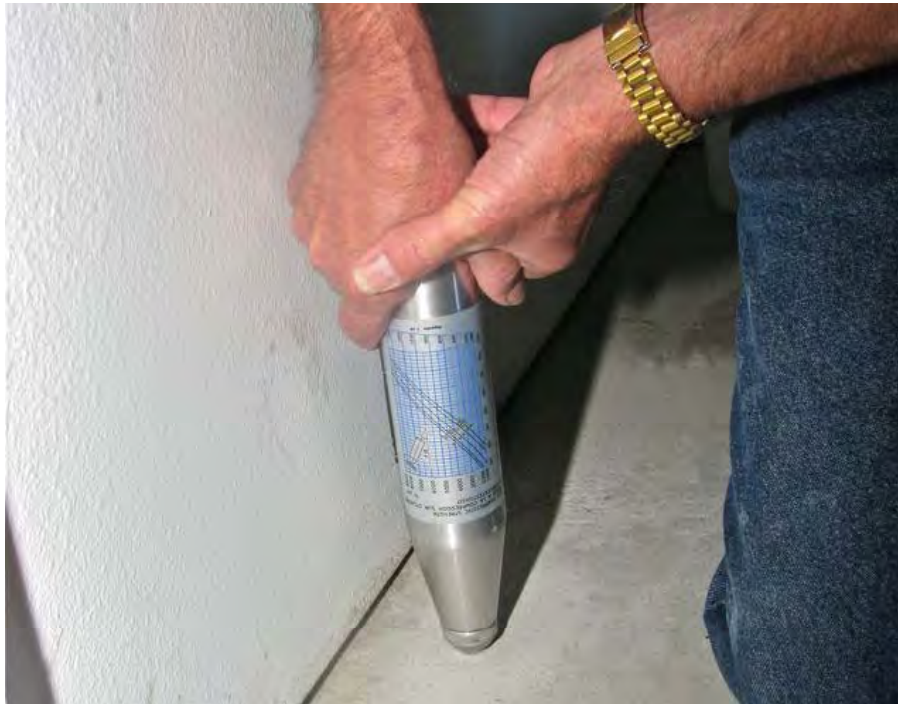
# Test Methods – Rebound Hammer

- Relative hardness of concrete

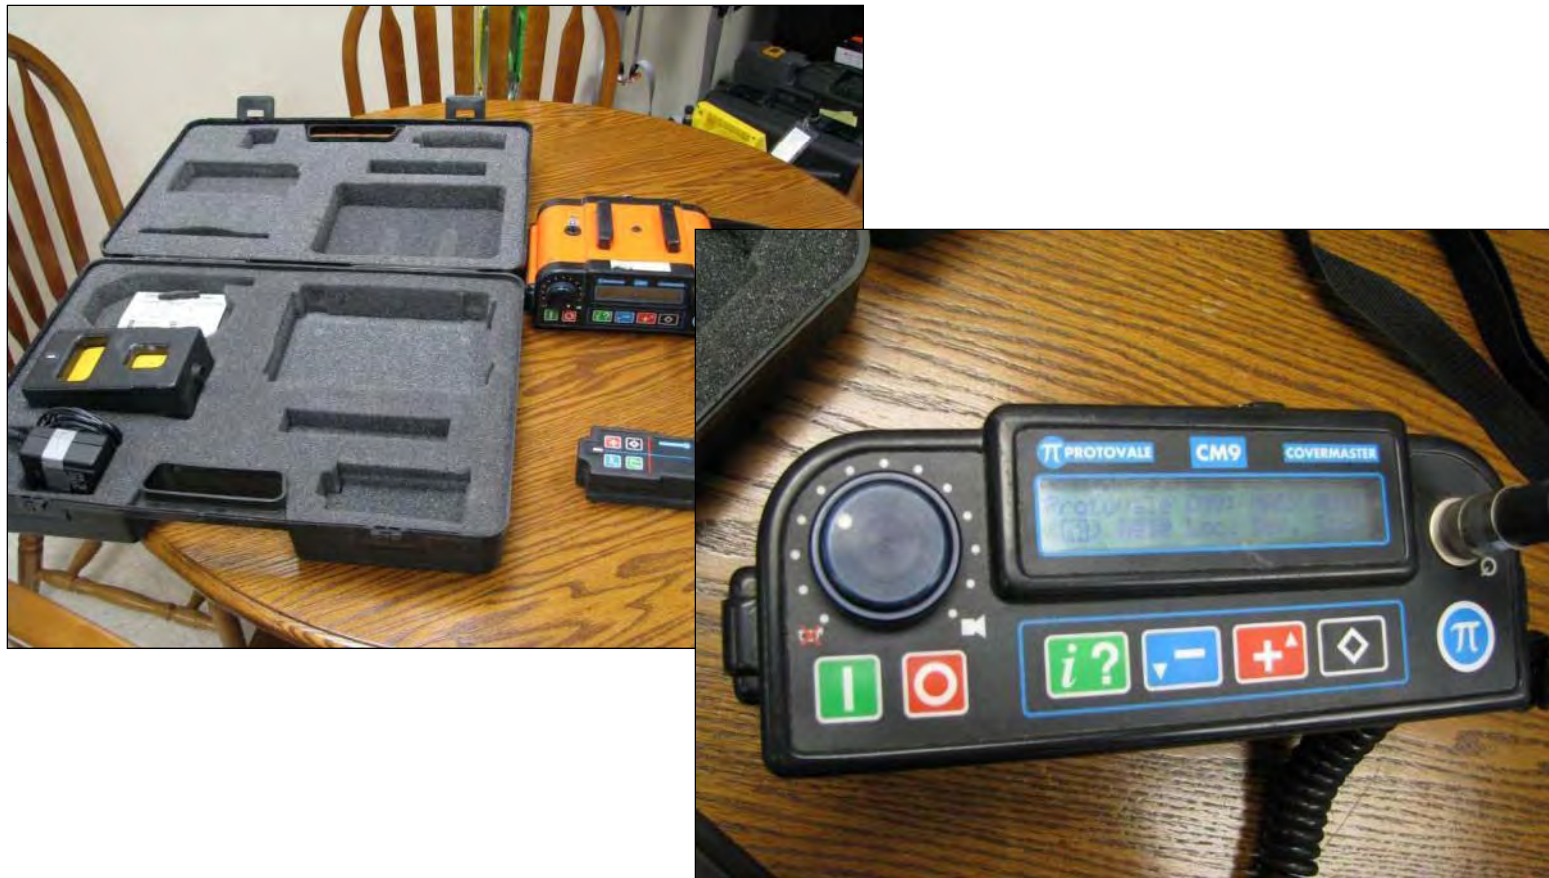
# Test Methods – Reinforcement Locator

- Spacing, size, and depth of steel reinforcement

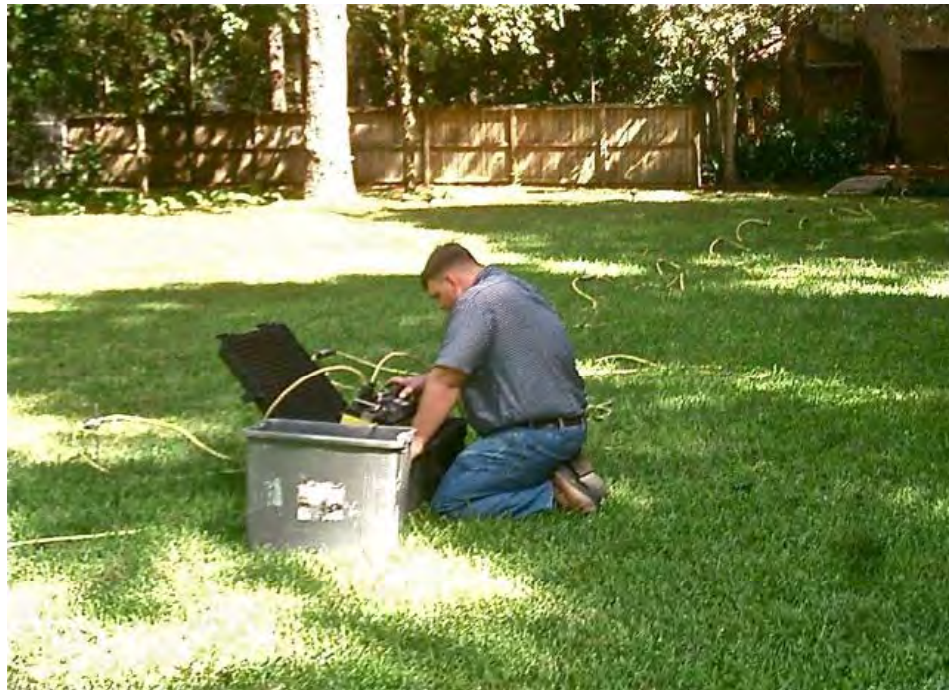
## Test Methods – Resistivity

- Evaluate effects of
  - Location of pre-existing ponds, foundation, lakes, etc
  - Accumulation of ground water
  - Plumbing leaks
  - Poor drainage
  - Location of pipes
  - Soil strata variations
  - Tree root zones

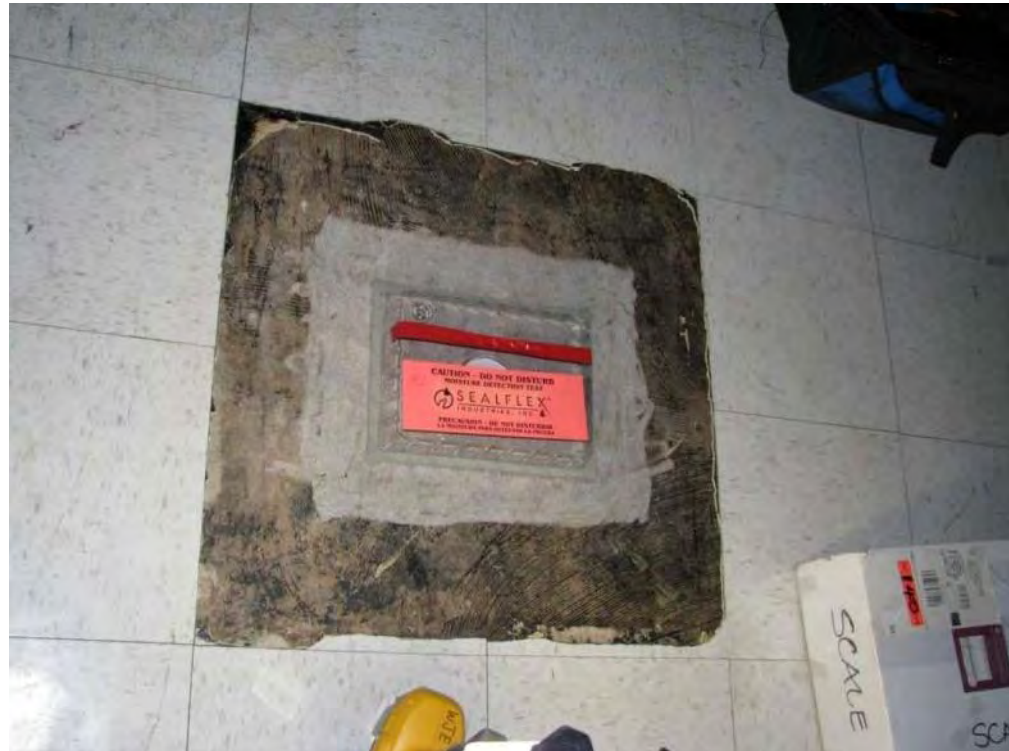
# Test Methods – Vapor Transmission

- Adequacy of slab-on-ground to receive floor finishes

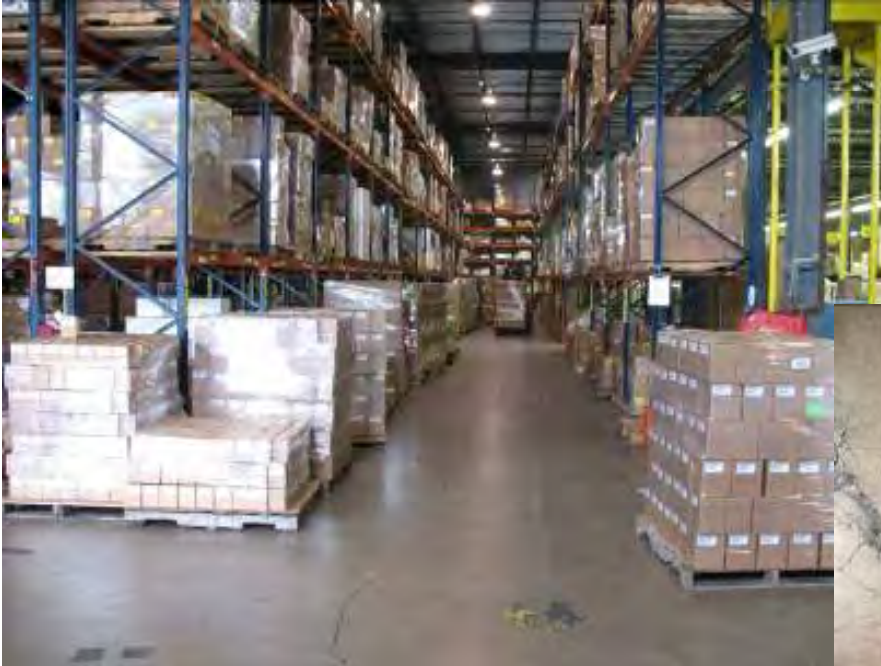
*View of a typical aisle in the east-west direction.*

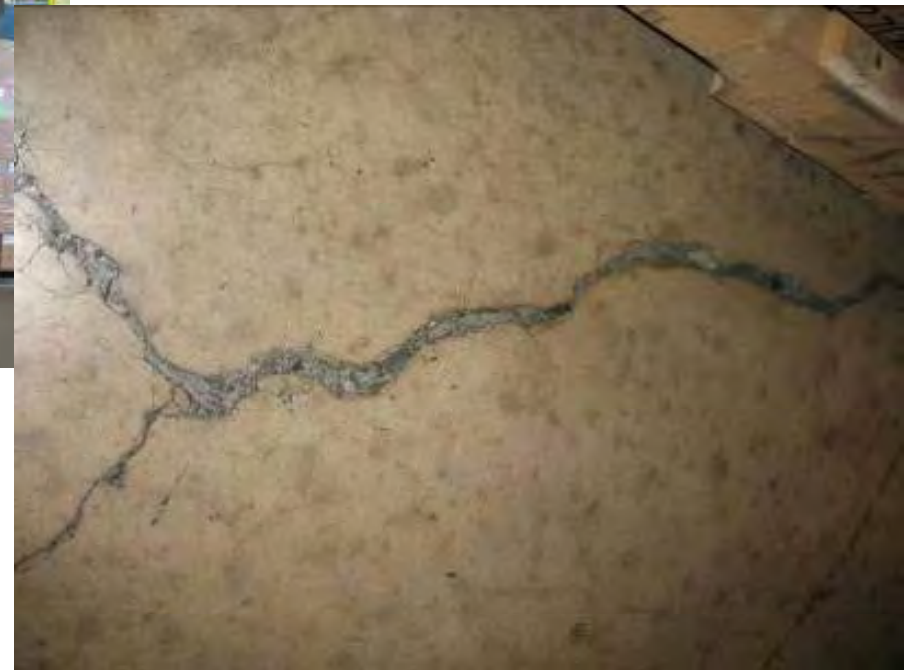
*Crack previously repaired with epoxy injection  
Al Bustamante, Wiss, Janney, Elstner  
Associates, Inc.*

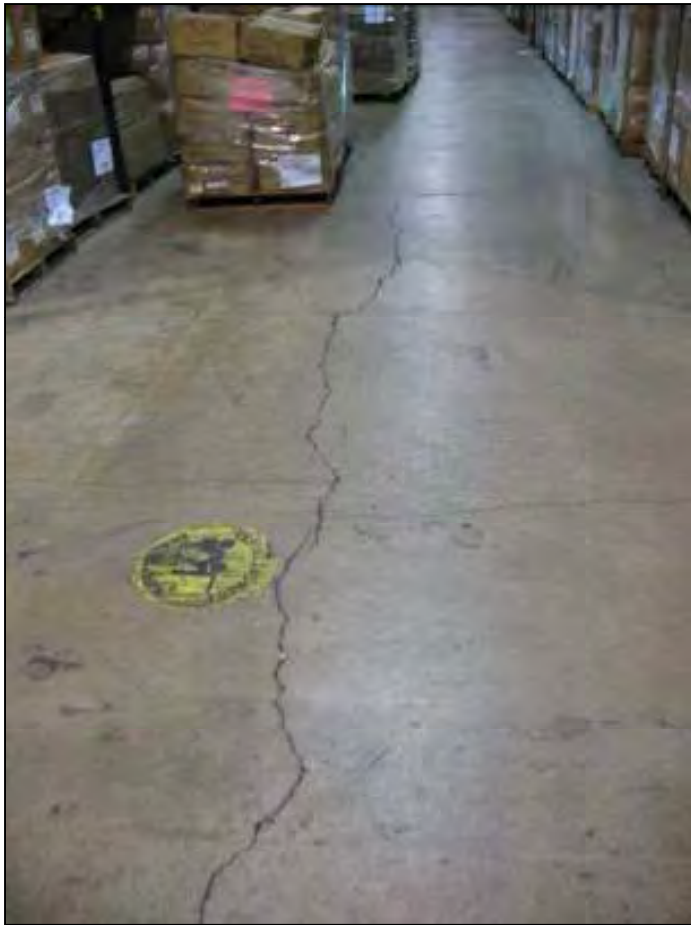
*Typical cracks located roughly in the middle of an aisle*

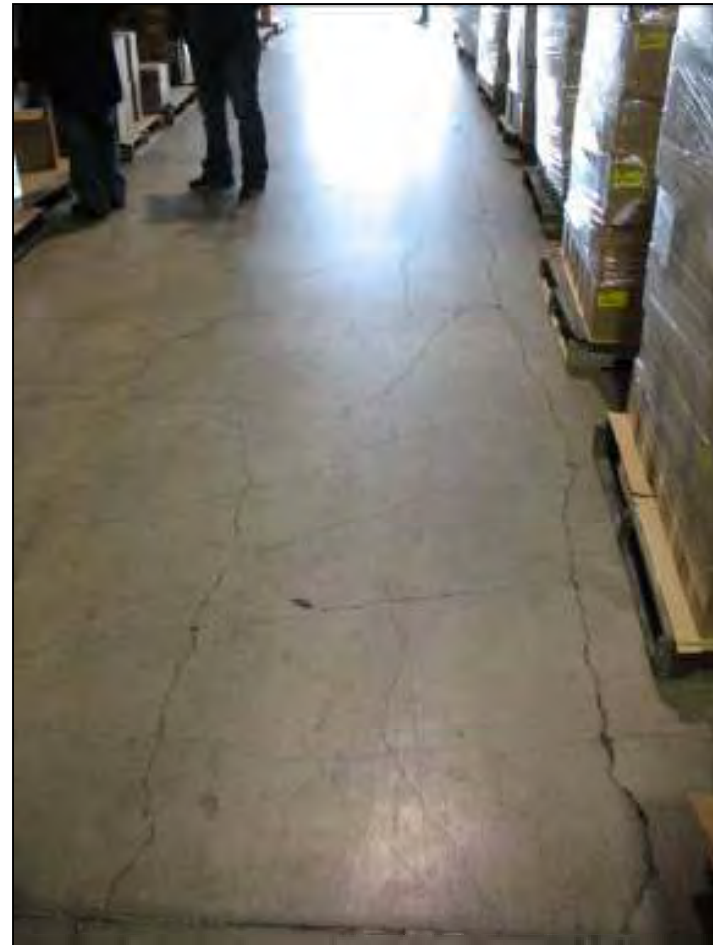
*Random crack pattern*

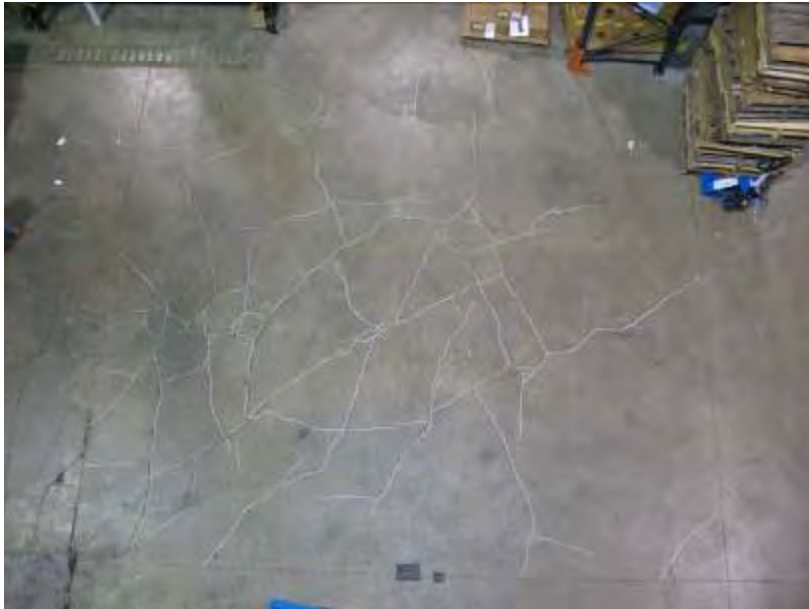
*View of a crack pattern thought to be from a crane load stabilization point*

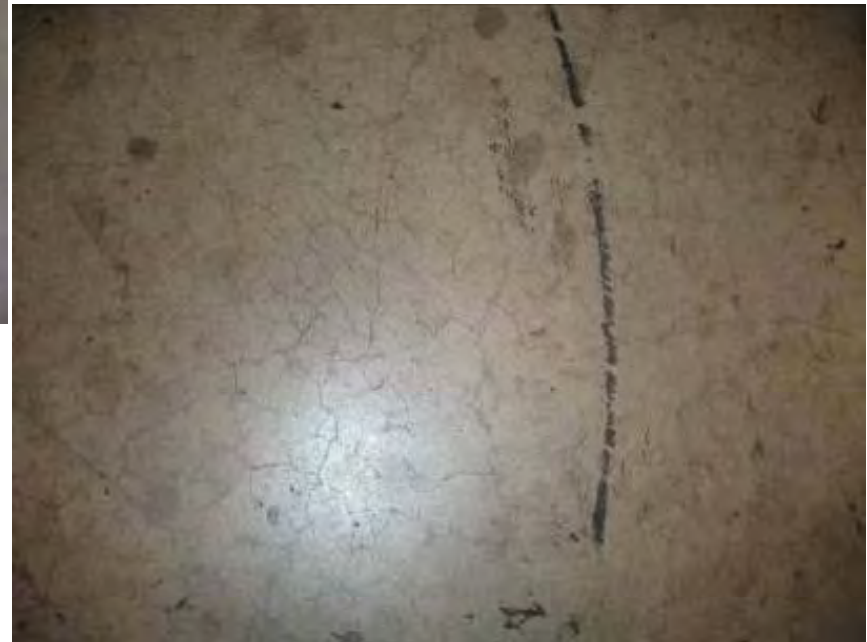
*Surface crazing cracking*

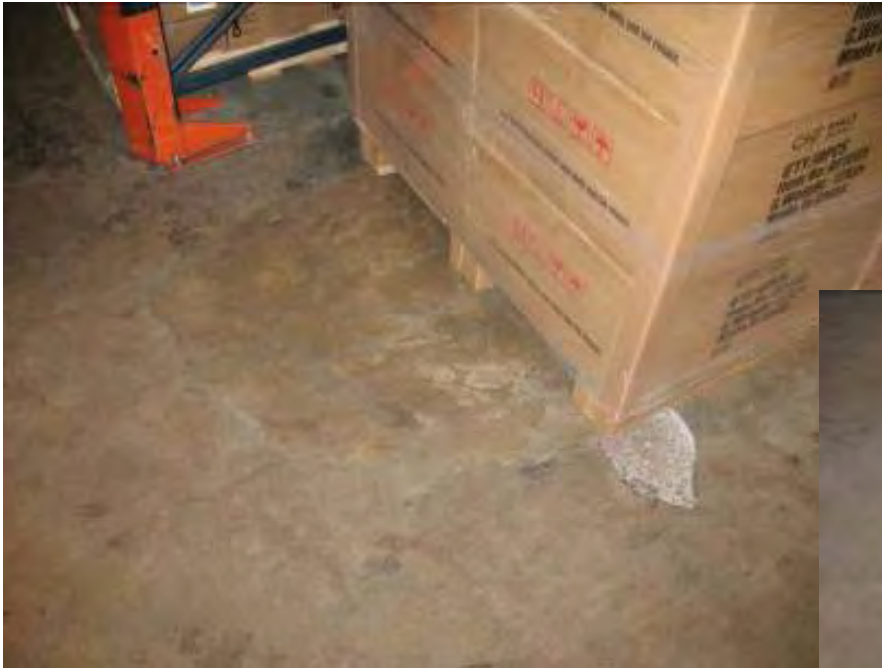
*Surface spall next to a pallet*
