# **TEST METHODS FOR EVALUATING EXISTING FOUNDATIONS**

**Document no:** FPA-SC-02

**Developed by:** FPA Structural Committee

**Presented to:** Foundation Performance Association

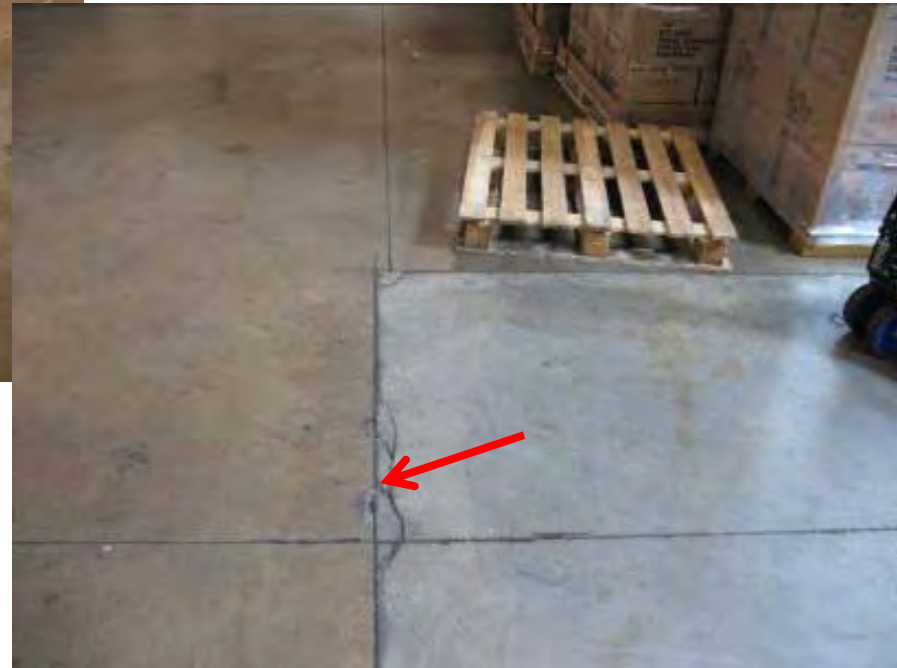
*Spall at edge of new concrete placed at equipment at overhead door (see arrow)*

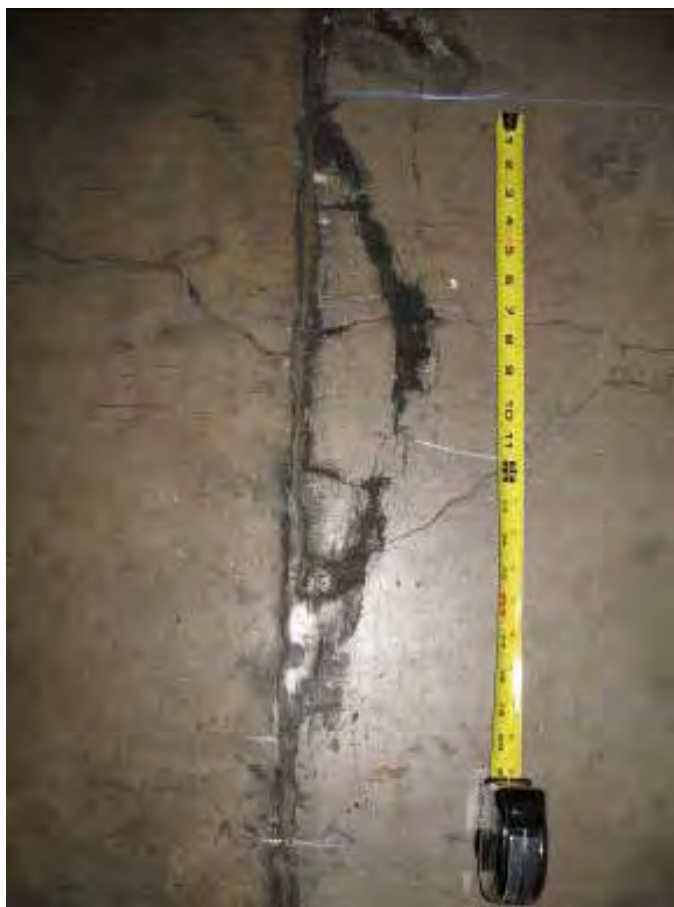
*Spall and cracks at control joint*

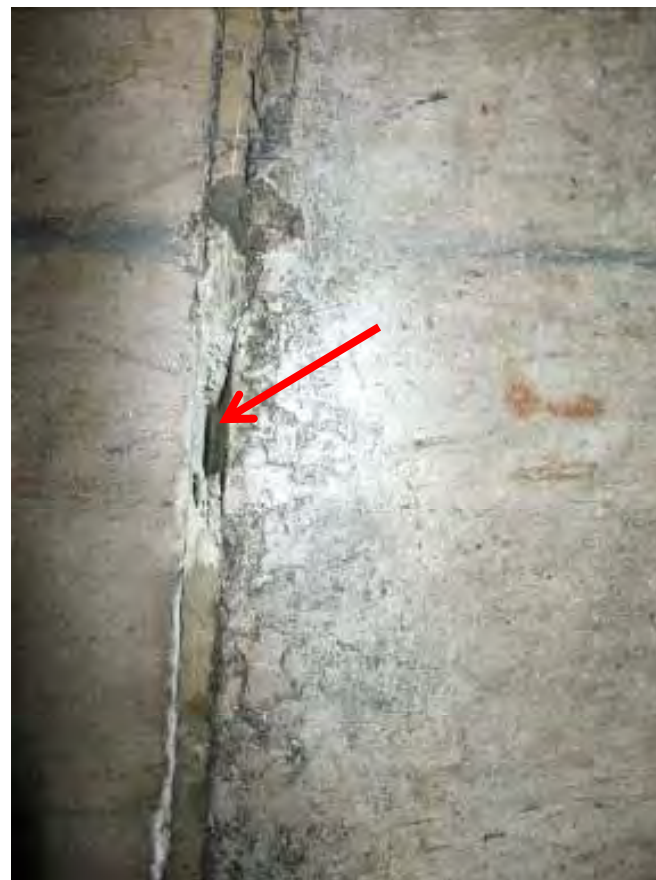
*Missing control joint material (arrow)*

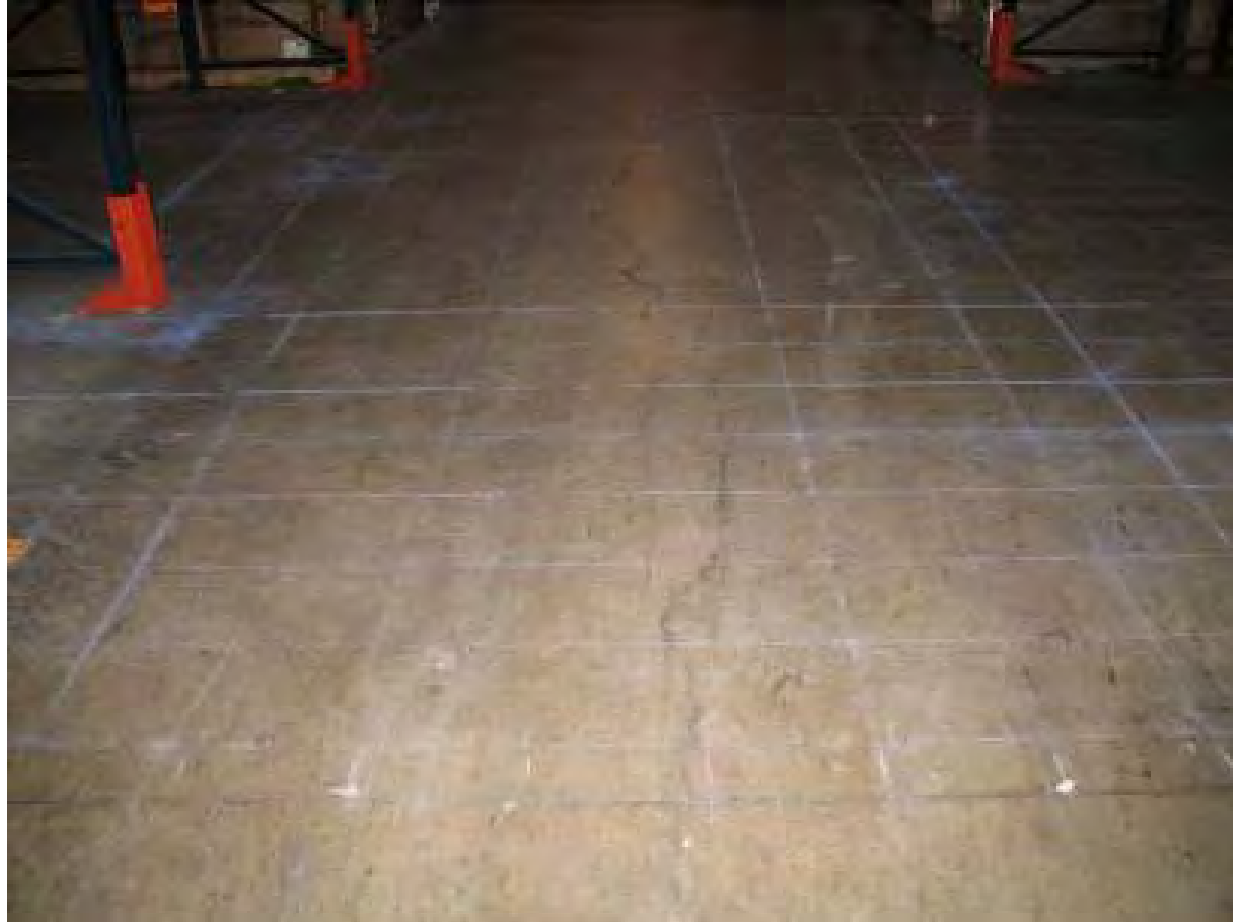
*Grid layout for detailed crack mapping area*

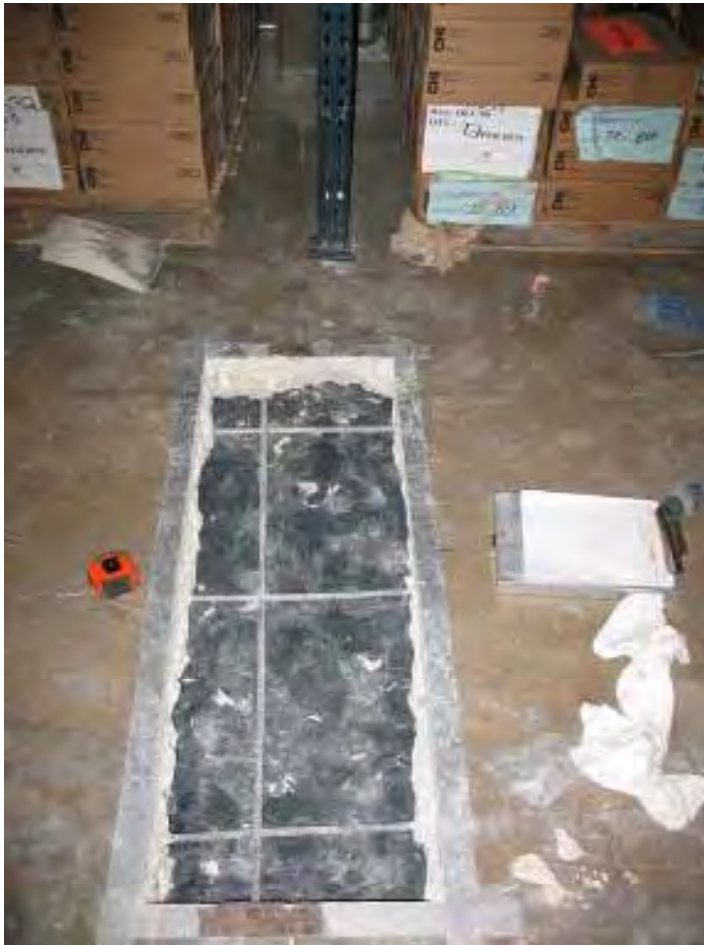
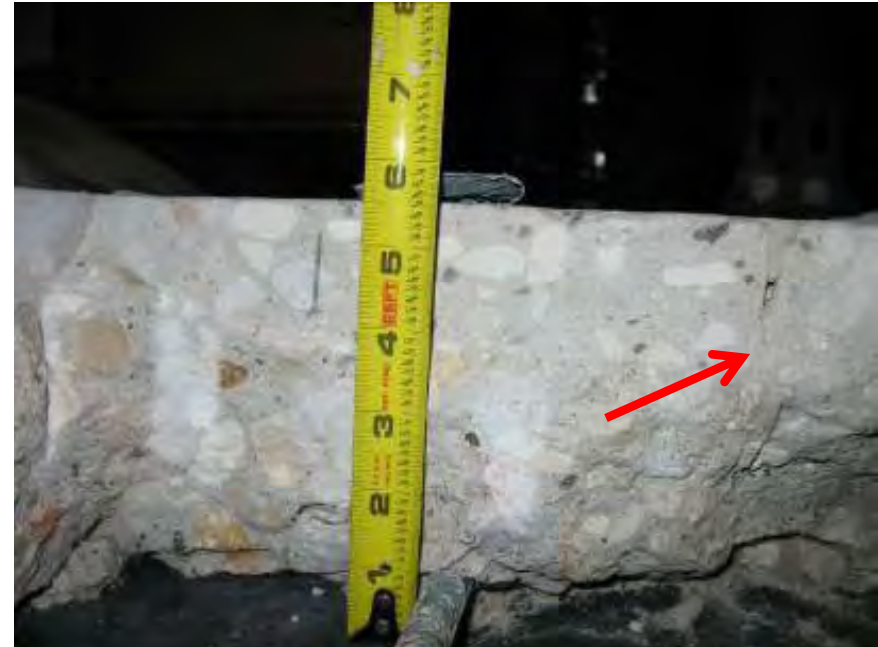
# Case Study – Inspection Opening

*Rebar located at the bottom of the slab. Note no cracking propagating from bottom of the control joint. (arrow).*
