Failures: What Can We Learn?

Case Study: Concrete Runway

Forensic Manual for Portland Cement Concrete Pavements

Prepared for TxDOT by
David Fowler and Zhanmin Zhang

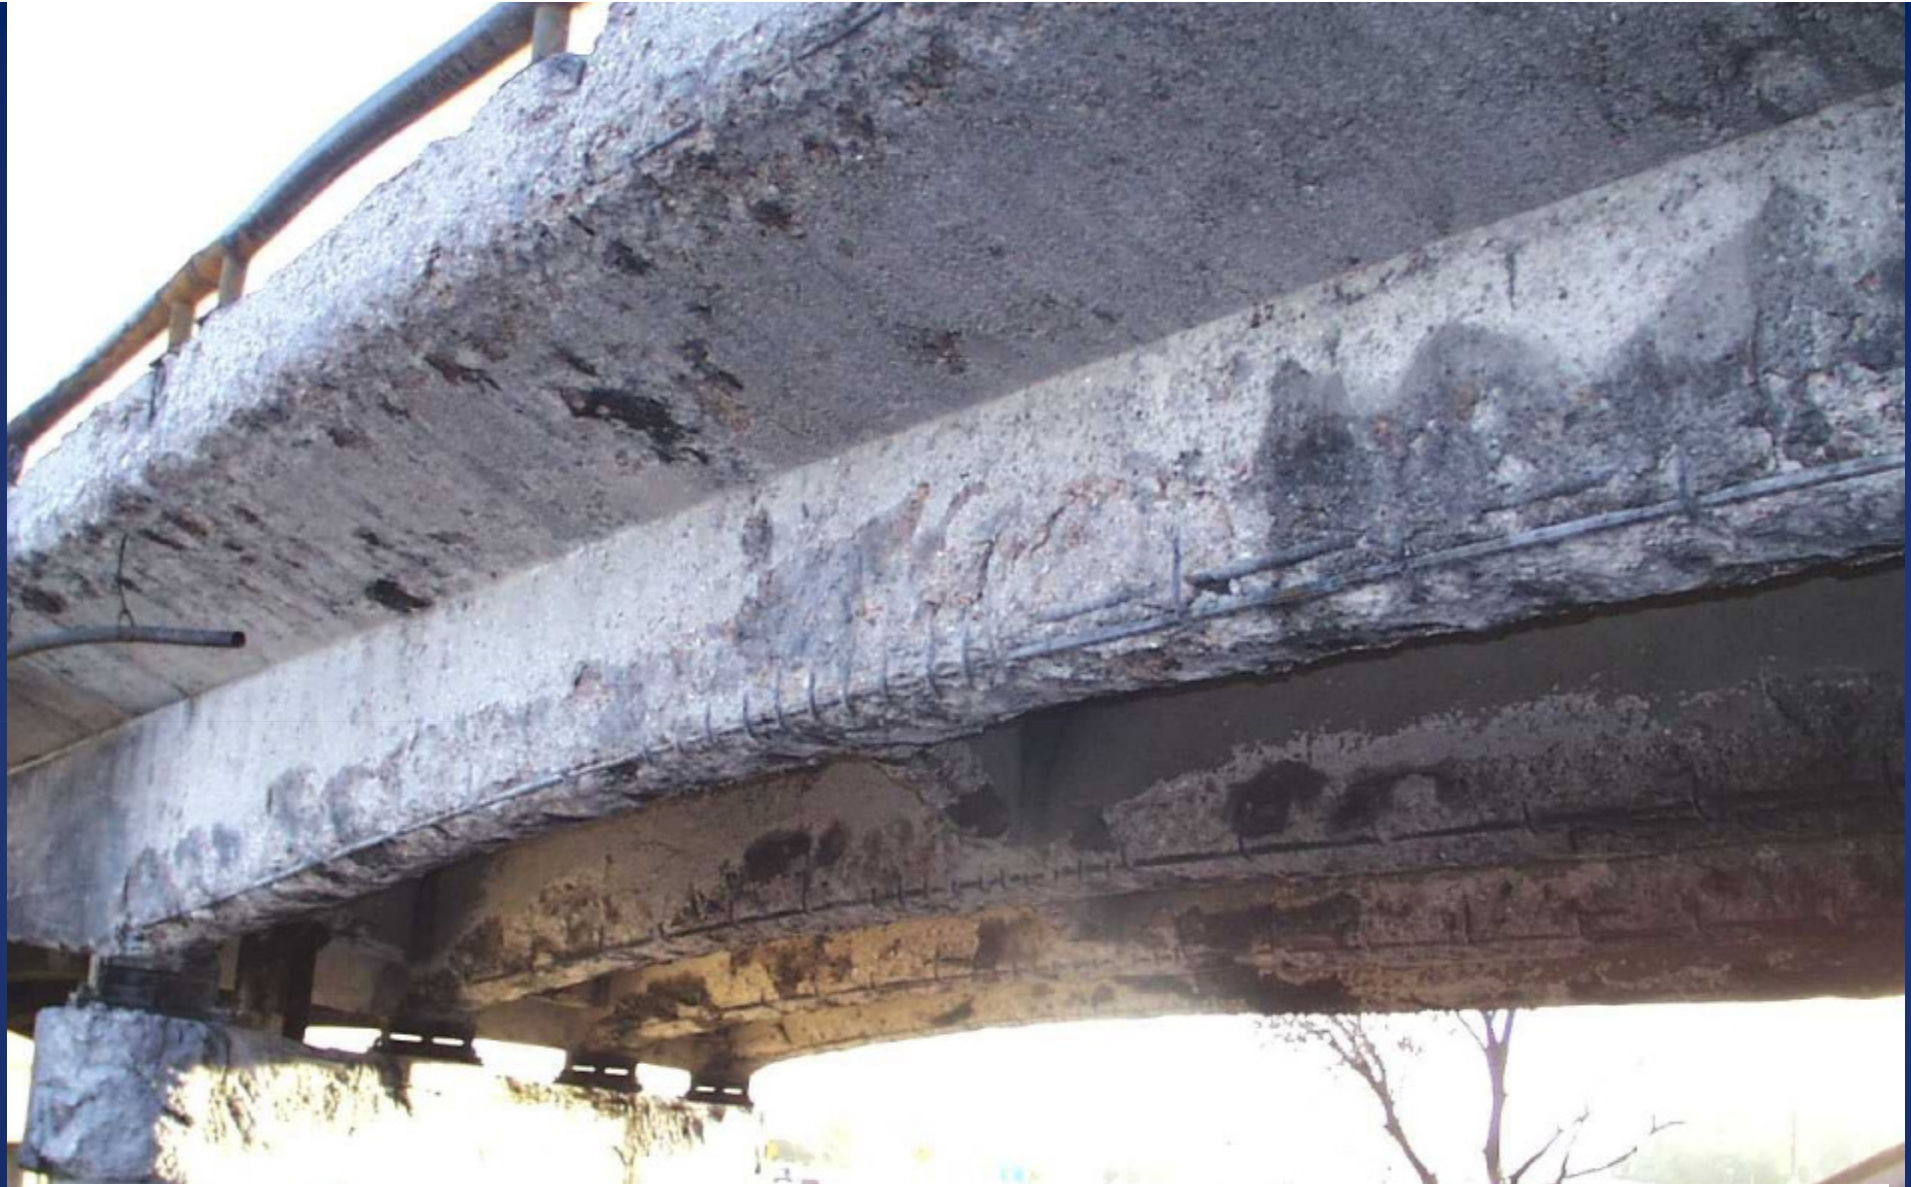
Compare with map-cracking due to ASR where extrusion of joint sealant provides evidence of expansion

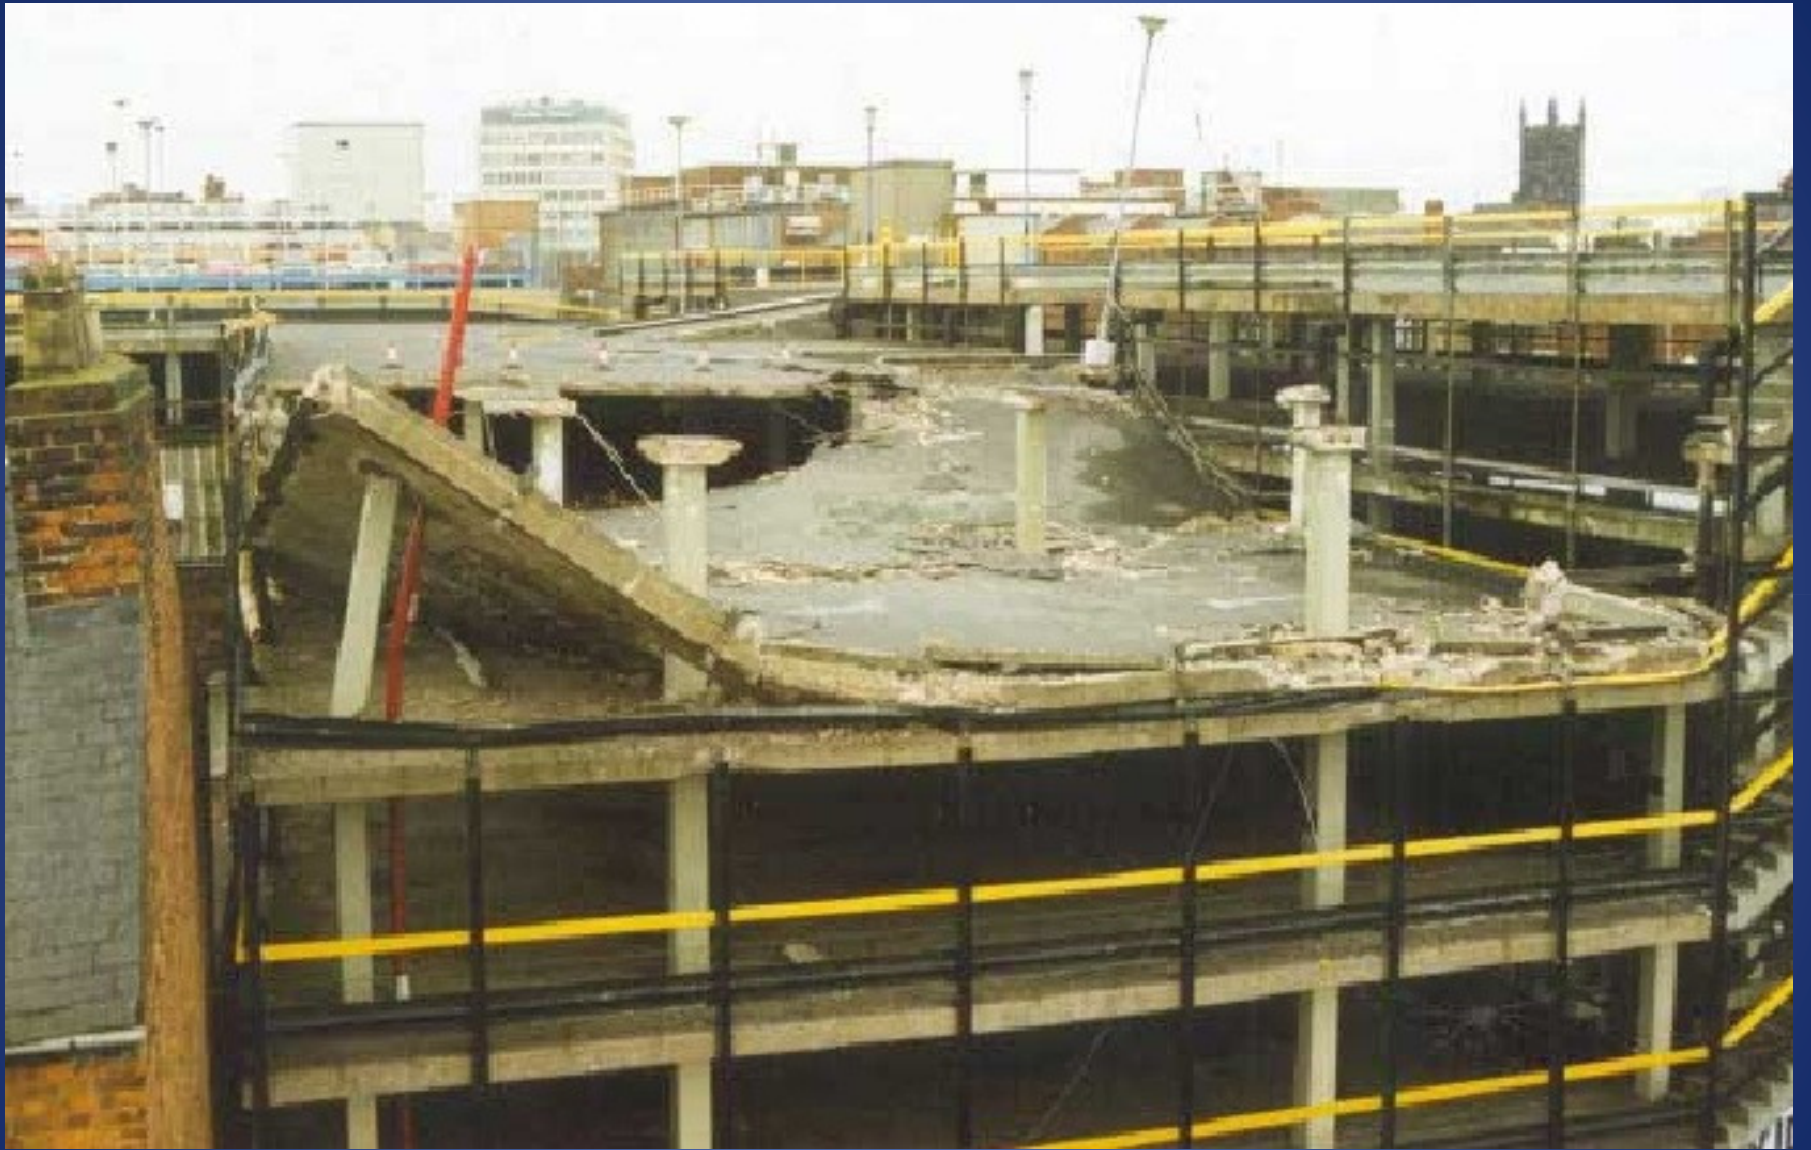
**Symptom**

Severe spalling of concrete surface

Cause

Fire damage (petroleum tanker crashed into bridge pier and ignited)

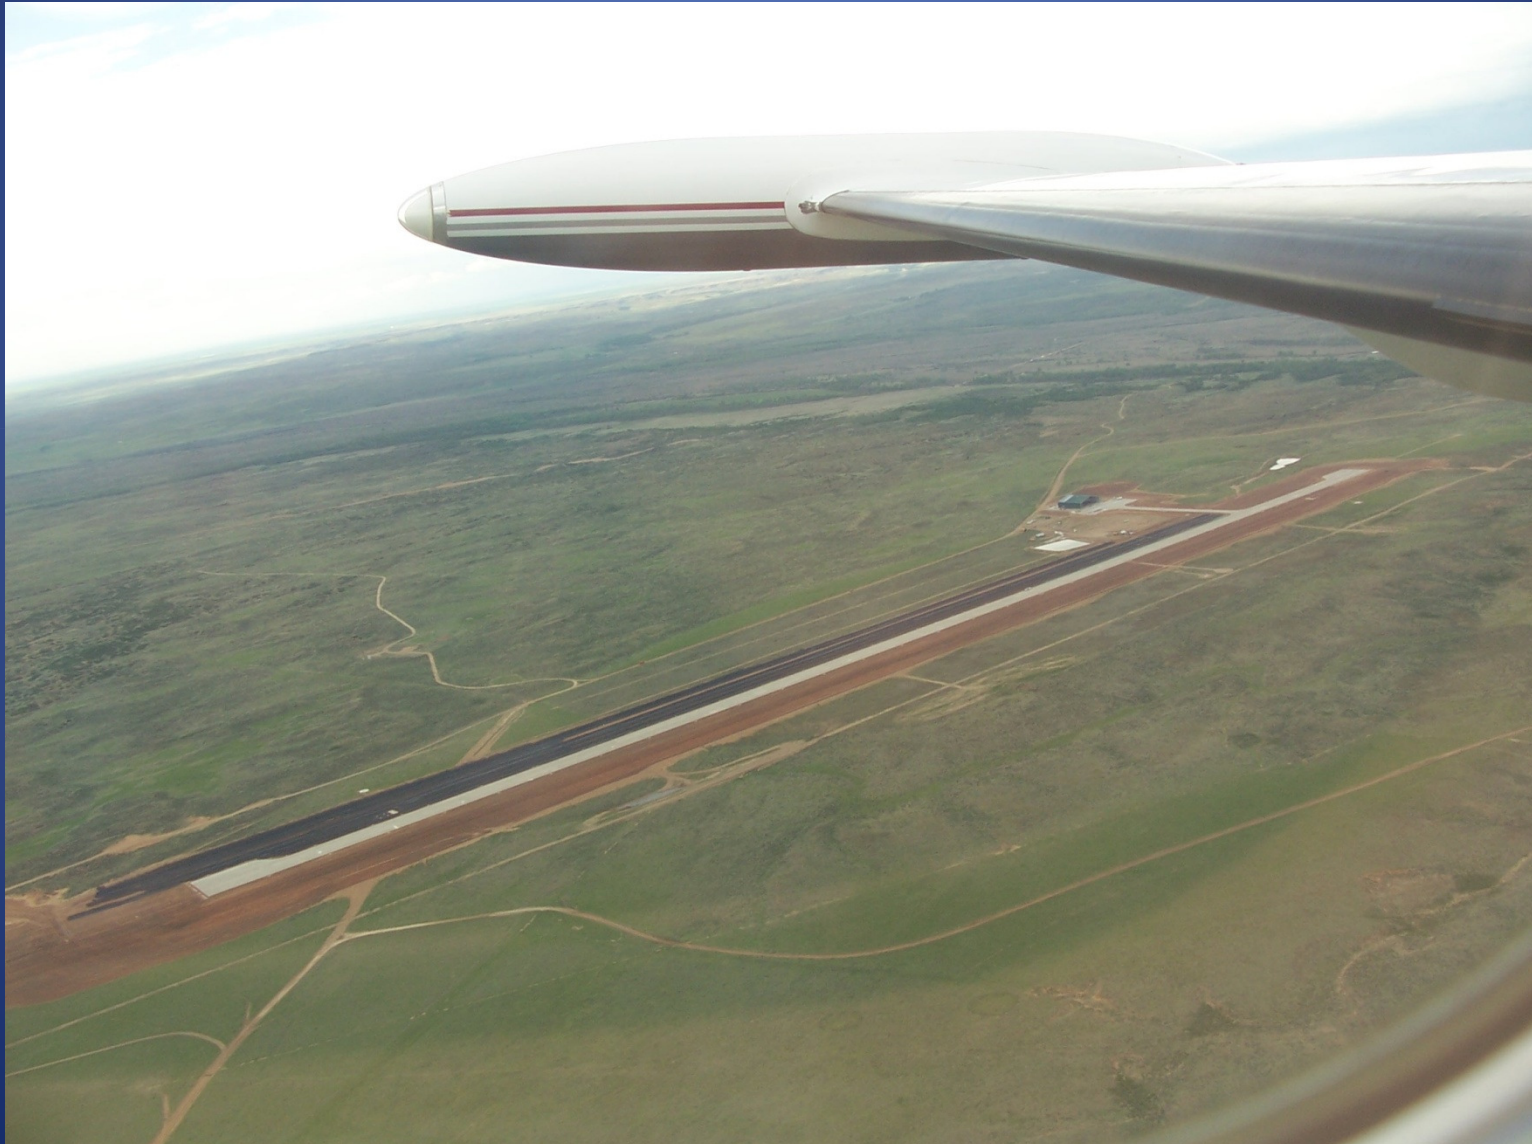
Aerial View of Runway

- Private runway in the Panhandle to accommodate big jets—100 ft. wide, 6000 ft. long, 11 ½ in. thick.
- Consisted of four 25-ft. lanes. with sawed transverse joints at 15-ft. spacing; dowel bars used at saw cut control joints

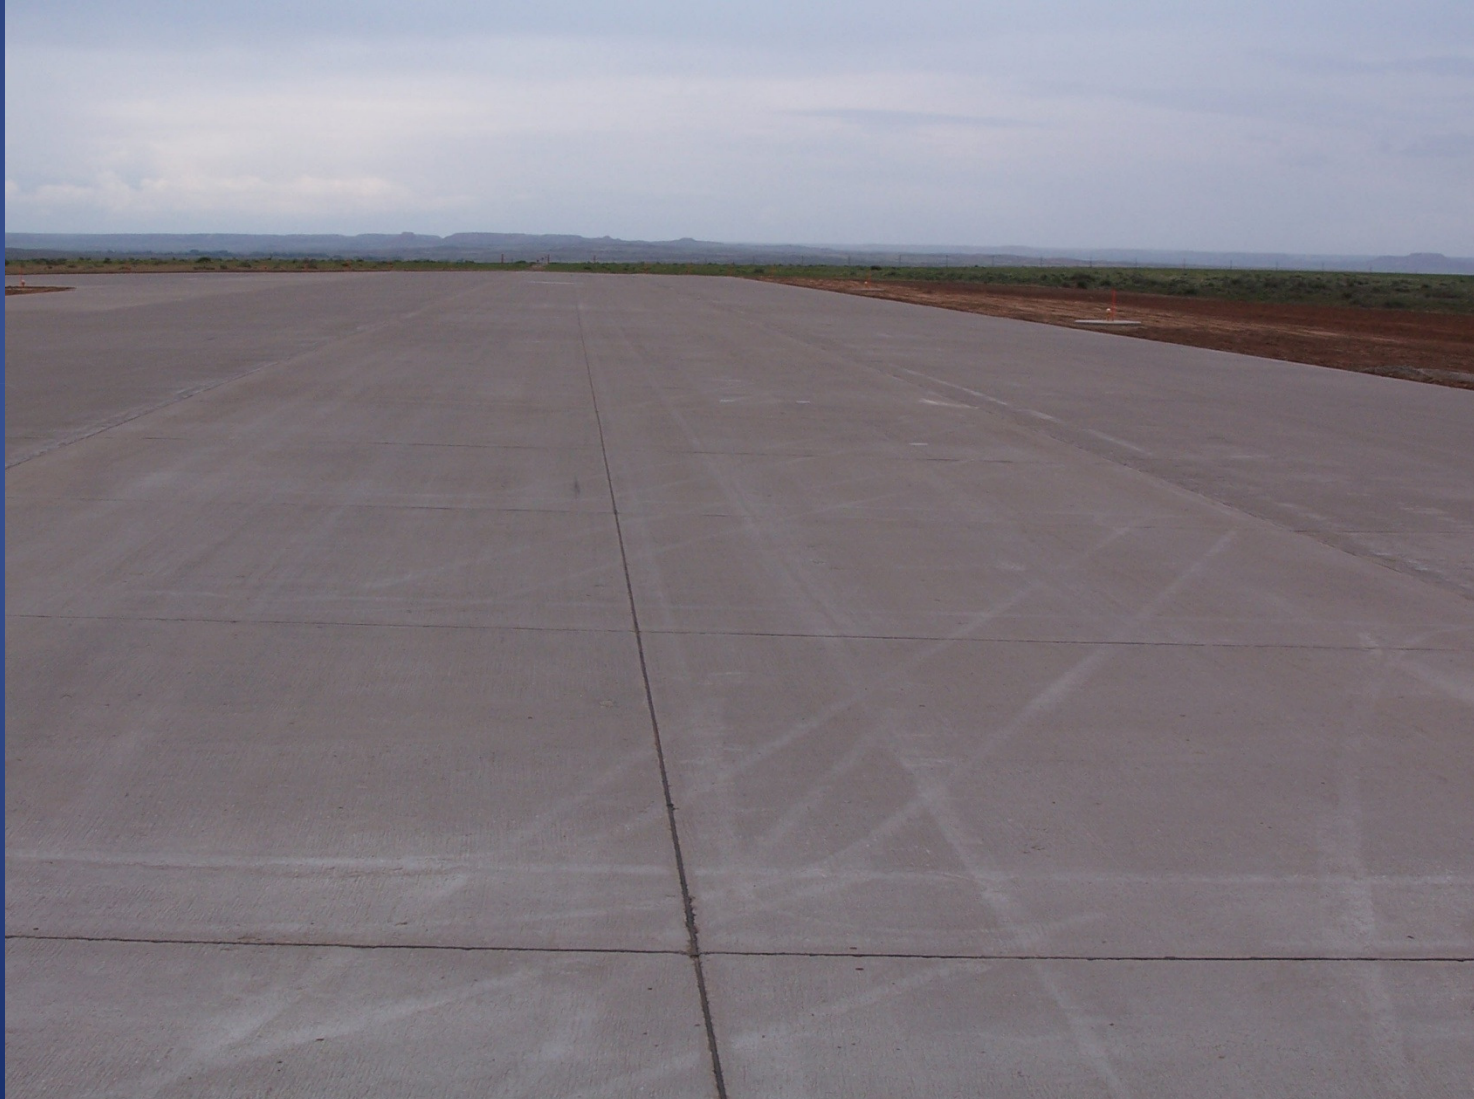
Pavement showing panels

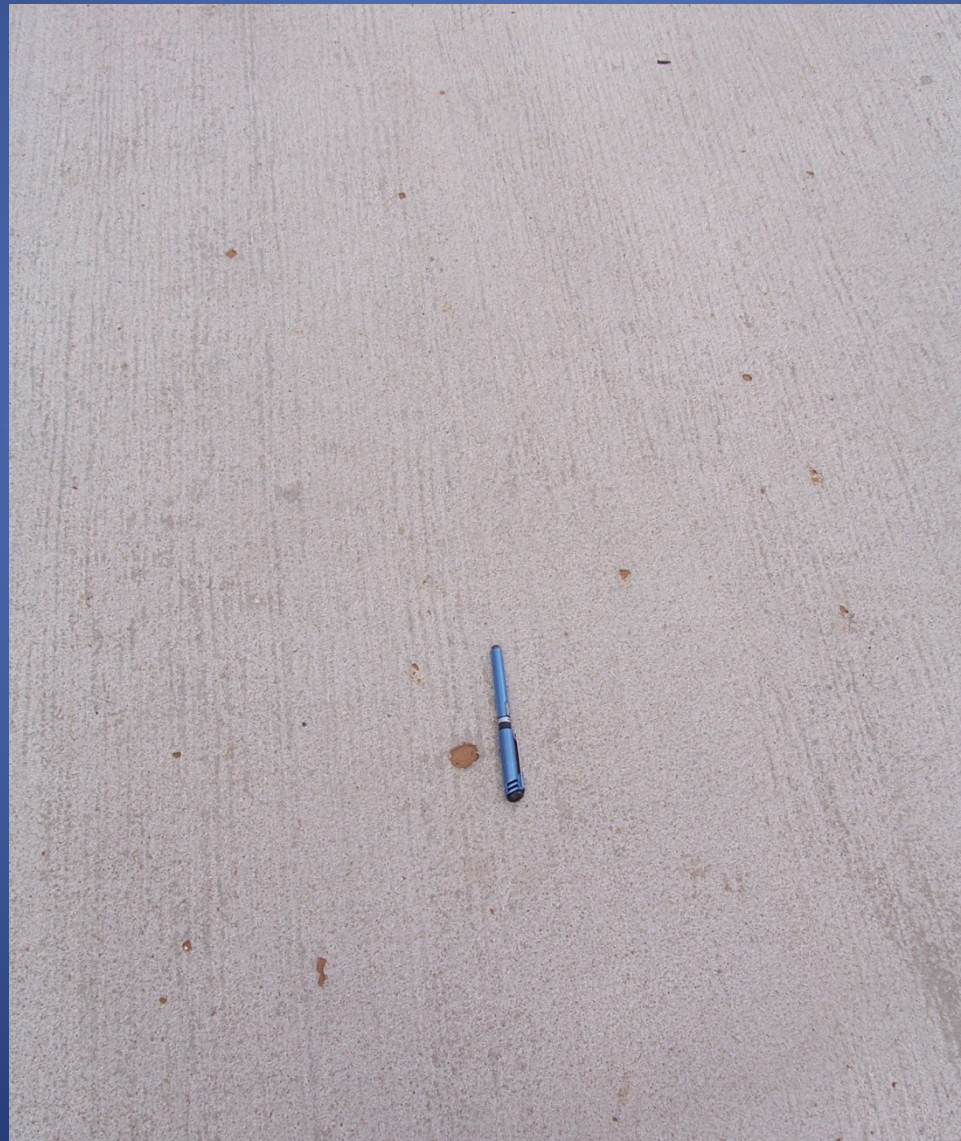
Clay balls in the surface

- Inadequate air void system
- Surface voids due to clay balls (~1/2 in. diam.), apparently due to “dirty” aggregate
- Lack of testing of aggregates for clay—only two tests were performed by the contractor
- Lack of washing of coarse aggregate—specification required it but contractor didn't wash it.

- ASTM D 5340 defines pop outs as ranging from “approximately 1 to 4 inches in diameter and ½ to 2 inches deep.”
- It goes on to say: “No degrees of severity are defined for pop outs. However, pop outs must be extensive before they are counted as a distress; that is, average pop out density must exceed approximately three pop outs per square yard.”
- These clay balls did not constitute a defect.

- American Concrete Pavement Association in an R&T Update (2004): : “If the voids are less than 2 inches in diameter, they do not require repair even if they are numerous. The recommendation is similar to the recommendation for pavement with a chert or shale pop out condition.” The Update states that clay balls “create a surface defect that is typically not a structural problem, but can detract from the **surface appearance**. ... They ‘float’ to the surface during vibration because they weigh less than the aggregates and other particles in the surrounding fresh concrete.”
- No defect according to ACPA

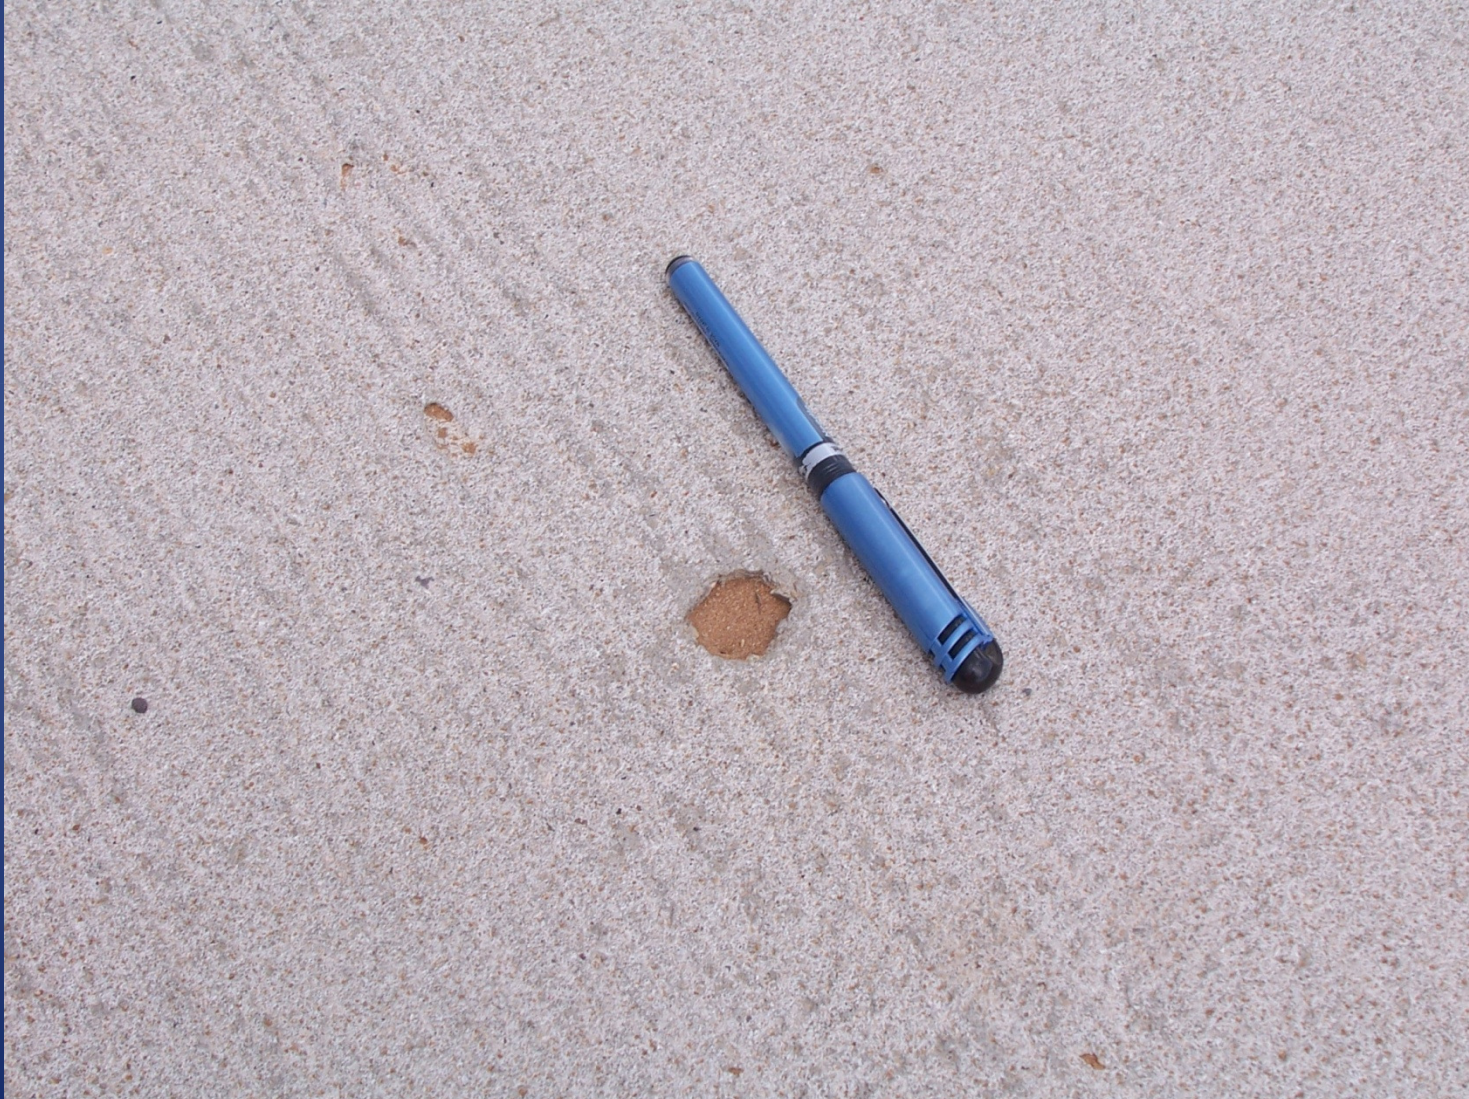
Reddish clay made them easily
visible

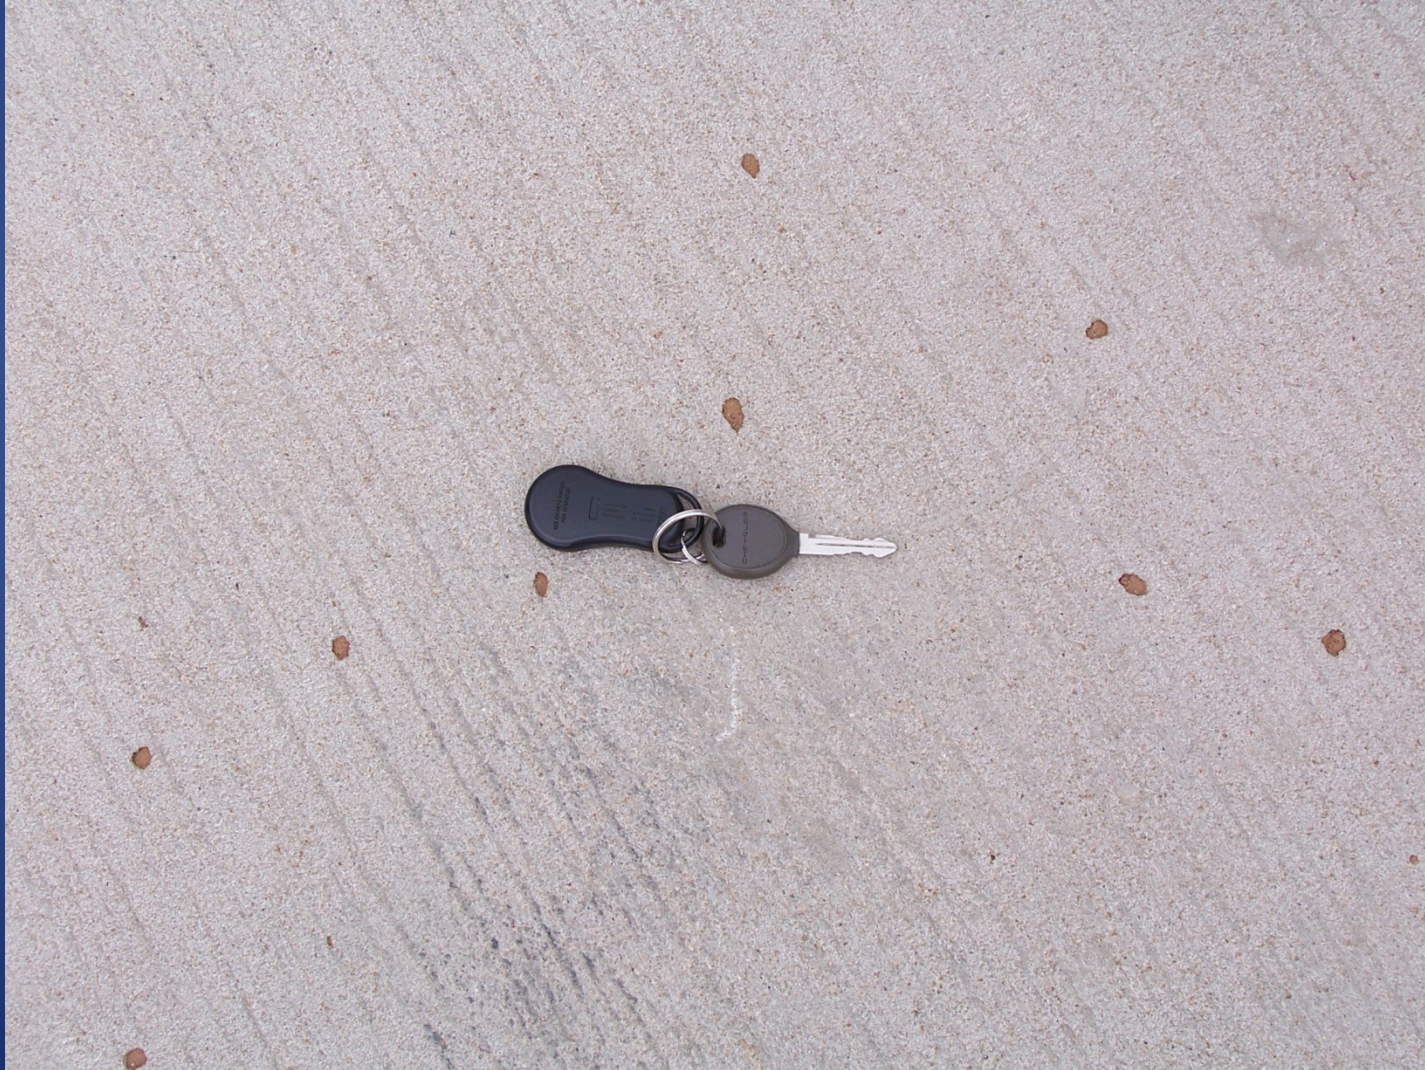
Many were quite small

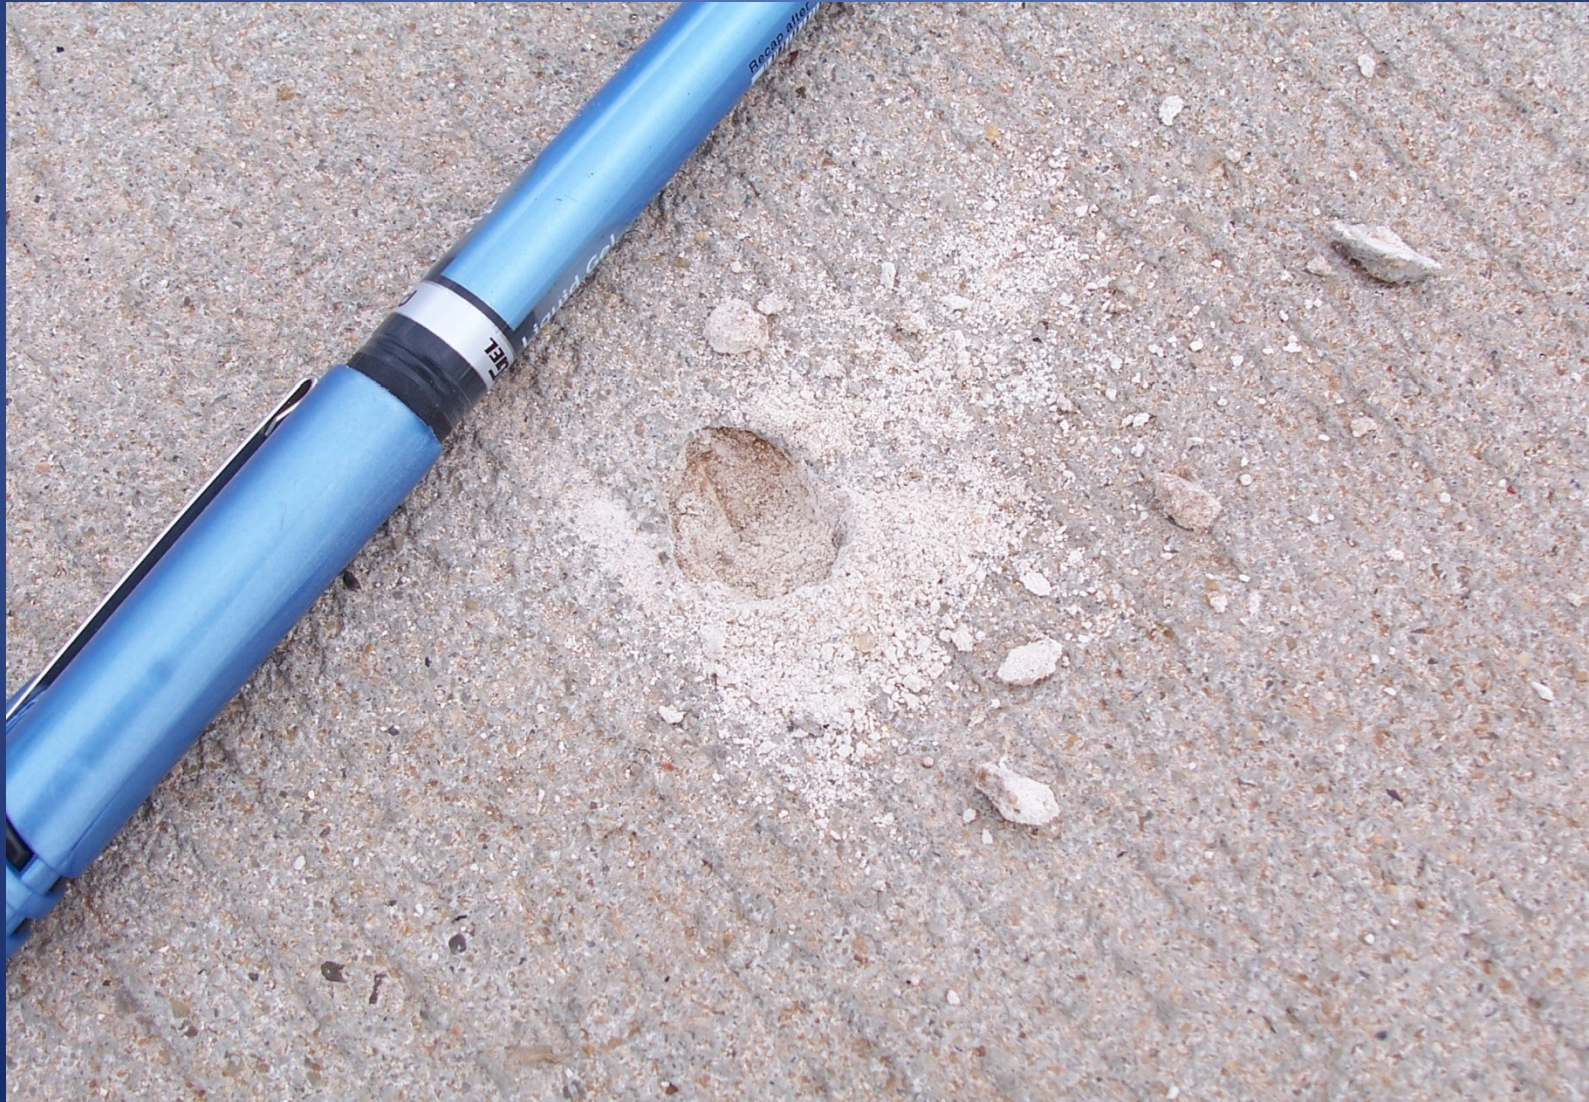
Clay could easily be chipped out

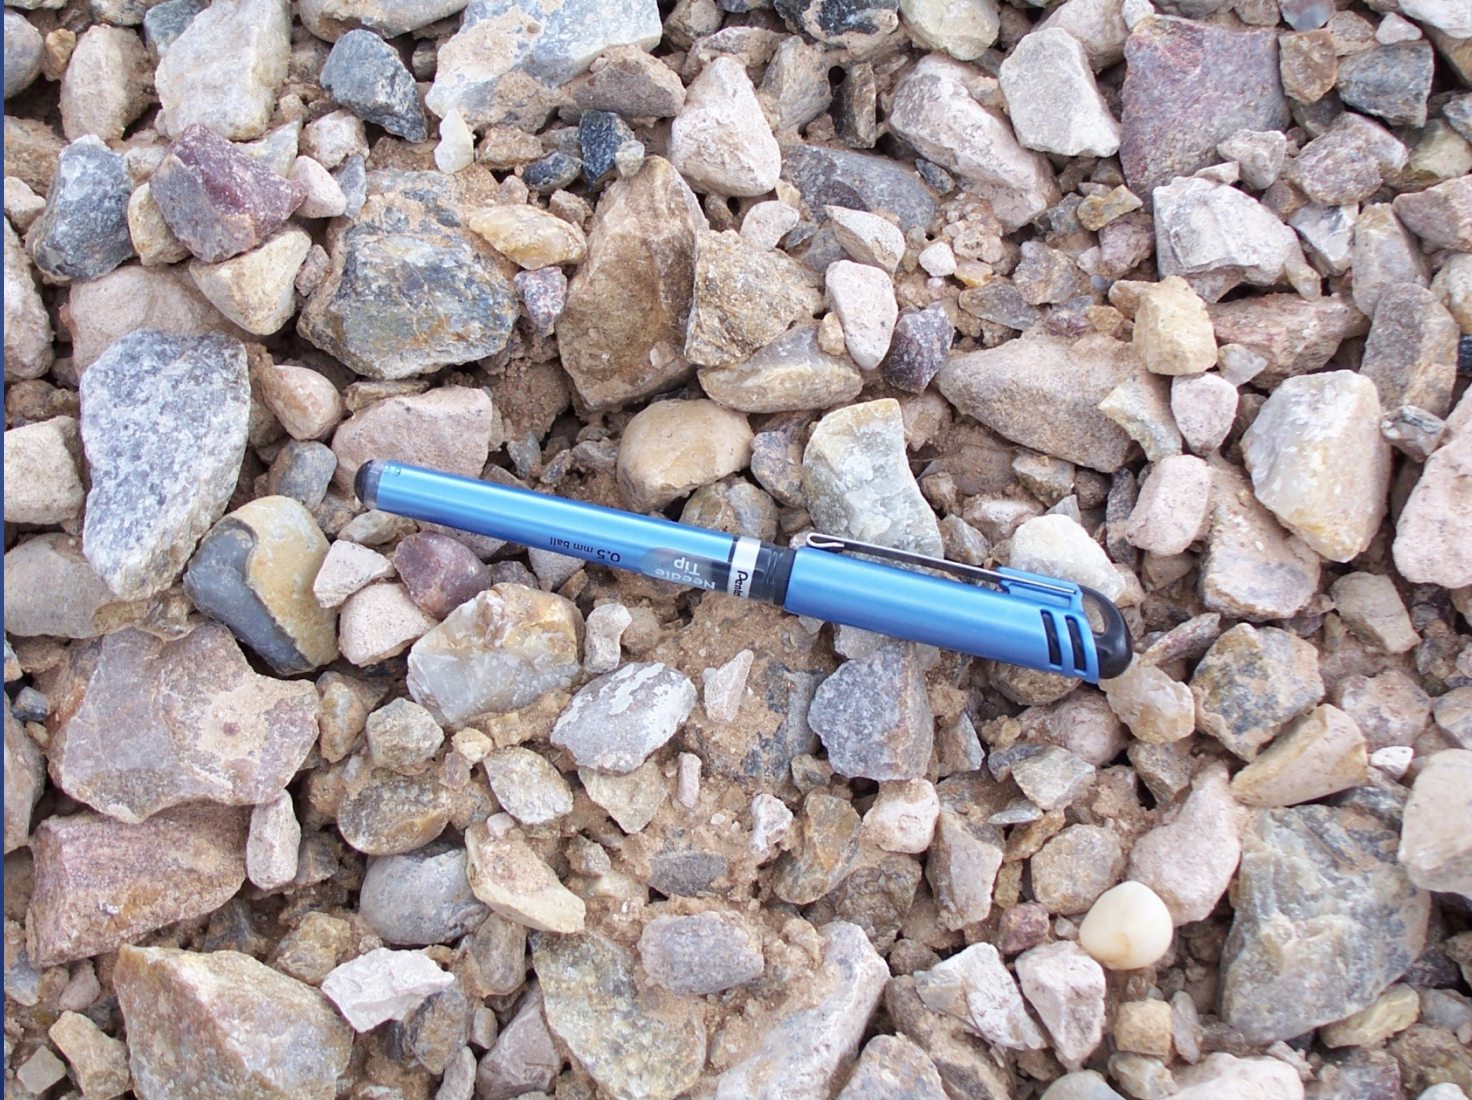
Siliceous aggregate that contained trace amounts of clay, chert, caliche

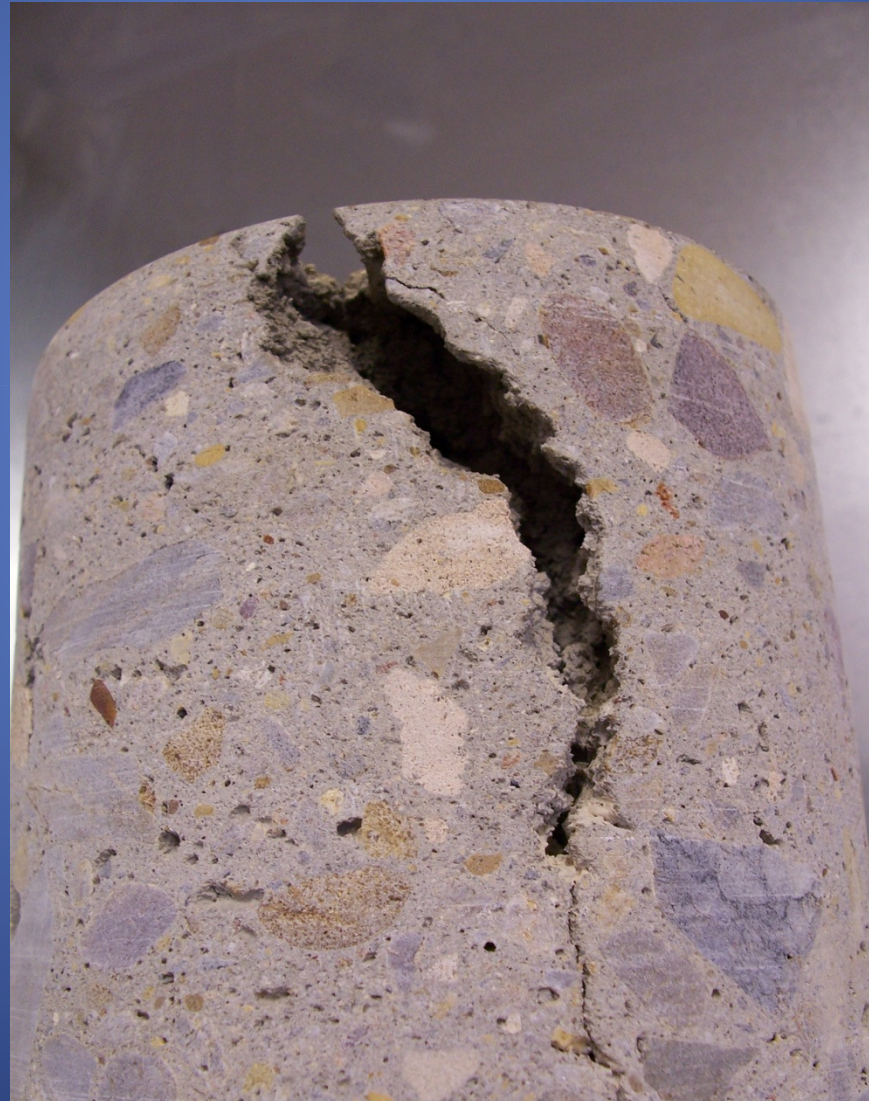
Void, likely due to paving operation

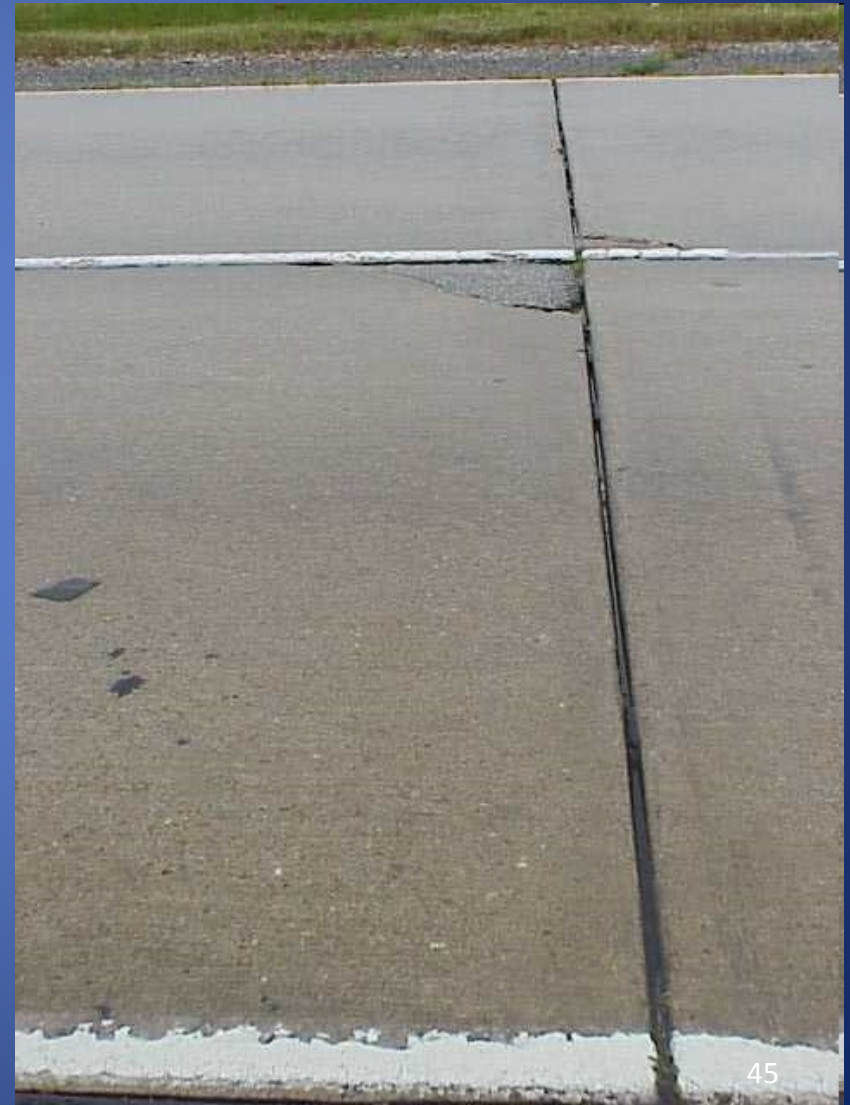
Corner Break

- A crack that extends from a transverse joint or crack to a longitudinal joint or the pavement edge.
- Each end of the crack should be less than six feet from the corner of the slab.
- If one end of the crack is further than six feet from corner of the slab, the crack should be categorized as a diagonal crack and not a corner break.
- A corner break extends through the thickness of the slab.

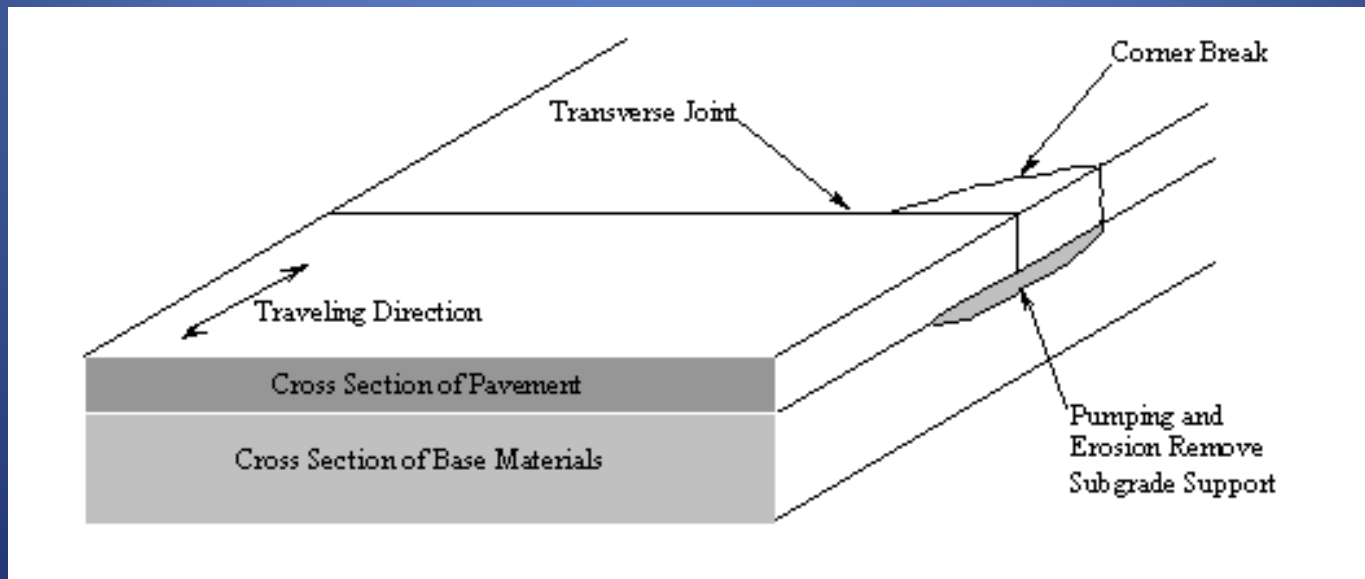
Corner Break

- A corner break is a result of repeated loading combined with lack of subgrade (can be a result of erosion).
- Poor load transfer across the joint, thermal curling stresses, and moisture warping stresses may also contribute to the formation of a corner break.

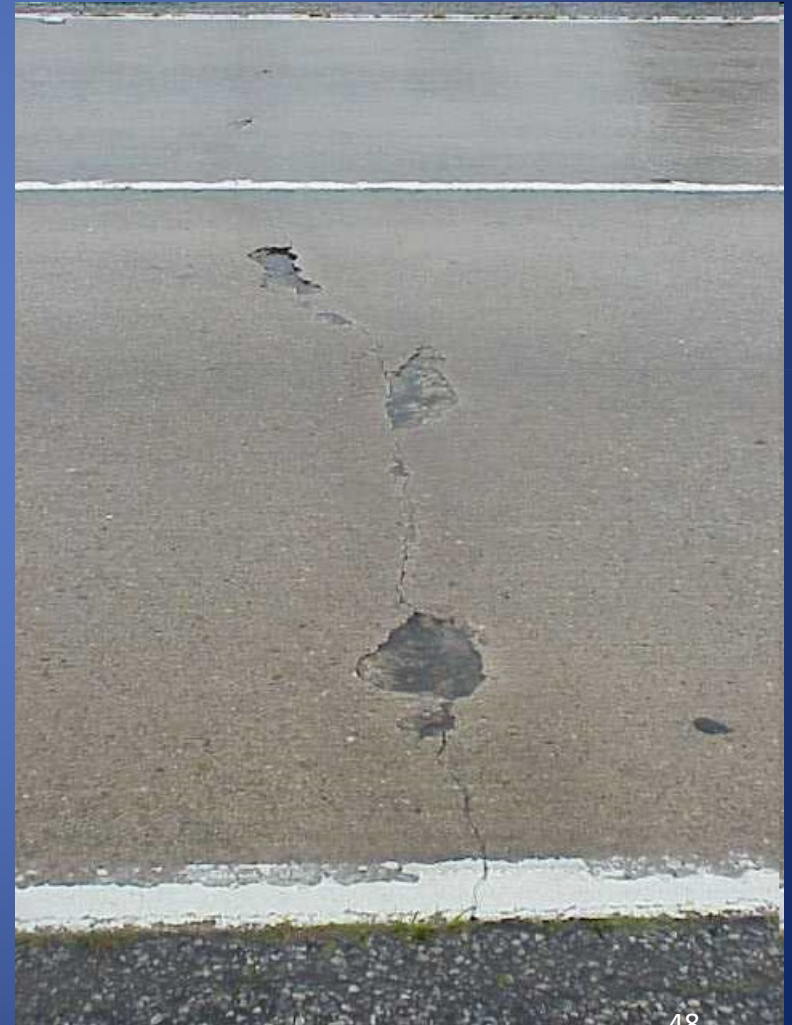
Cracking Spalling

- Crack spalling is the chipping of the concrete slab at the edges of longitudinal or transverse cracks.
- Crack spalling is due to excessive local pressure at the joint. This pressure may be due to a combination of traffic action, thermal expansion, and/or steel corrosion.
- The spall might progress into pothole.

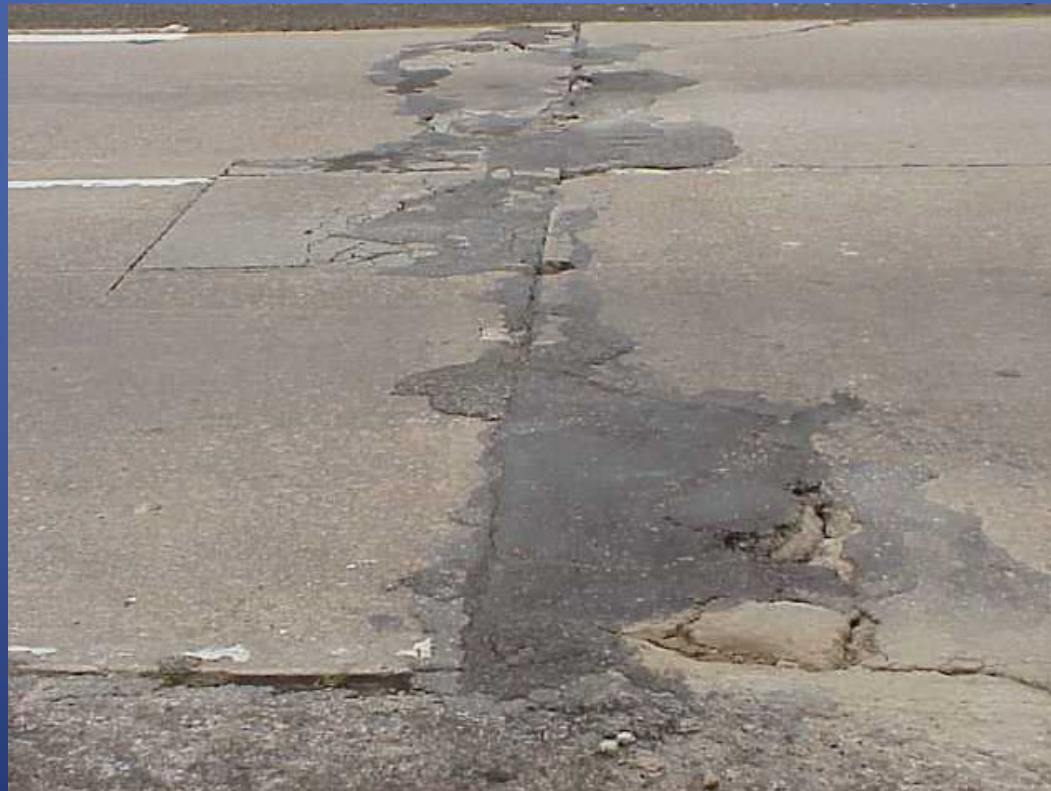
- Joint failure can be separated into buckling (or blowup) and shattering. Joint buckling is the upward displacement of the slab edge at the transverse joint. Joint shattering is the crushing of the concrete near a slab edge at the transverse joint.

Localized Joint Failure

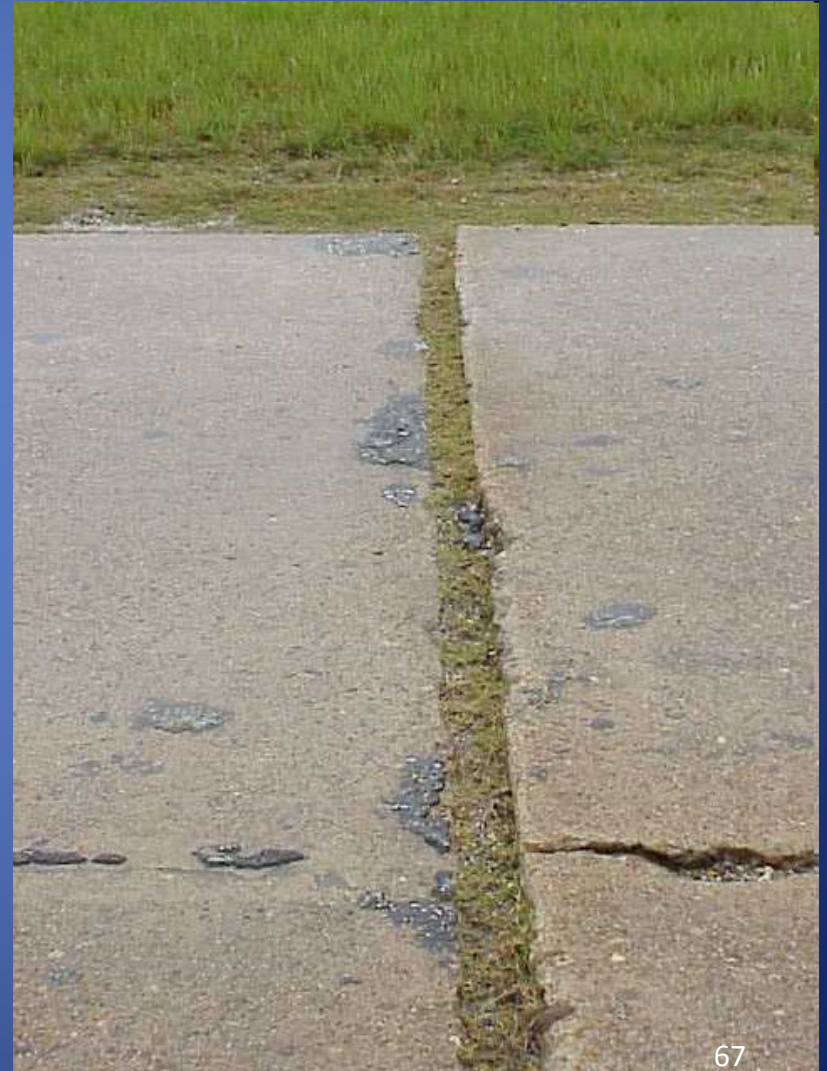
Joint Separation

- Joint separation is the lateral slippage of slabs resulting in the widening of a longitudinal joint. Joint separation usually occurs between the traffic lane and the shoulder.
- Lane separation is not considered serious unless water can easily infiltrate into the joint. The infiltration of water may cause additional damage or movement.

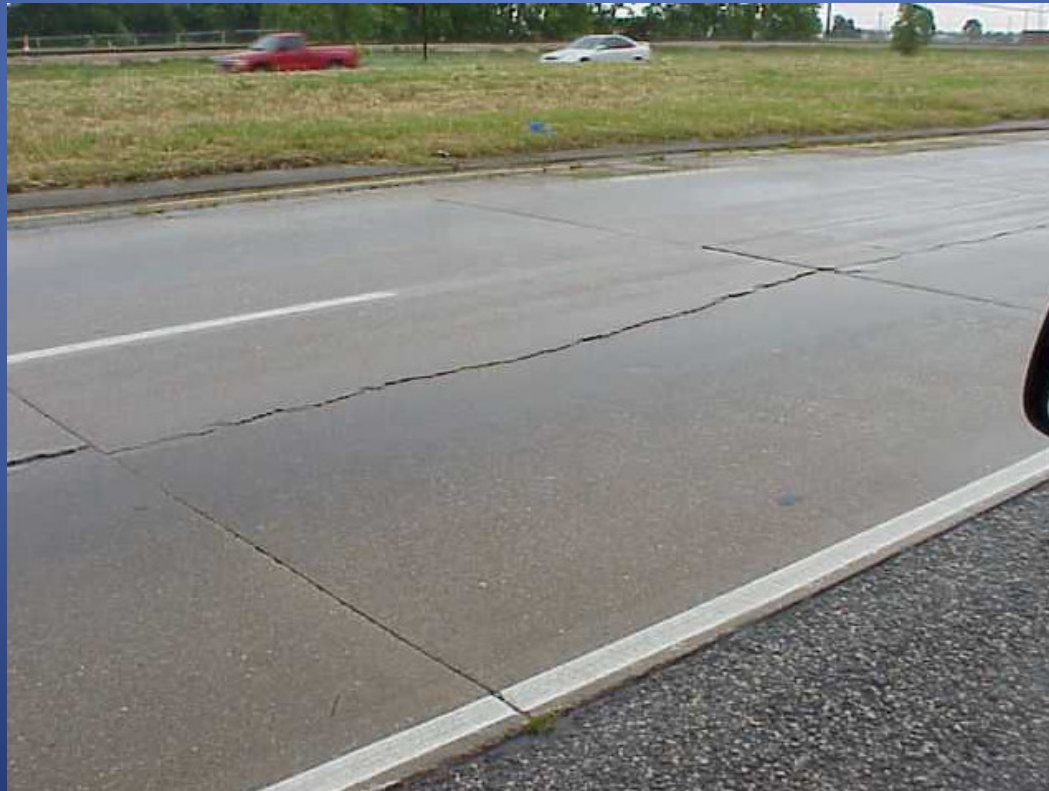
Longitudinal Cracking

- Longitudinal cracks are cracks that follow a course approximately parallel to the centerline of the pavement. These cracks are generally straight but they may curve slightly back and forth across the length of the pavement.

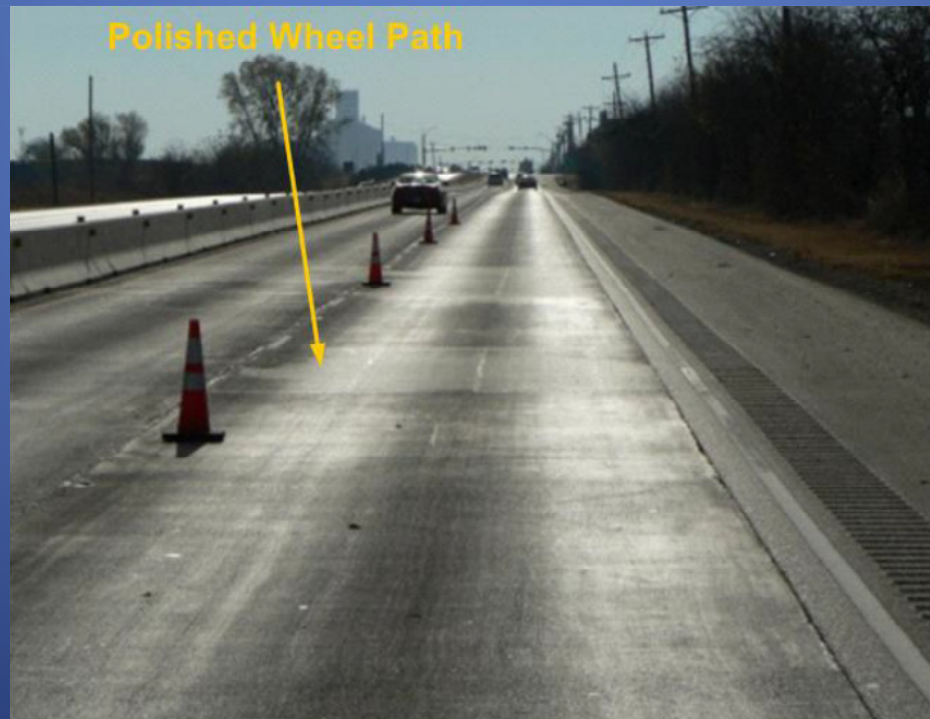
Loss of Skid Resistance

- Loss of skid resistance occurs when the surface of the pavement becomes polished, or slippery. Polishing is the shining of the coarse aggregates located at the surface of the pavement.
