Failures: What Can We Learn?

Case Study: Concrete Runway

Forensic Manual for Portland Cement Concrete Pavements

Prepared for TxDOT by
David Fowler and Zhanmin Zhang

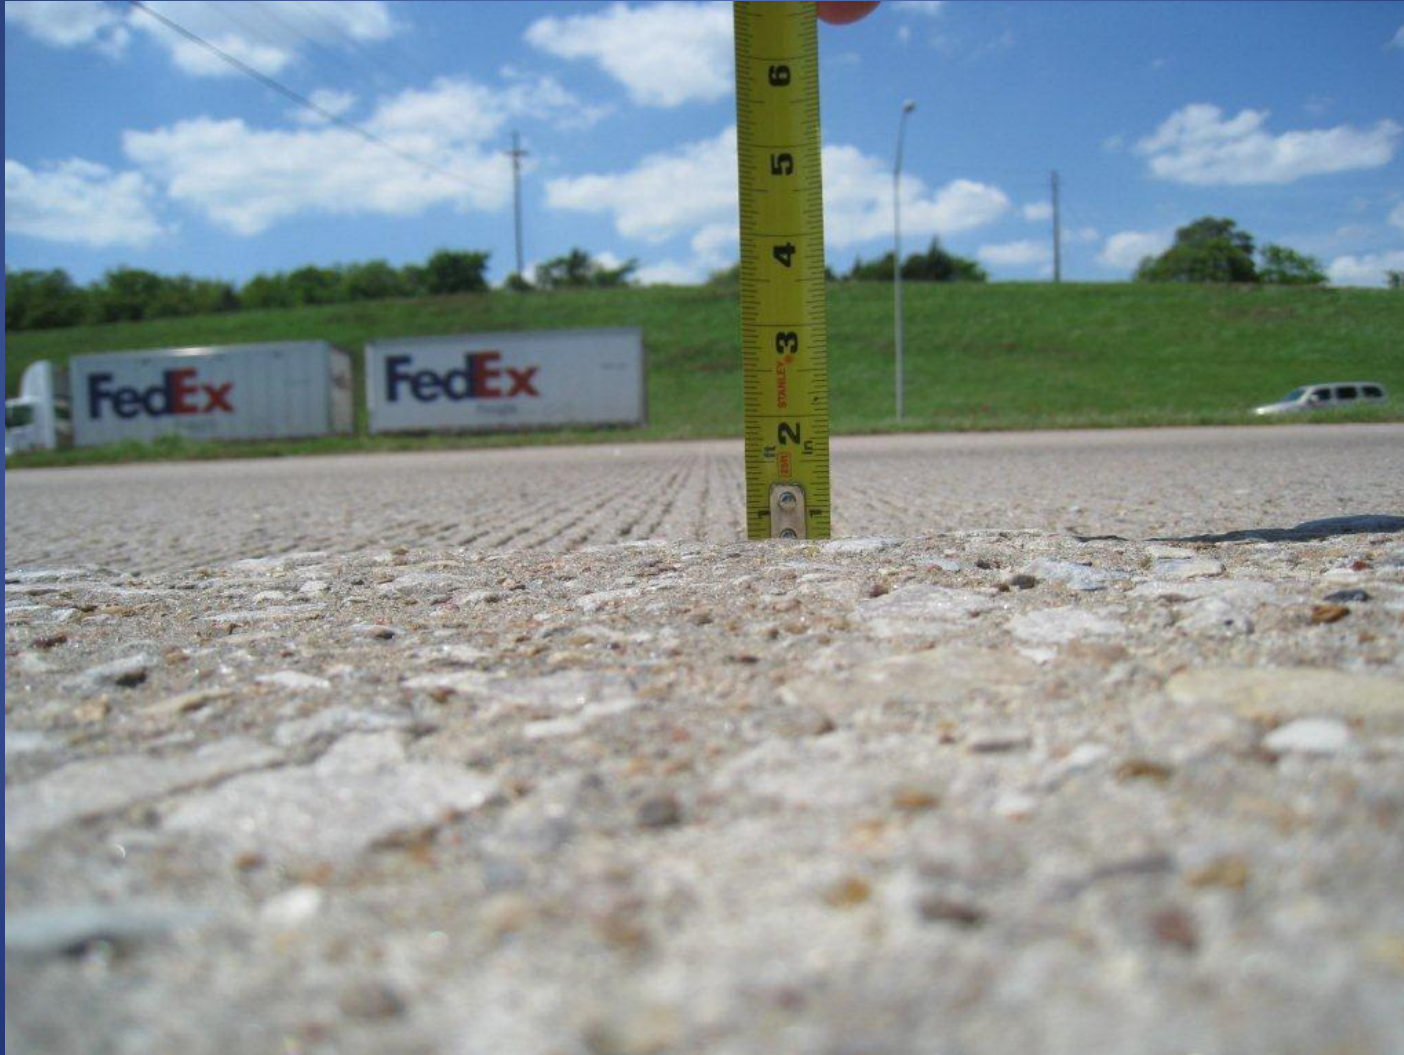
Loss of Surface Material

- Scaling is the progressive peeling or flaking of the rigid pavement surface. Scaling may occur anywhere on the pavement surface, but the affected areas are located randomly (spotty) across the pavement.
- Raveling is the loss of fine aggregates from the pavement surface. Raveling is continuous over the pavement surface and is usually the worst in the wheel paths.
- An aggregate pop out is the removal of coarse aggregate particles from the surface. Potholes are bowl shaped holes of various sizes in the pavement surface and can also be classified as loss of surface material.

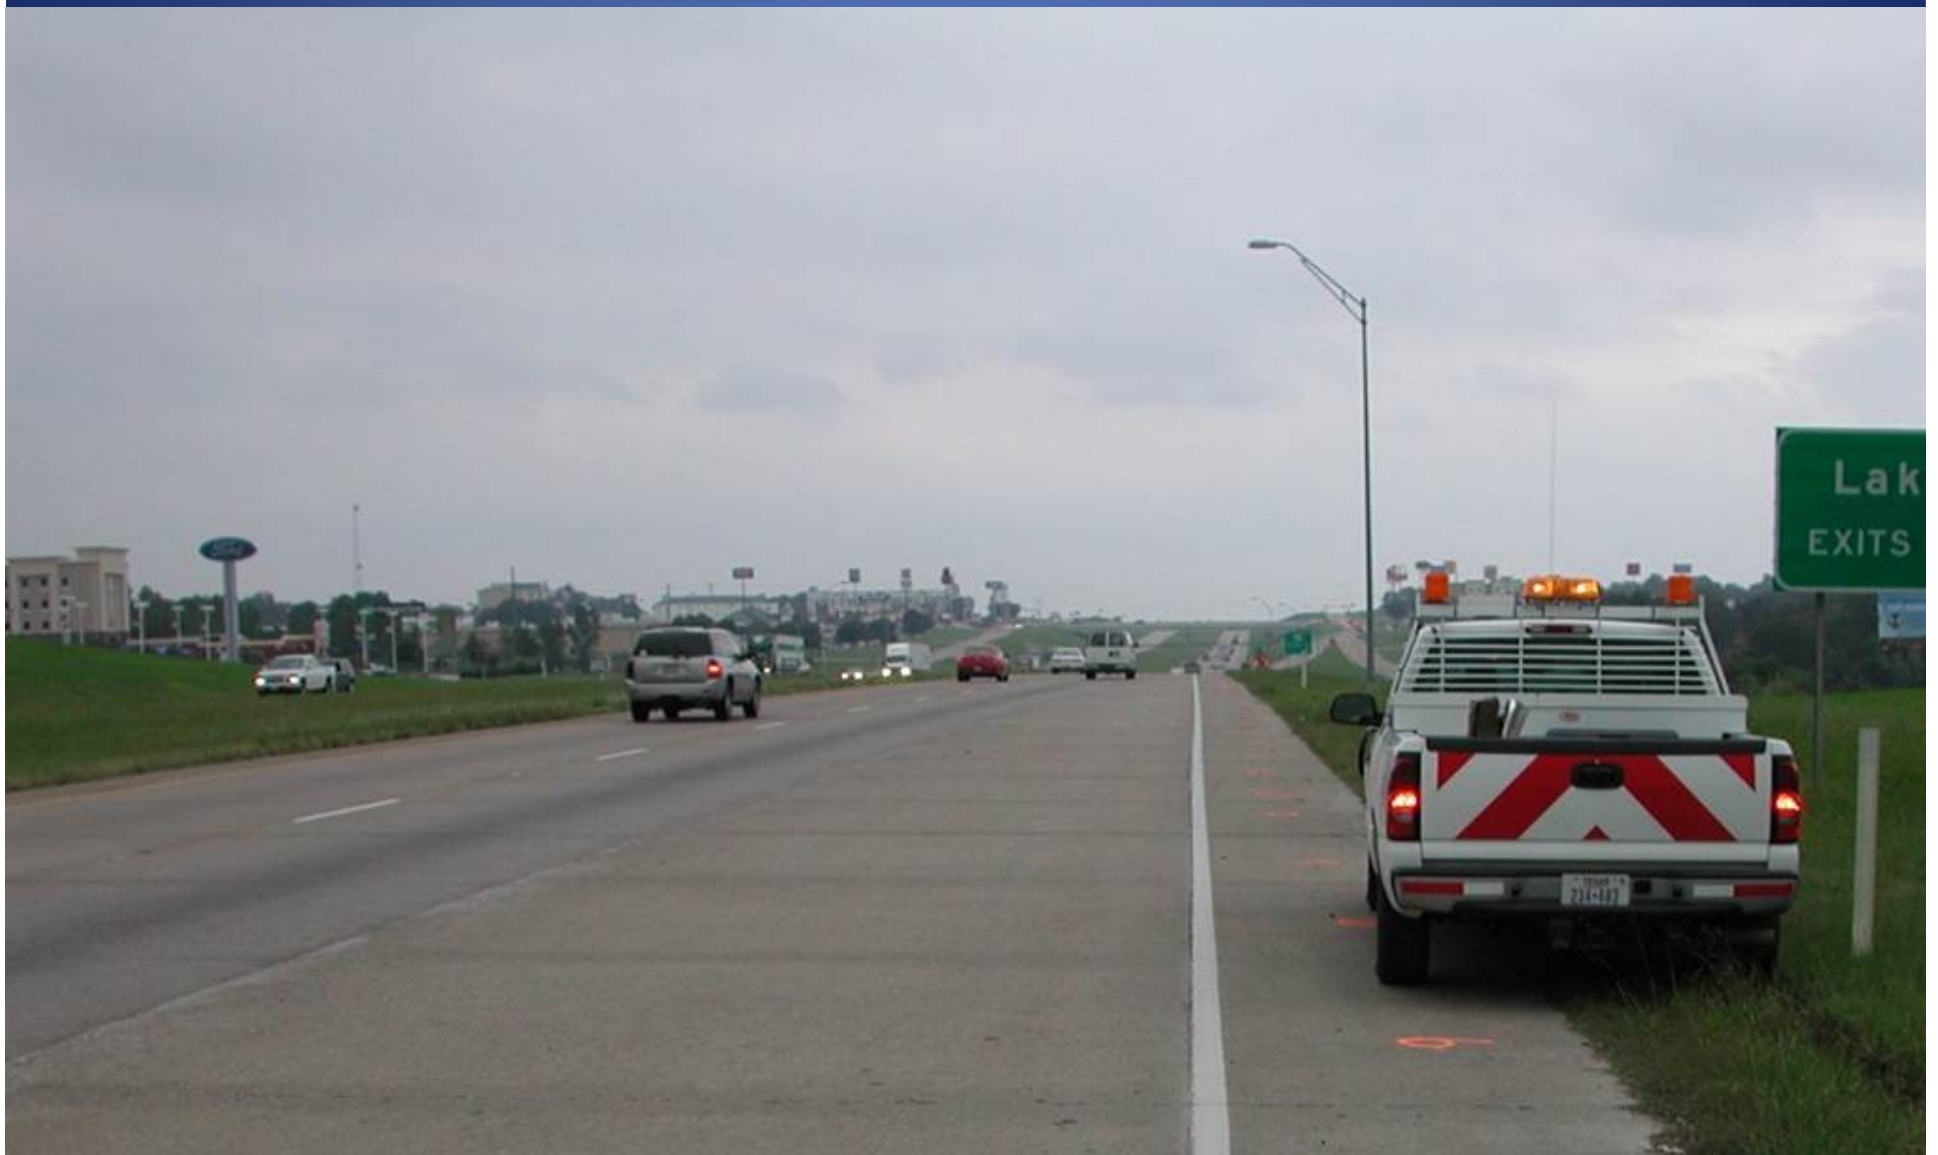
Pumping—see staining

- Pumping is the expulsion of water and silts, sands, or clays from joints or cracks when load is applied to the pavement. If water enters the joint or crack it may erode the underlying layers of the pavement.

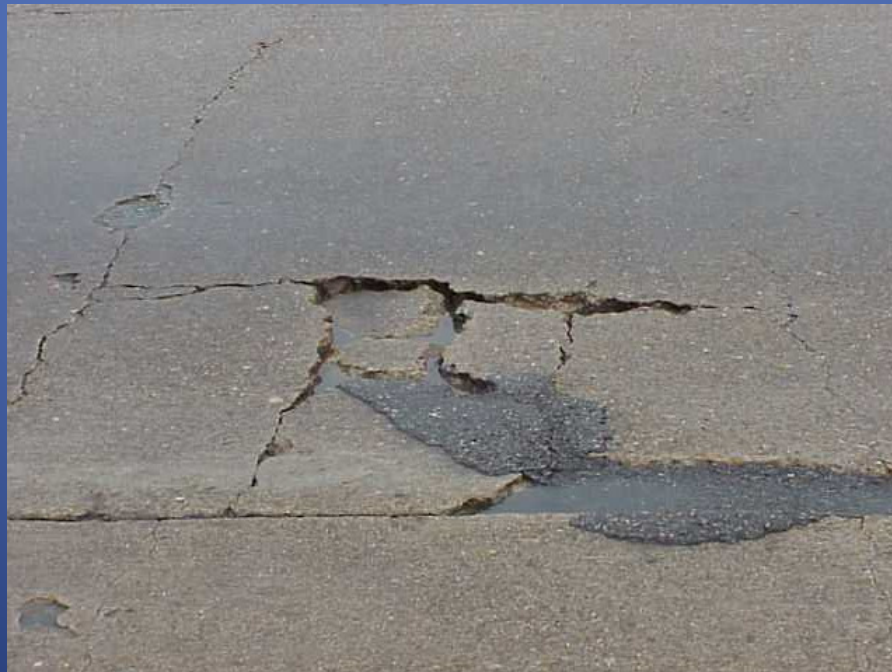
- A punchout is a full-depth block of pavement, formed at the edge, when one short longitudinal crack forms between two existing transverse cracks. The existing cracks are closely spaced, usually less than four feet apart. The punchout is often rectangular, but some may appear in other shapes. Punchouts are most common in continuously reinforced concrete pavements.

Punchout—note two transverse cracks and longitudinal crack

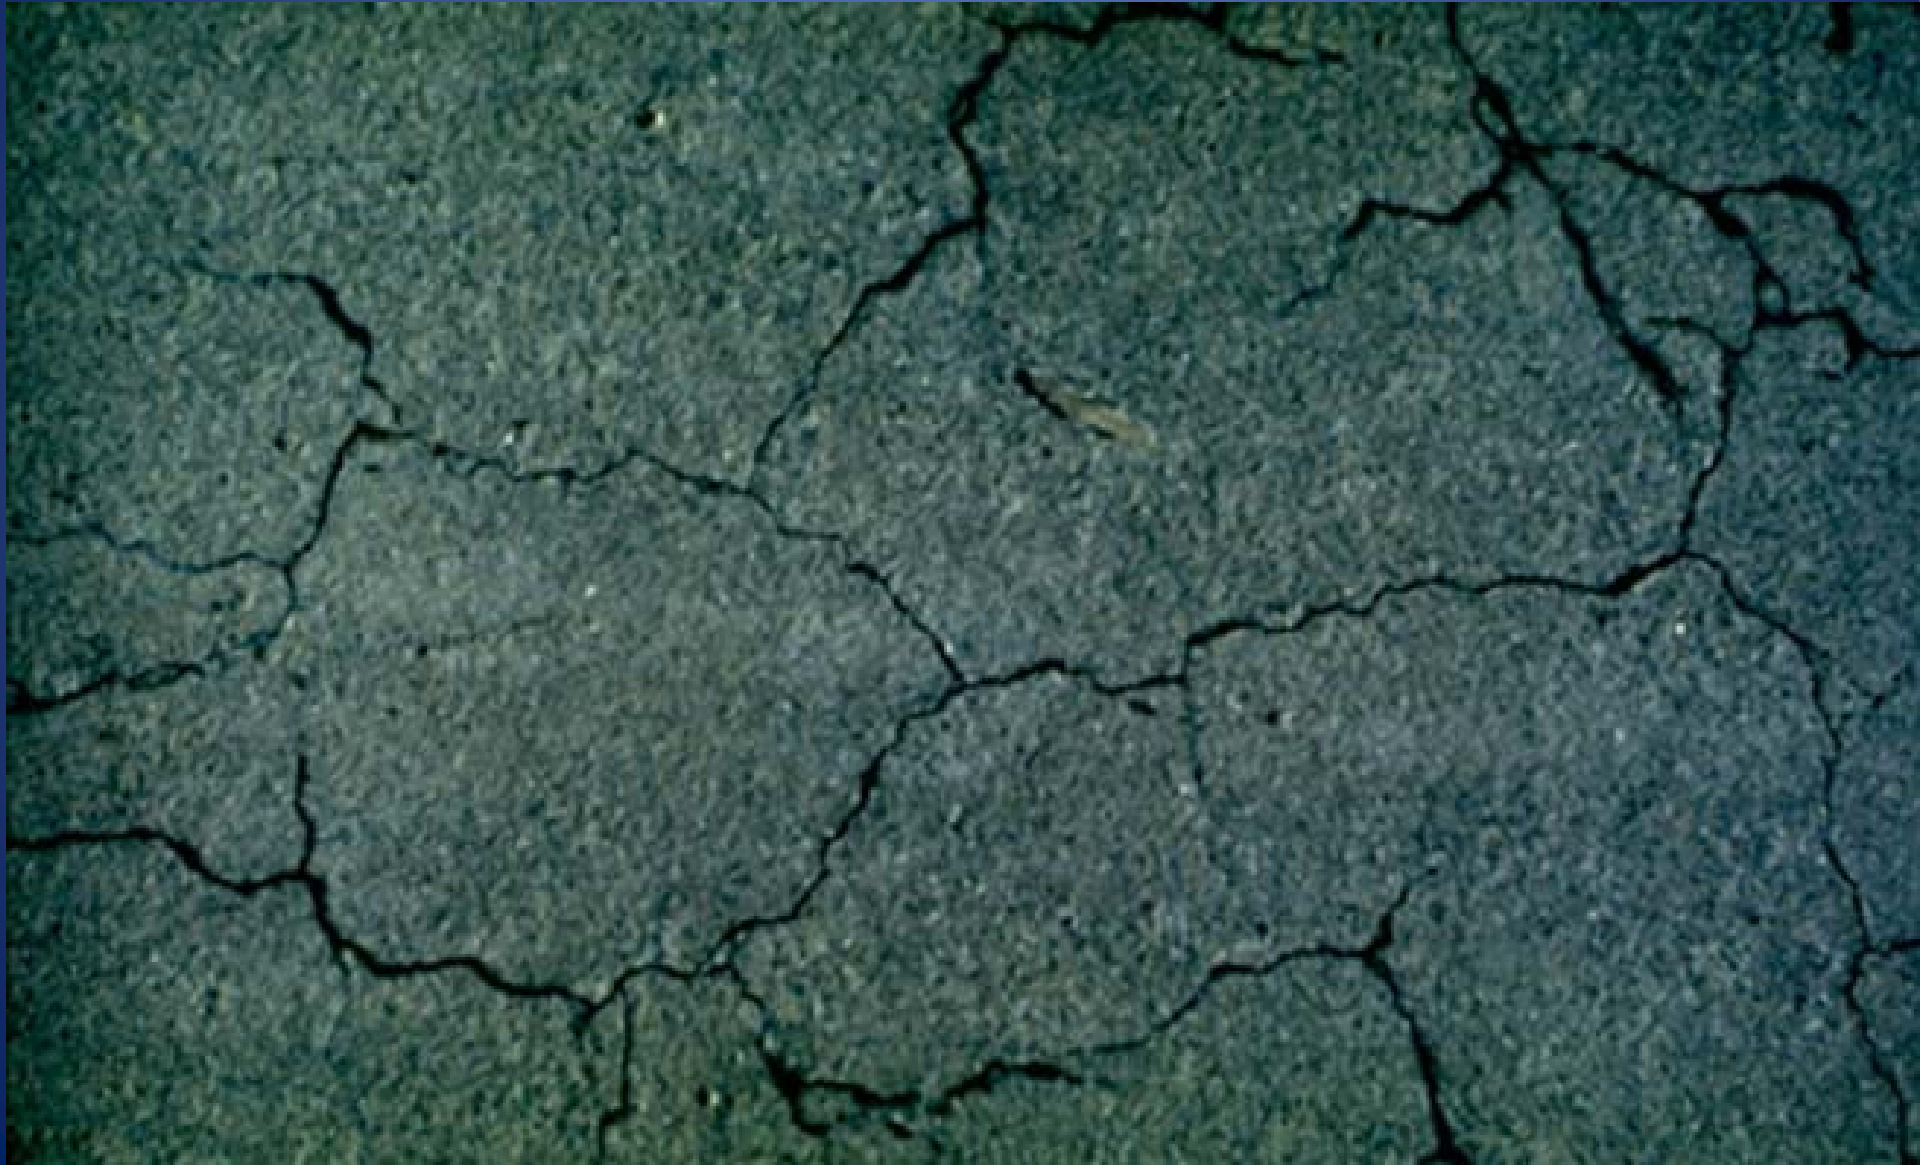
Note ASR gel around aggregate

1. Alkali-silica reaction occurs when aggregates that contain certain forms of silica react with the alkalis in the cement paste. This reaction, which aided by a warm, moist environment, will produce a gel-like material. The gel expands when it absorbs water. The expansion of the gel may result in cracking of the hardened concrete.

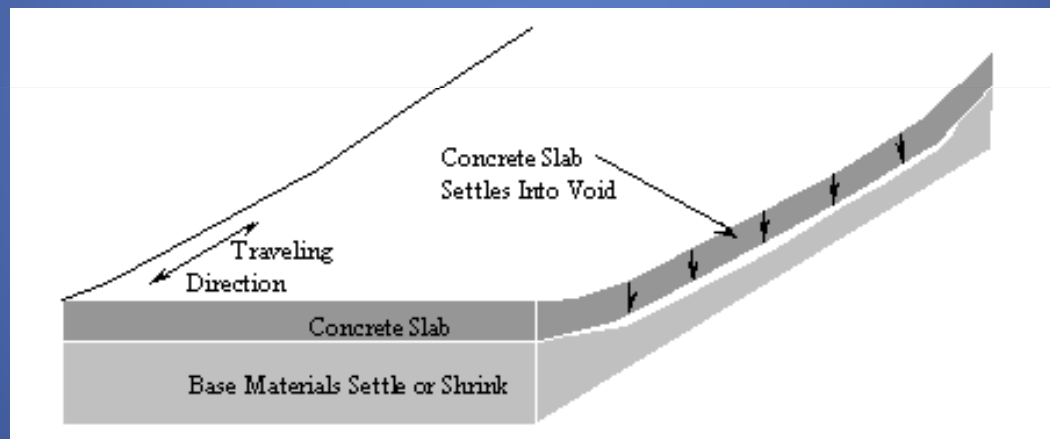
2. The pavement may settle due to lack of subgrade support. Erosion of the base materials may leave large voids beneath the rigid pavement and the pavement may settle into these voids.

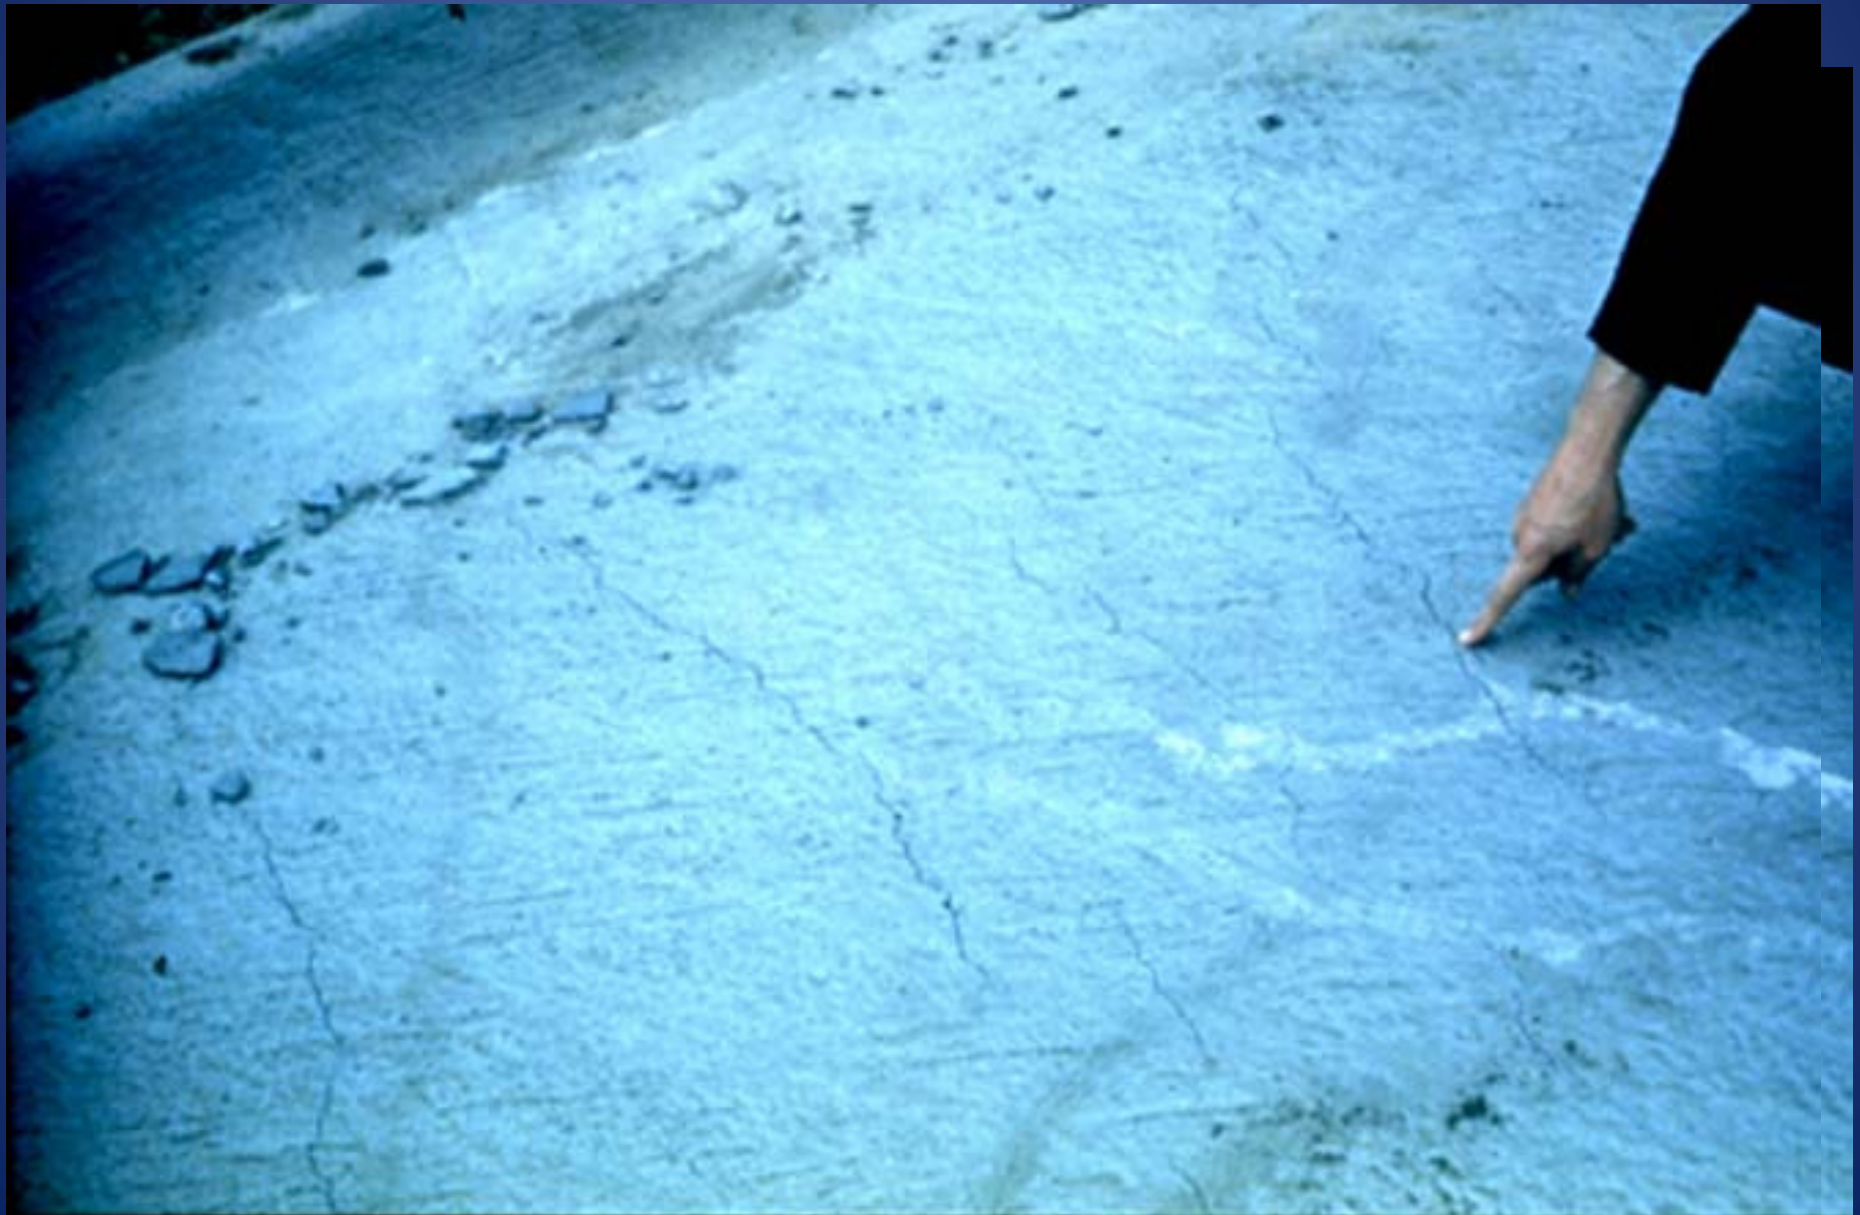
Plastic Shrinkage Cracking

- Shrinkage cracks are hairline cracks that often occur on the surface of freshly mixed concrete.
- The pattern of shrinkage cracks is random with cracks oriented in all directions.
- Shrinkage cracks are shallow and rarely penetrate the full depth of the slab.
- The cracking occurs during plastic shrinkage and may take place during finishing or soon after it is placed.

Shrinkage cracks occur when moisture evaporates too quickly from the surface of the freshly placed concrete. When water evaporates from the surface faster than it can appear at the surface during the bleeding process, drying shrinkage tensile stresses are created. Since the strength of the fresh concrete mix is lower than the design strength, these tensile stresses causes cracking.

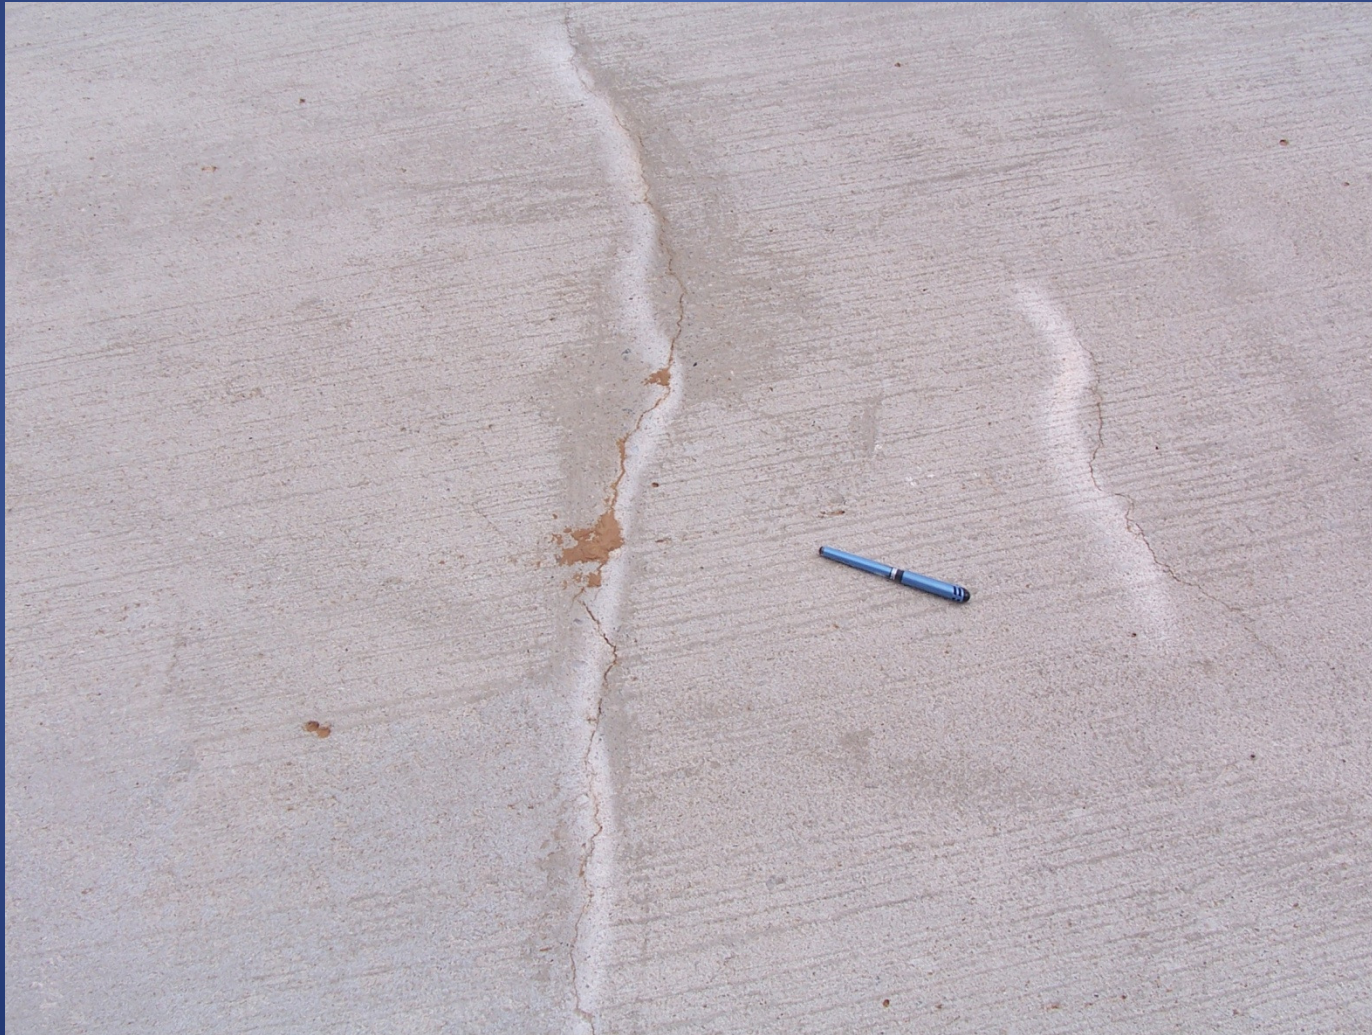
Drying Shrinkage Cracking

- As moisture continues to be lost due to evaporation after concrete sets, there is a continued reduction in volume, greatest at the surface of the pavement. If the stress due to shrinkage exceeds the concrete strength, the concrete cracks.
- The more restraint due to continuity of the pavement or friction on the bottom, the greater the probability of cracking.

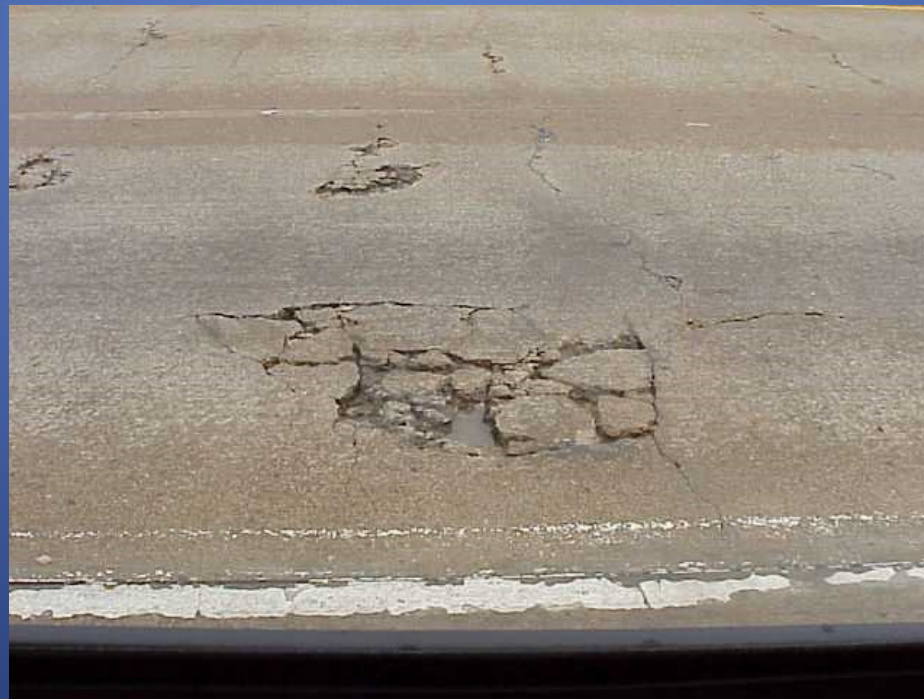
Slab Shattering

- Shattered slabs are formed when a series of cracks intersect to divide the slab into four or more pieces.
- Although the pieces still remain in their original position, they may settle below the original elevation of the pavement. Also, the intersecting cracks are usually accompanied by severe spalling.

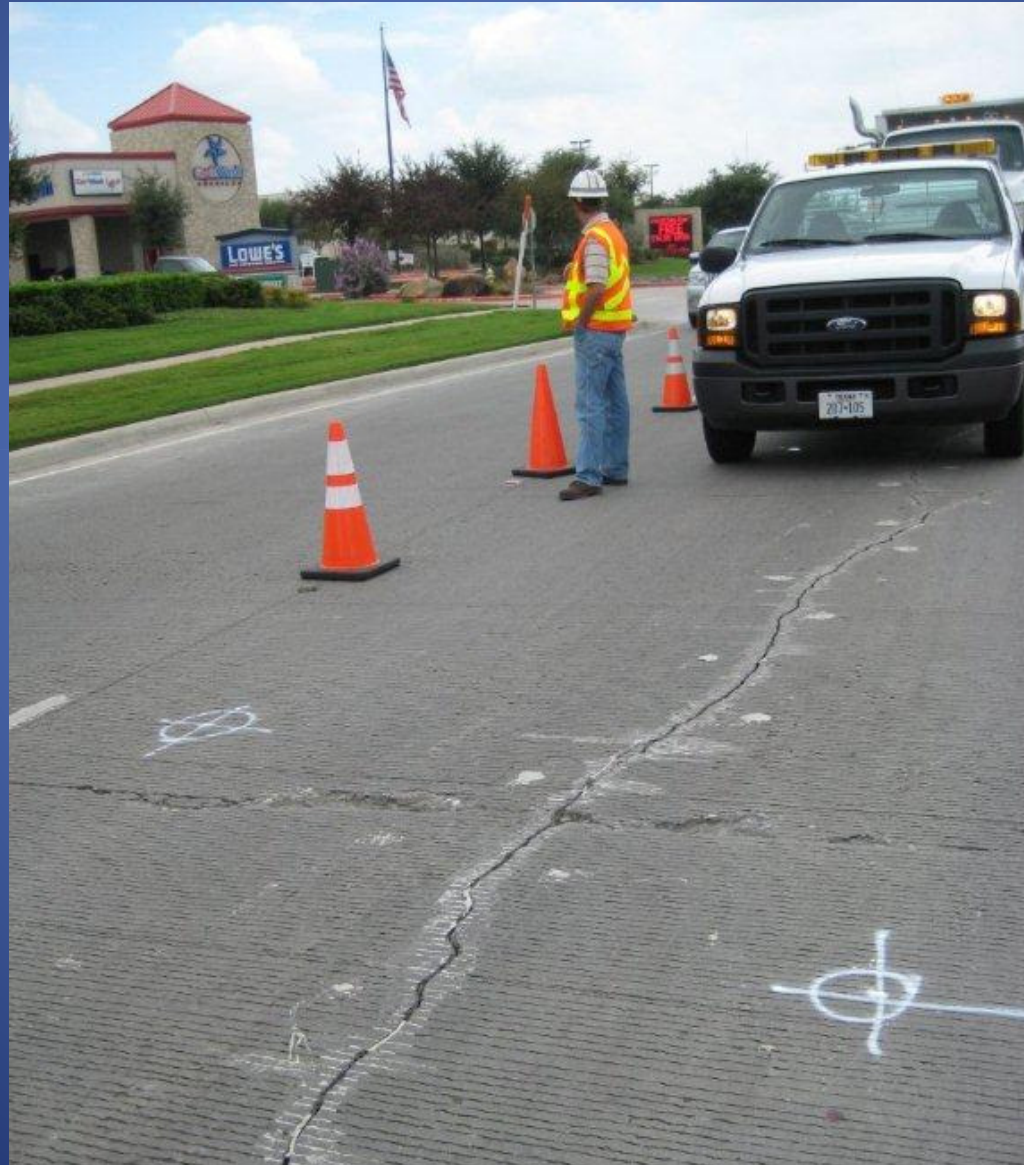
Transverse/Longitudinal Cracking

- Transverse cracks are cracks that follow a course approximately at right angles to the centerline of the pavement. Transverse cracks are generally straight. A meandering crack wanders back and forth across the traffic lane, usually at a joint.

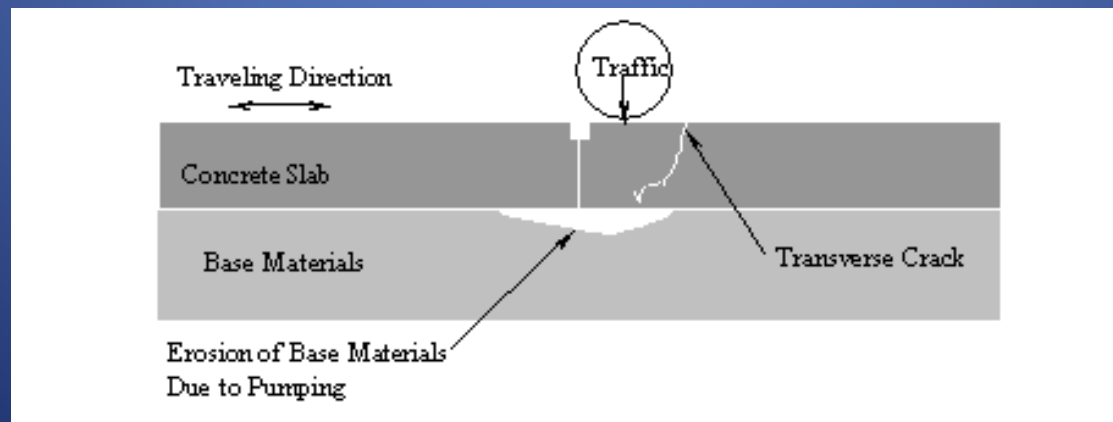
Transverse Cracking

1. Transverse and meandering cracking may be caused by improper joint construction.
2. Improper design, construction, or materials of the pavement may result in the formation of transverse cracks.
3. Swelling soils may result in an upward movement of the pavement.
4. The loss of foundation support may initiate a transverse or meandering crack.
5. Warping and curling stresses may initiate a transverse crack
