Forensic Engineering = Detective Engineering

David W. Fowler

The University of Texas at Austin

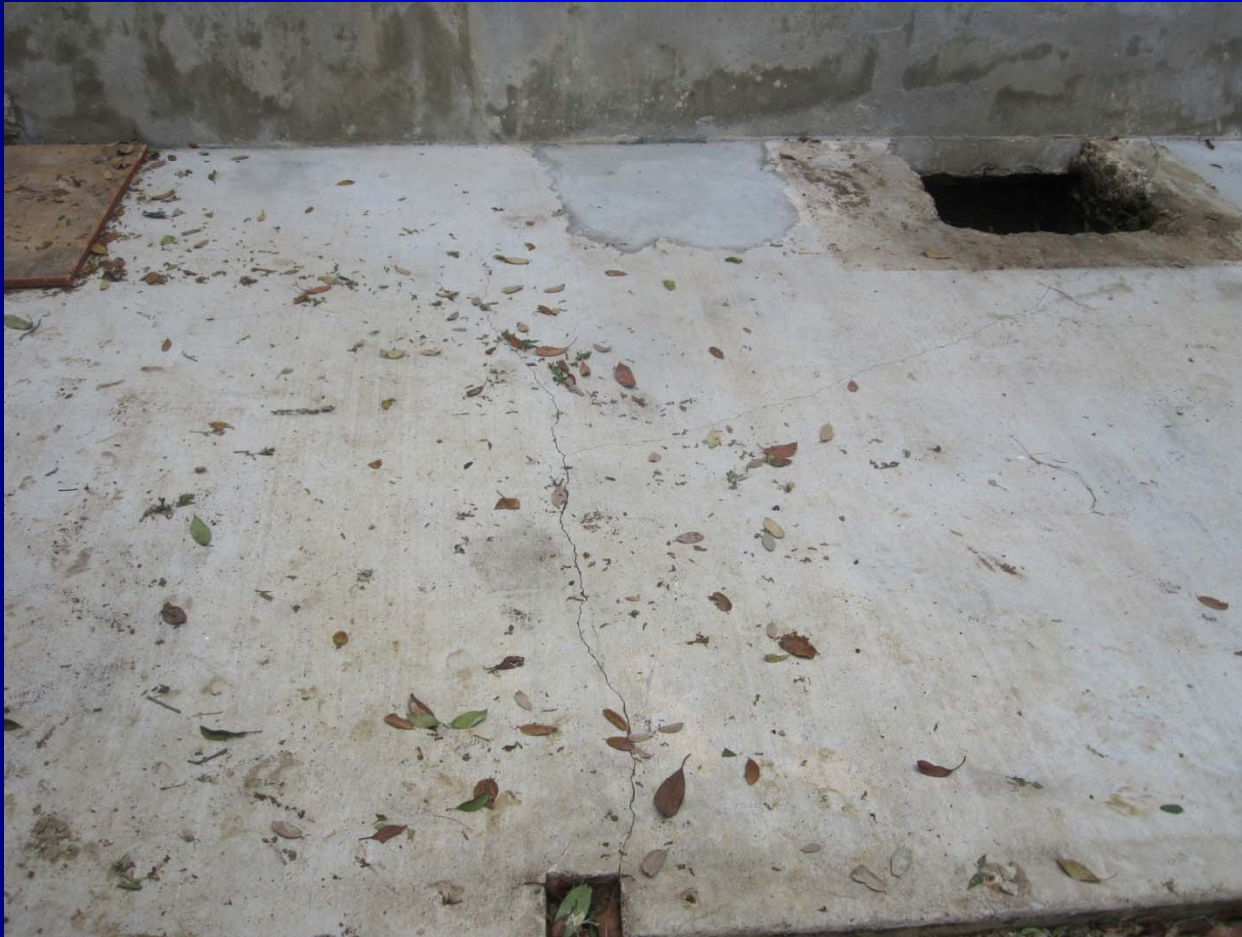
Failed Foundation

- *Original drilled piers
- *Pressed Piles

Exterior

- *Foundation cracks

Interior

- *Cracks in slab
- *Drywall separation
- *Drywall shear cracks at window and door corners
- *Relative floor elevation

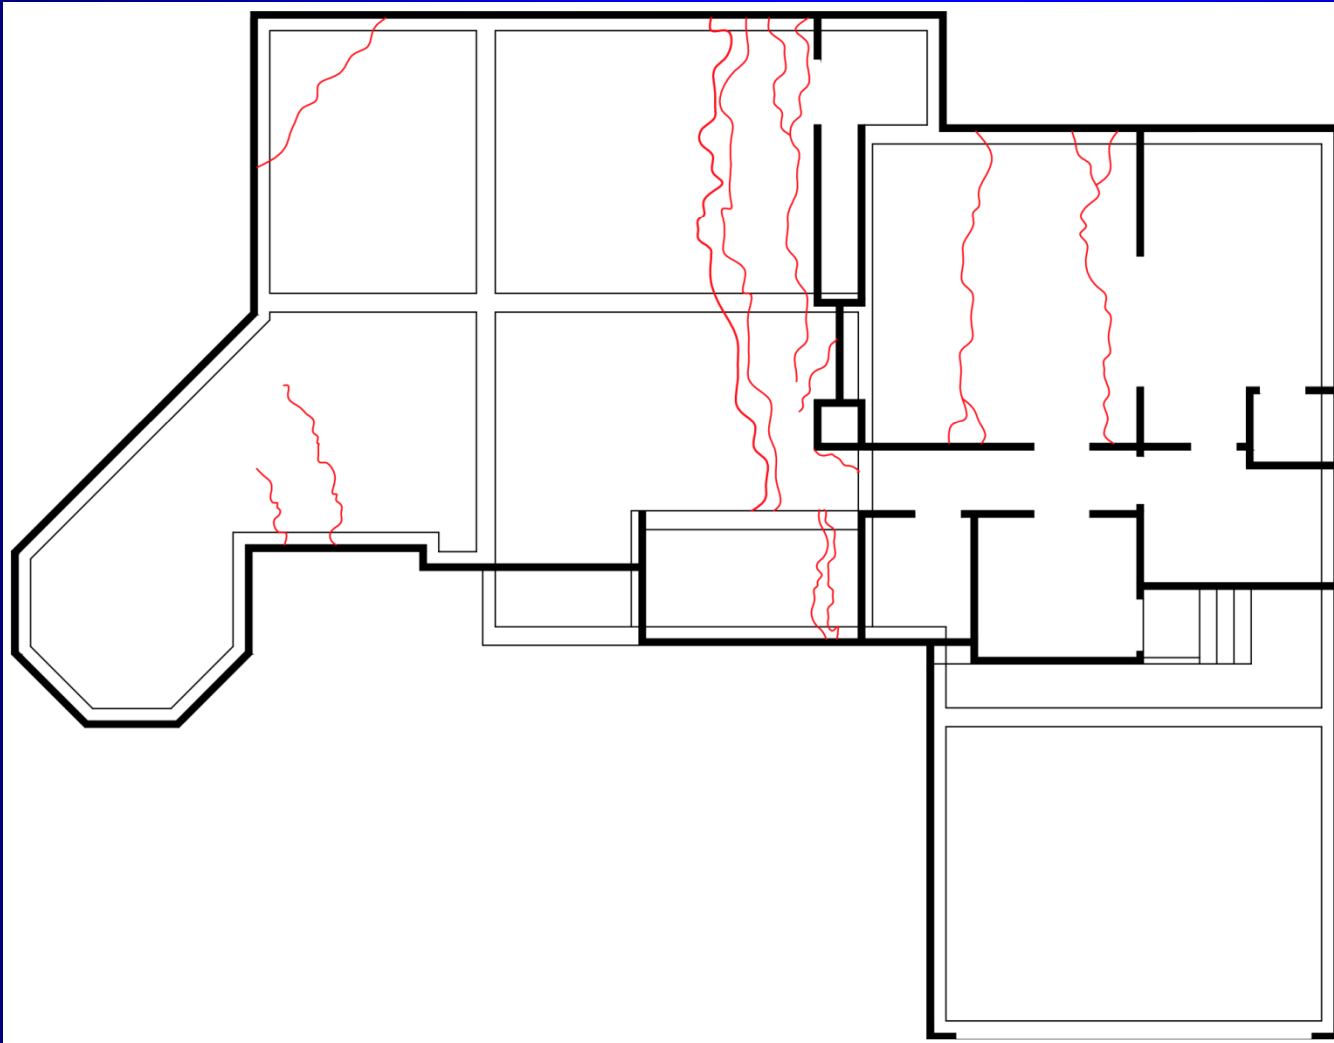
Failed Foundation

- *Original drilled piers
- *Pressed Piles

Exterior

- *Foundation cracks

Interior

- *Cracks in slab
- *Drywall separation
- *Drywall shear cracks at window and door corners
- *Relative floor elevation

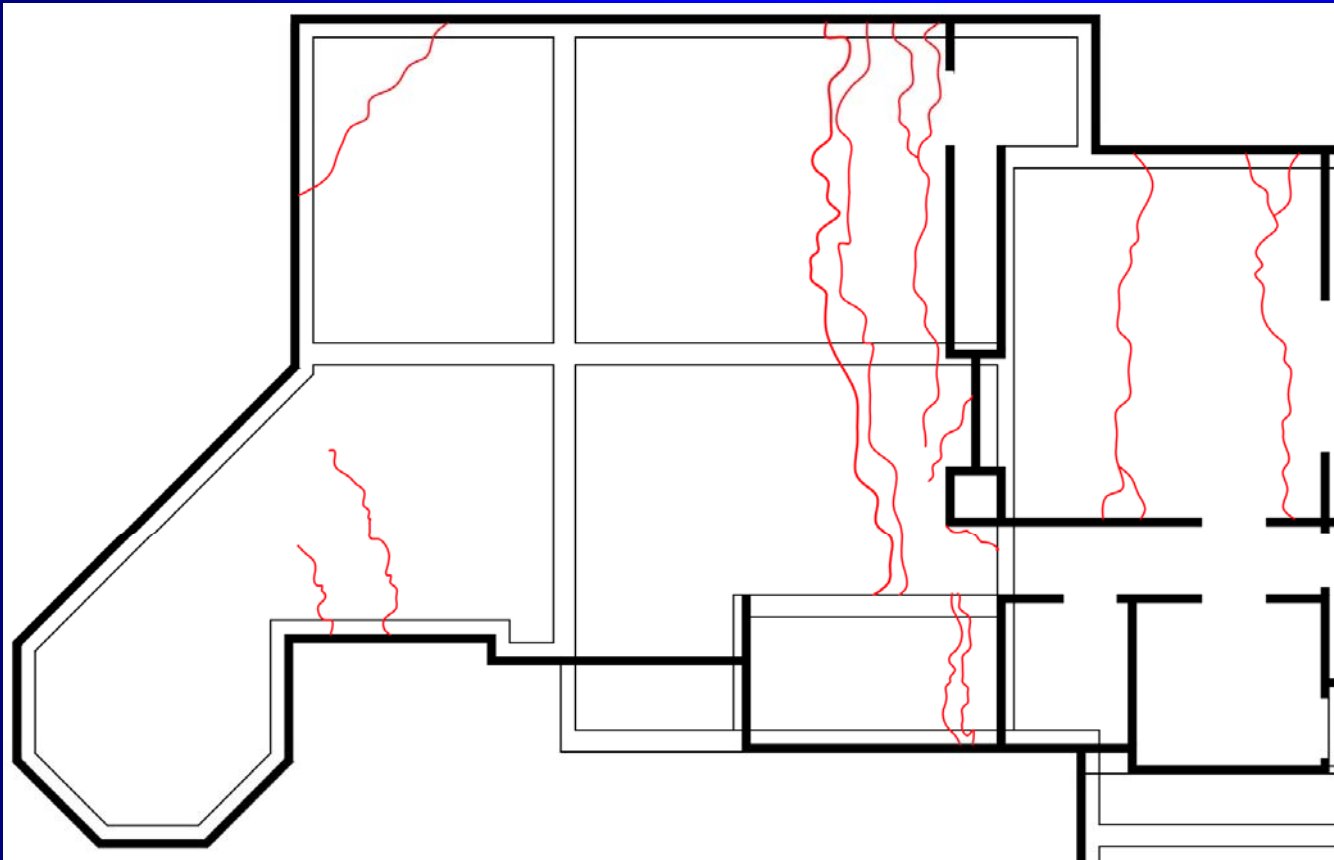
Failed Foundation

- *Original drilled piers
- *Pressed Piles

Exterior

- *Foundation cracks

Interior

- *Cracks in slab
- *Drywall separation
- *Drywall shear cracks at window and door corners
- *Relative floor elevation

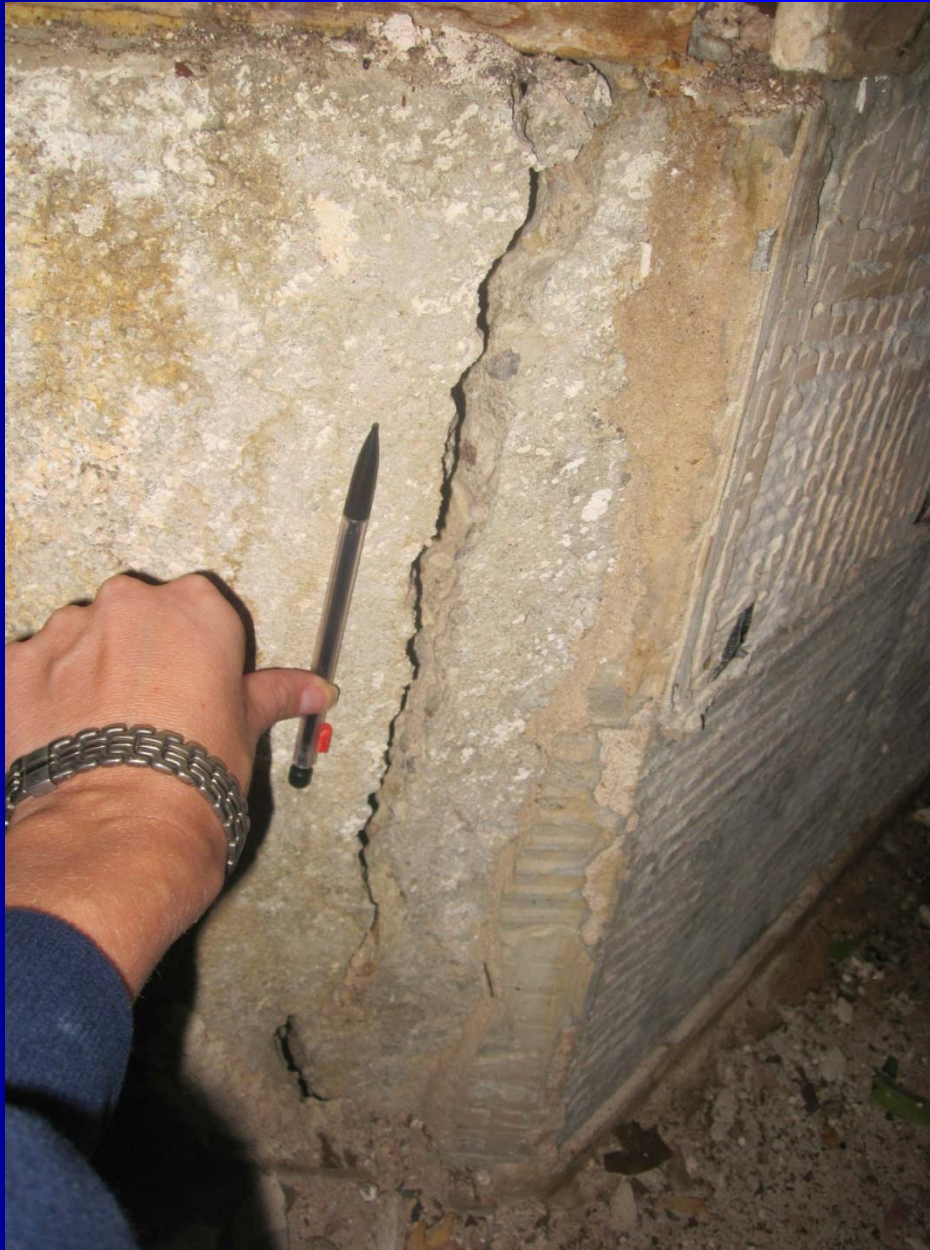
Failed Foundation

- *Original drilled piers
- *Pressed Piles

Exterior

- *Foundation cracks

Interior

- *Cracks in slab
- *Drywall separation
- *Drywall shear cracks at window and door corners
- *Relative floor elevation

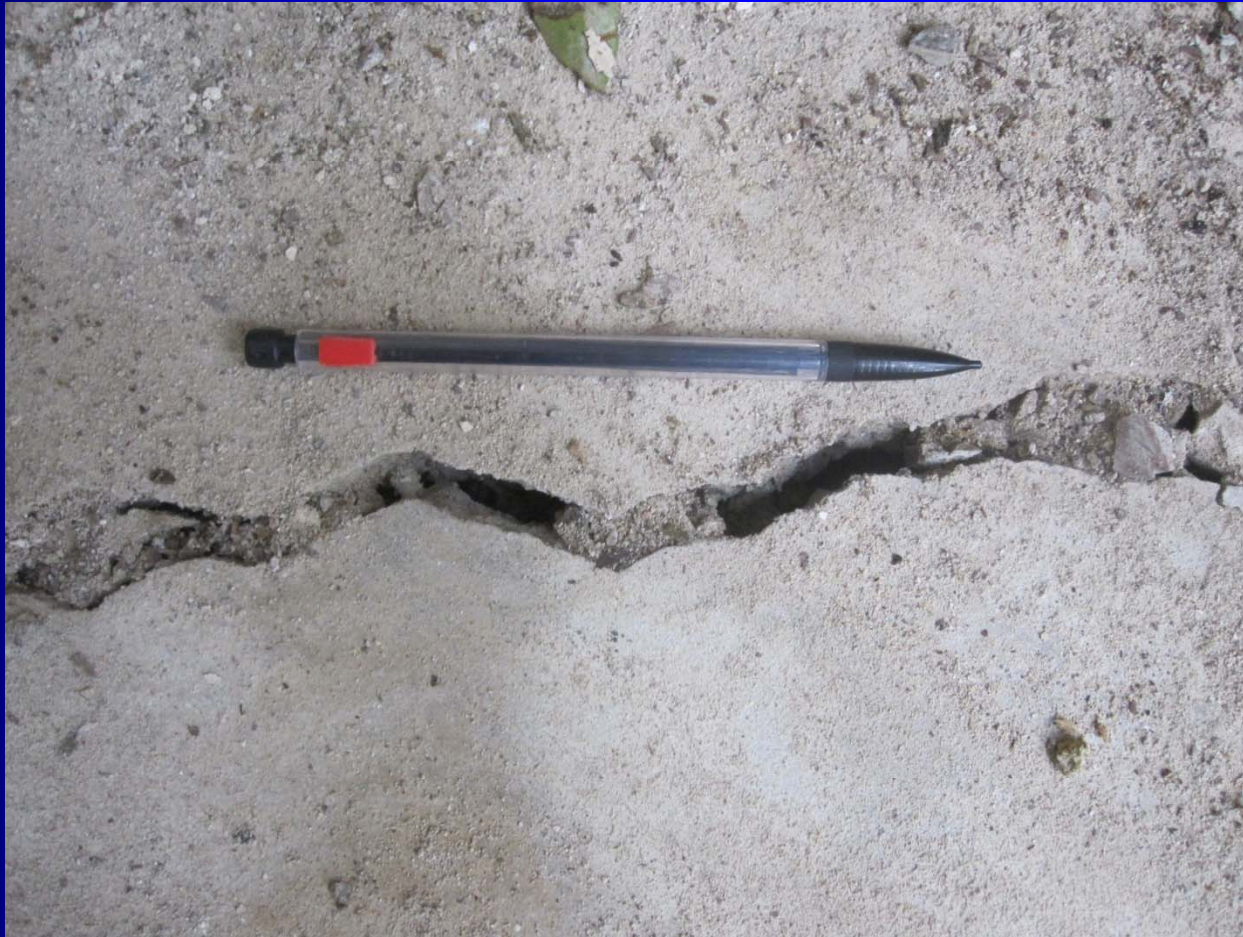
Failed Foundation

- *Original drilled piers
- *Pressed Piles

Exterior

- *Foundation cracks

Interior

- *Cracks in slab
- *Drywall separation
- *Drywall shear cracks at window and door corners
- *Relative floor elevation

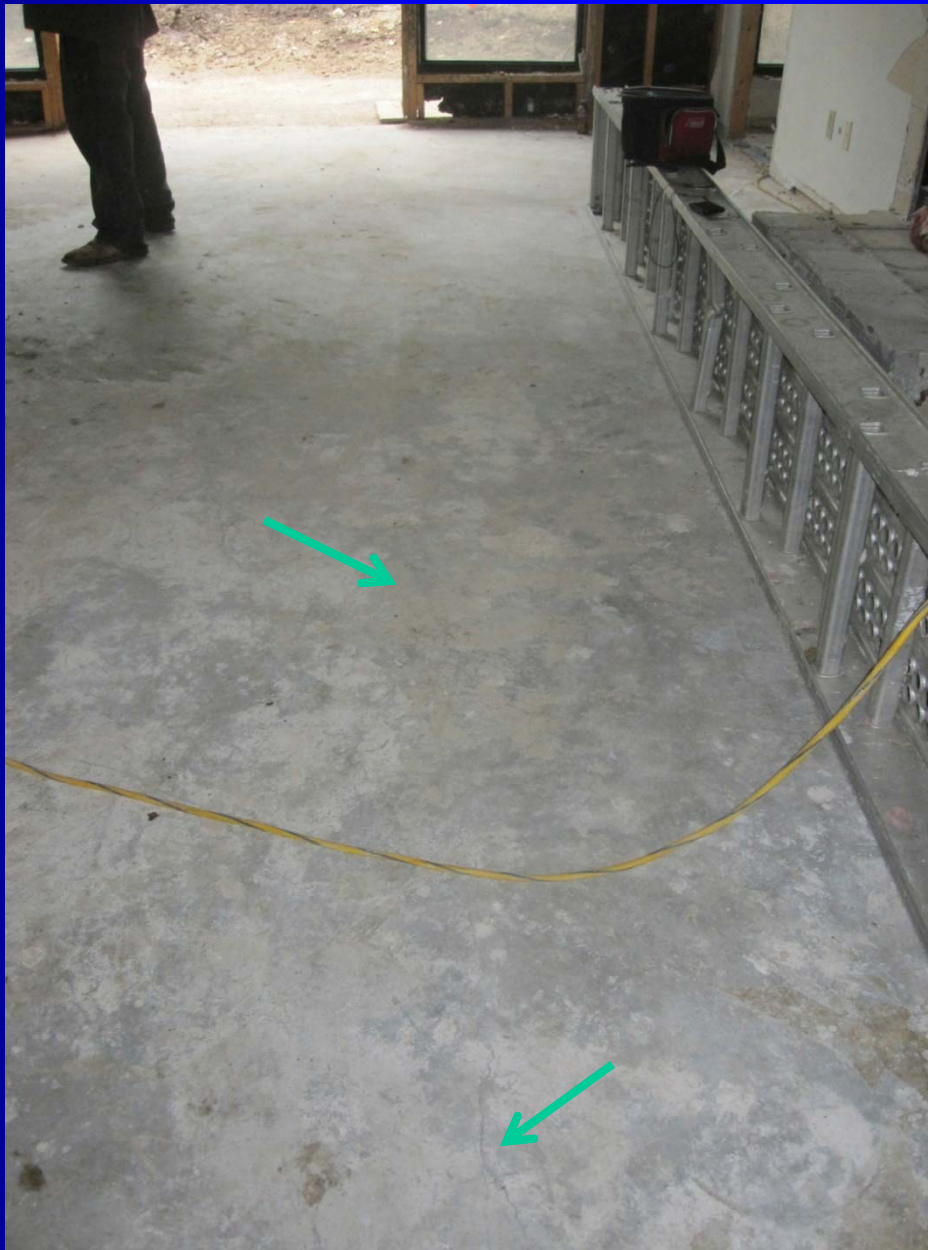
Failed Foundation

- *Original drilled piers
- *Pressed Piles

Exterior

- *Foundation cracks

Interior

- *Cracks in slab
- *Drywall separation
- *Drywall shear cracks at window and door corners
- *Relative floor elevation

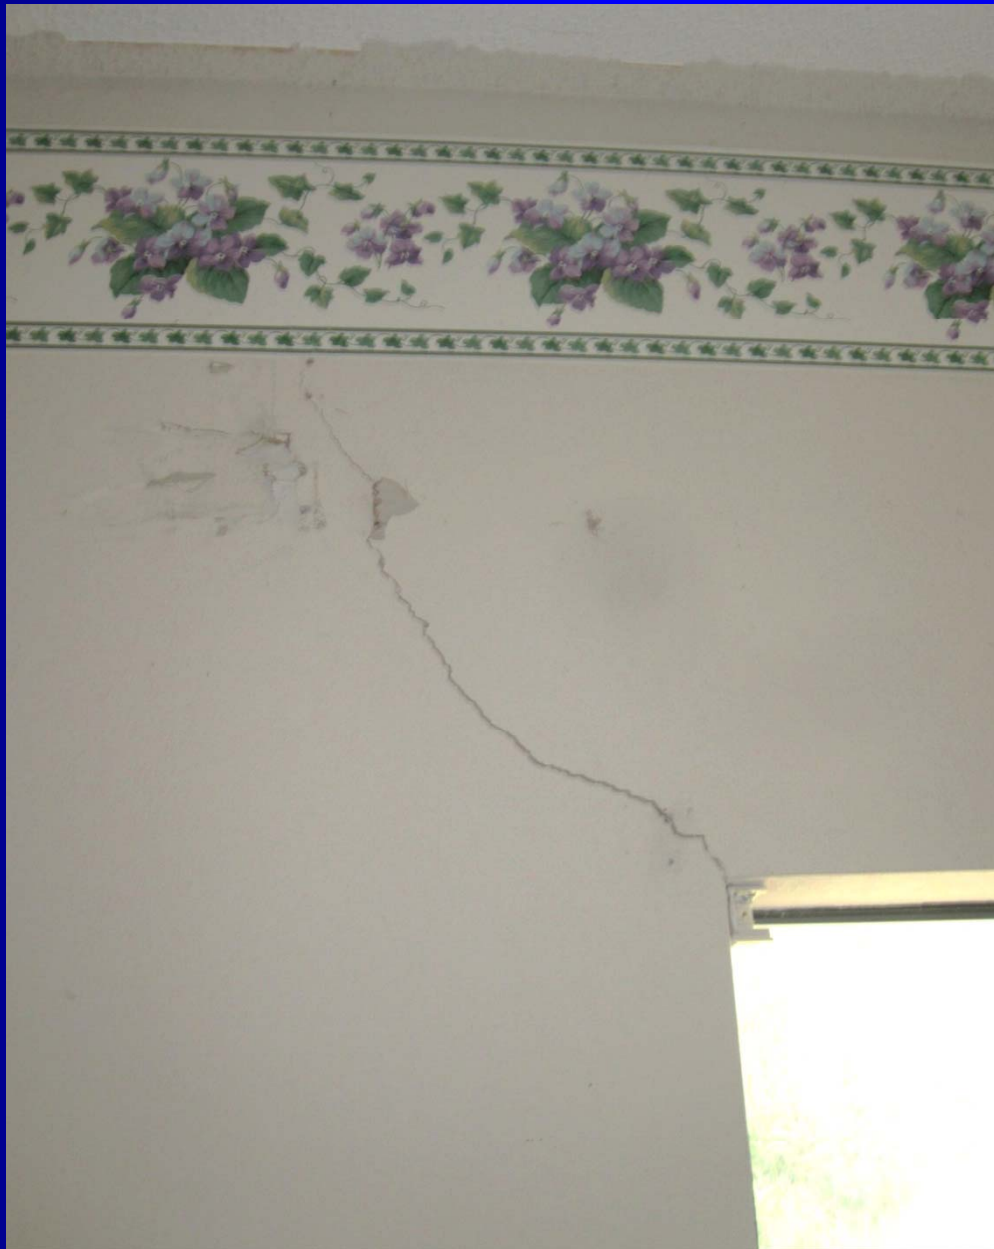
Failed Foundation

- *Original drilled piers
- *Pressed Piles

Exterior

- *Foundation cracks

Interior

- *Cracks in slab
- *Drywall separation
- *Drywall shear cracks at window and door corners
- *Relative floor elevation

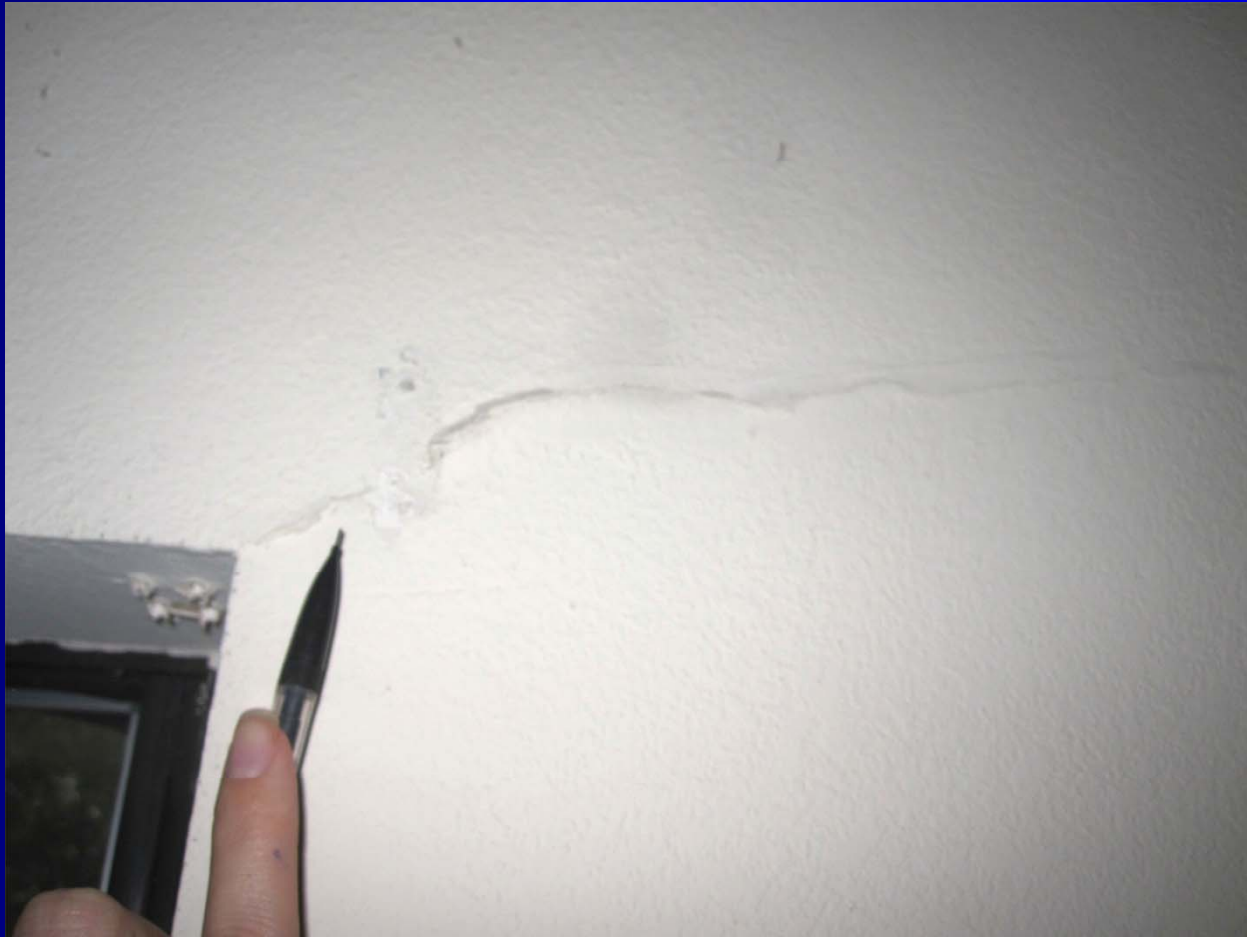
Failed Foundation

- *Original drilled piers
- *Pressed Piles

Exterior

- *Foundation cracks

Interior

- *Cracks in slab
- *Drywall separation
- *Drywall shear cracks at window and door corners
- *Relative floor elevation
