# Concrete Floor Covering Failures

*B. Lee Lawrence, P.E.*

*Wiss, Janney, Elstner Associates, Inc.*

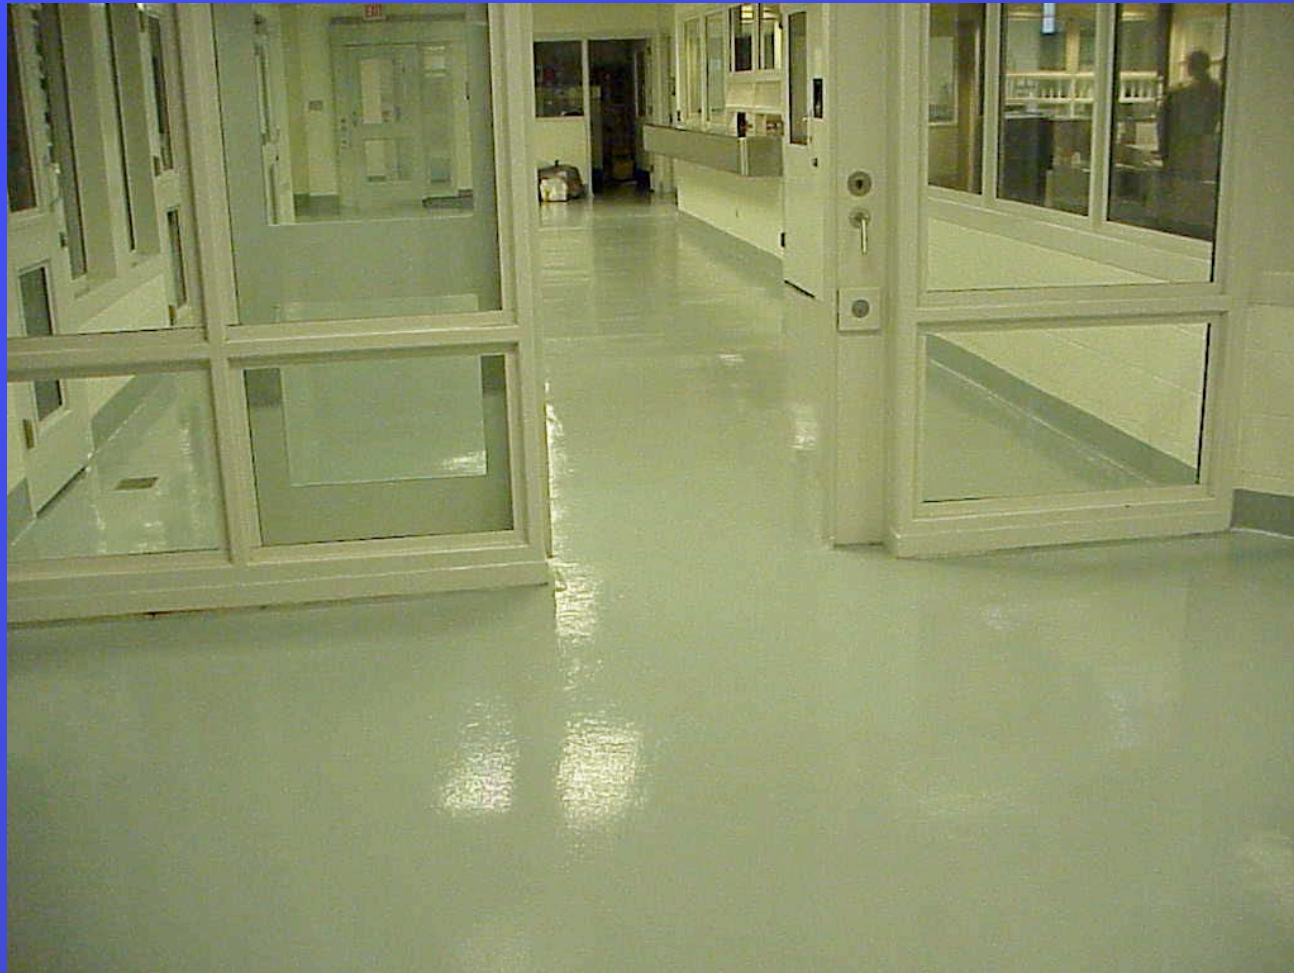
## Epoxy floor system

- *Epoxy coating applied on a two-year-old concrete slab with vapor barrier underneath*
- *Scaling and blistering observed within several months of application*
- *Cores were taken and examined petrographically*
- *Concrete was of good quality*
- *Near-surface ASR was identified involving fine rhyolite particles*
- *No ASR detected at the interior of the concrete*

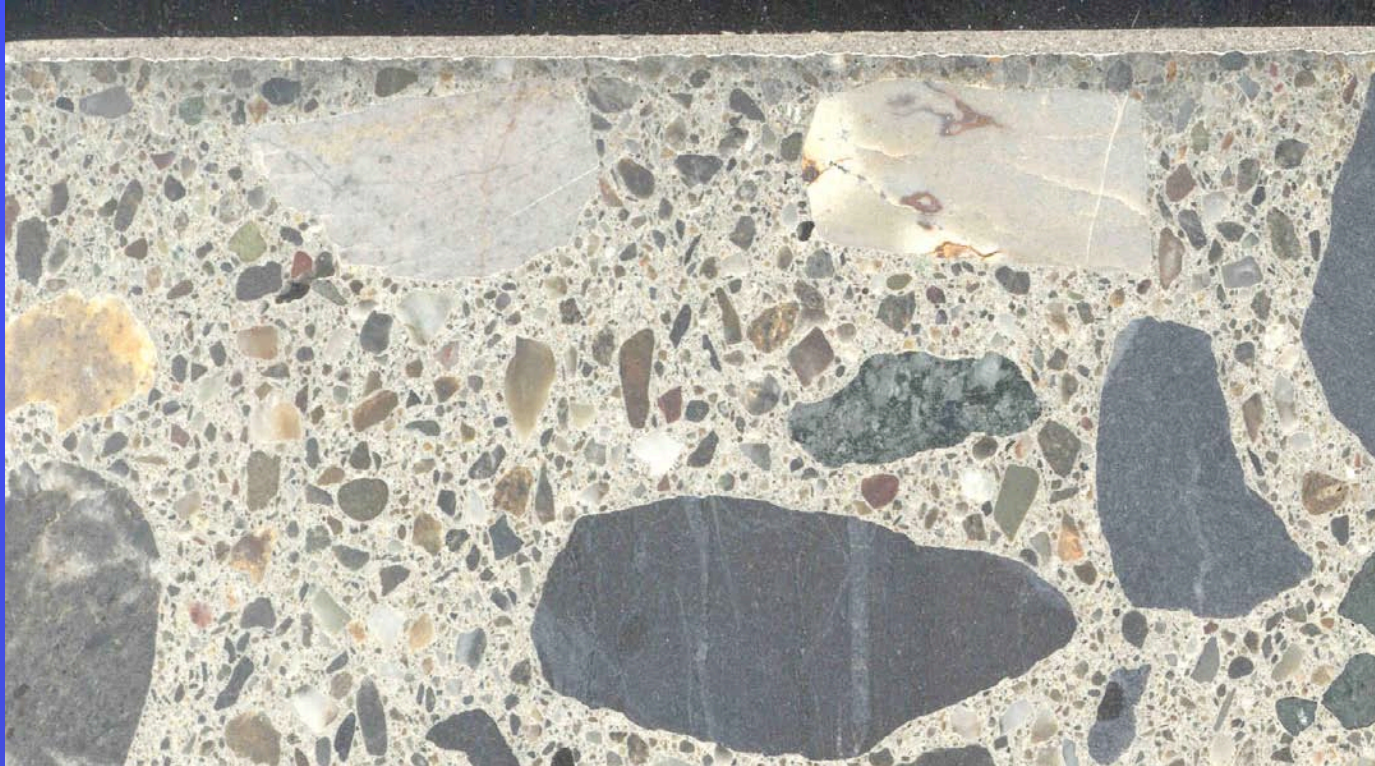
## Concrete with leveling mortar

- *Vinyl tiles and sheet vinyl were installed on a slab-on-grade less than two years old*
- *Localized debonding occurred within a few months*
- *Petrographic examinations were performed on concrete cores taken from the slab. The concrete was normal.*
- *A shrinkage compensating mortar was present above the concrete*
- *Vinyl floor covering was installed with an adhesive that was applied with a notched trowel*
- *Abundant ettringite deposits were observed between the strips of adhesive and in the leveling mortar*

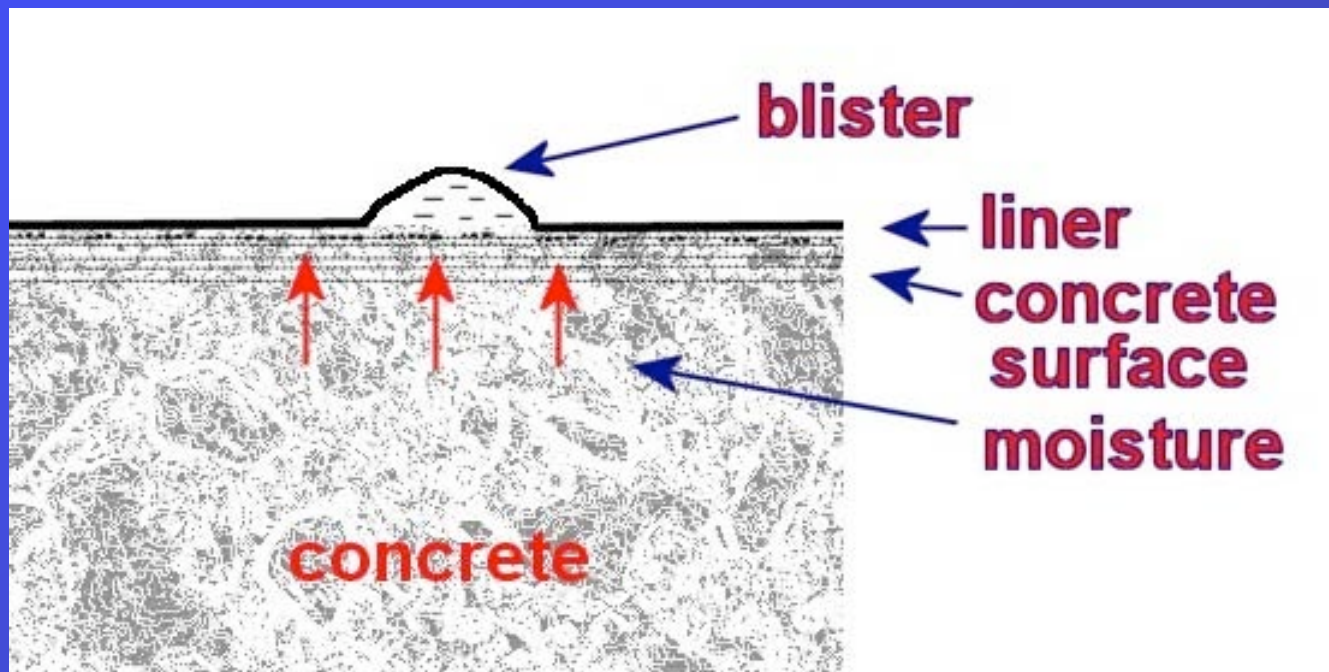
*On the floor and wall surfaces, the coating and/or the primer acts as a semipermeable membrane. Contaminants from the concrete, or solvents from the coatings left on the concrete surface, and moisture inside the concrete form the osmotic blister.*

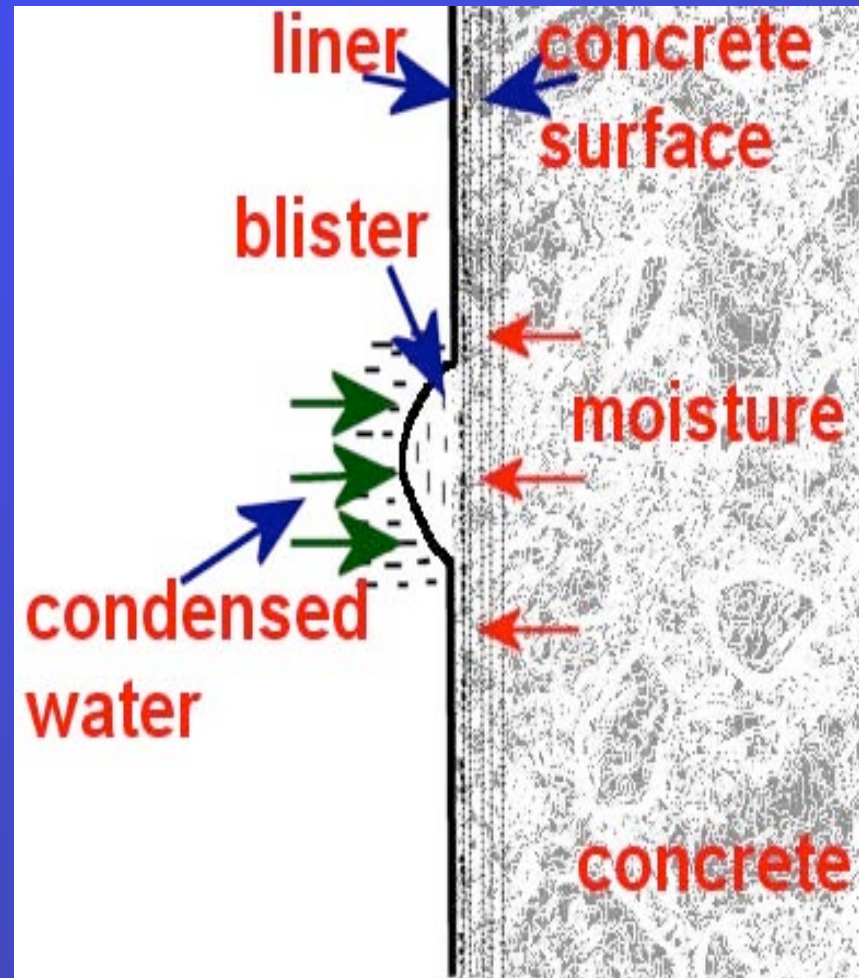
*On the floors and walls, both the concrete surface and the coating and/or the primer act as a semipermeable membrane. Contaminants are likely from concrete or coating solvents.*

*Condensed water from tank or moisture in concrete are likely contributors to the osmotic blistering.*
