CASE STUDY OF THE PAVEMENT DISTRESS AT A SERVICE STATION

By Hsienjen Stephen Tien, Eng.D.¹ and David A. Eastwood, P.E.²

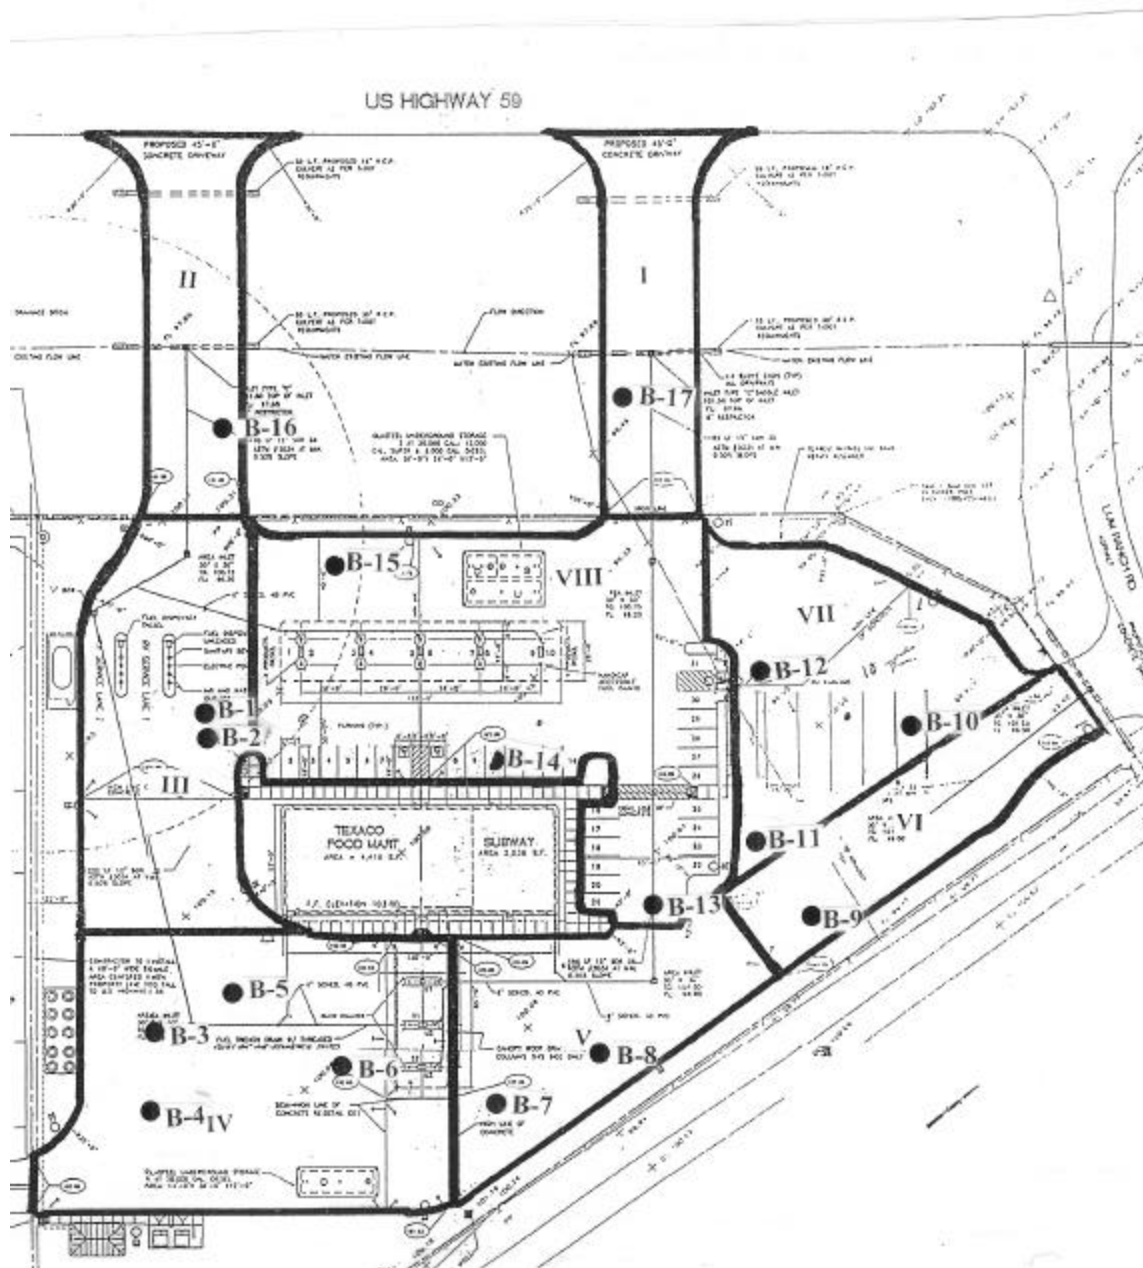
Figure 6. Plan of Borings (Boring locations and dimensions are approximate.)

Subsoil conditions at the project site were explored by seventeen (17) soil borings. Approximate boring locations are shown on Figure 6, Borings B-1 through B-15 were drilled around the food mart building, and B-16 and B-17 were drilled at the driveways (approaches) connecting to the adjacent highway. Among the seventeen (17) borings, Borings B-1, B-2, B-10 through B-12 and B-14 through B-17 were cored and drilled at the areas that had apparent cracks and damages on the pavements (bad areas). Borings B-3, B-4 and B-6 through B-9 were located at the areas with better pavement conditions. Furthermore, Borings B-5 and B-13 were sampled at the replaced concrete patch areas.

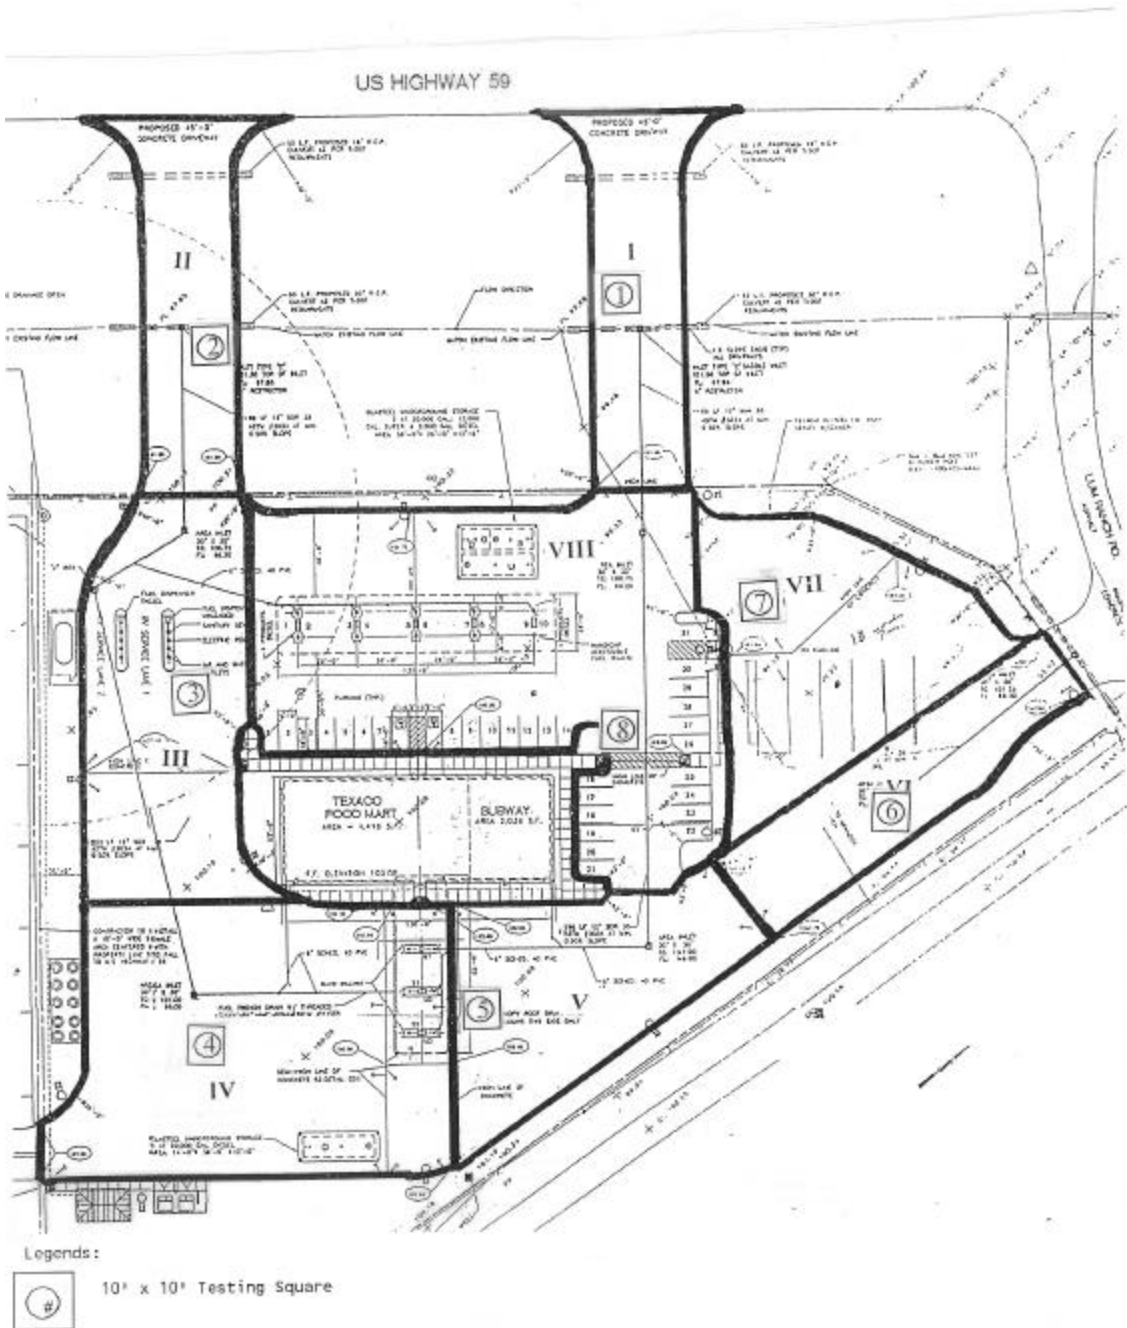
Figure 7. Non-Destructive Tests for Rebar Locations (Testing locations and dimensions are approximate.)

Eight 10-ft by 10-ft square blocks at different locations were checked for the rebar locations and are shown on Figure 7. In general, 59% of the rebars in the concrete pavement were placed at inappropriate depths and 31% of the rebar spacings did not comply with the specifications, according to our field test results.

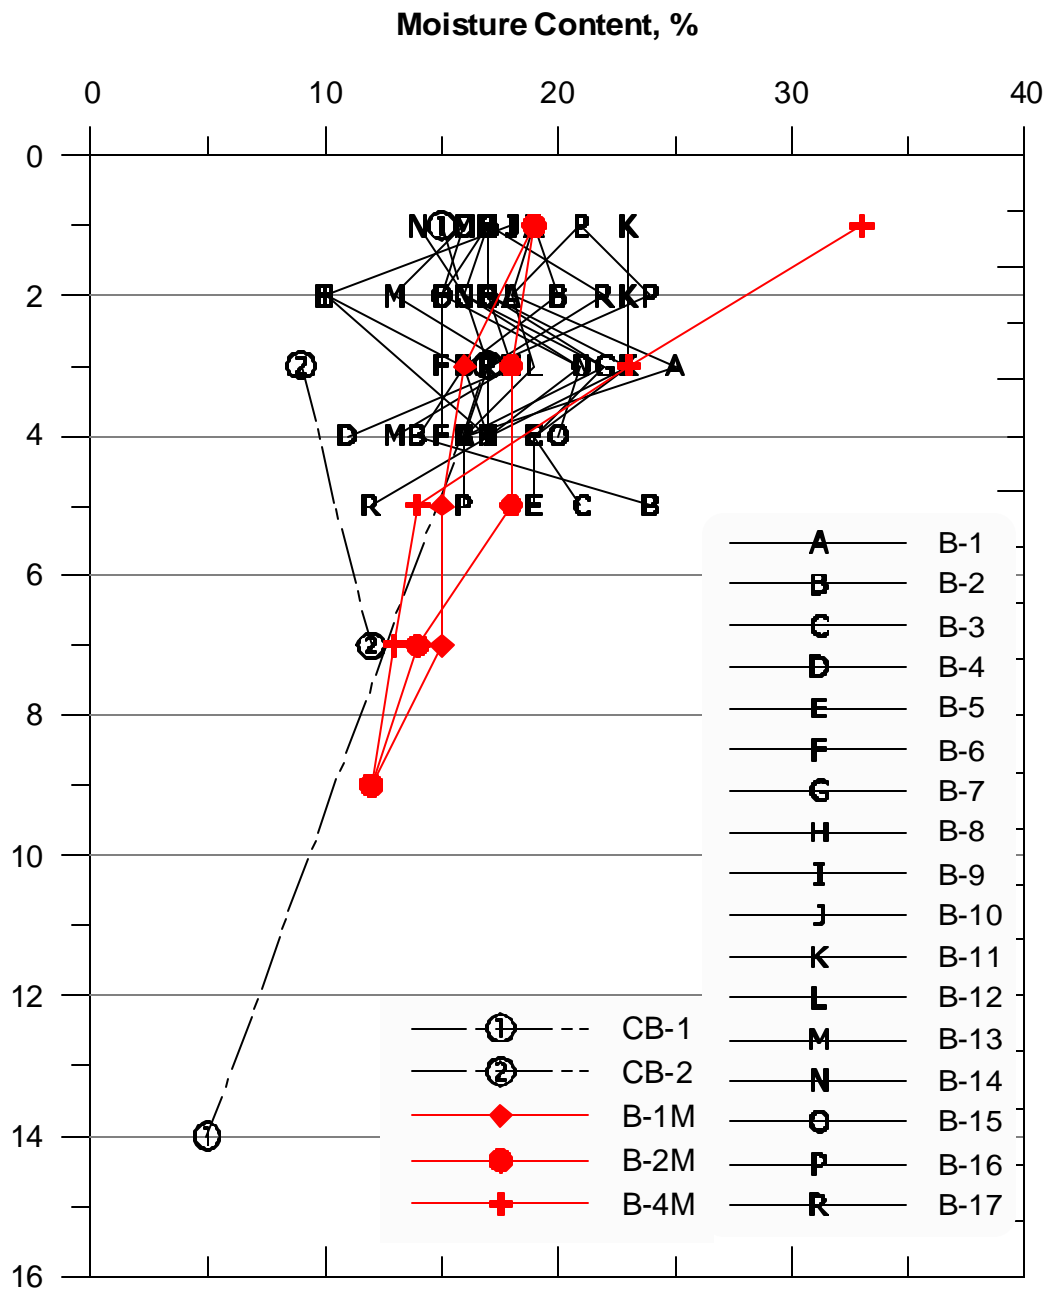
Figure 8. The Variation of Soil Moisture Contents versus Depth

As an aid to visual soil classifications, physical properties of the soils were evaluated by ASTM test method D2487 which is used for classification of soils for engineering purposes. These tests consisted of natural moisture content tests (ASTM D4643), Atterberg limits determinations and plasticity tests on clay soils (ASTM D4318), percent passing No. 200 sieve (ASTM D1140) and dry unit density test (ASTM D2166). Similarity of these properties is indicative of uniform strength and compressibility characteristics for soils of essentially the same geological origin. In addition, undrained shear strengths of the cohesive soils were further measured with laboratory hand penetrometer and laboratory hand operated Torvane. These test results are summarized in Table 1. Furthermore, the moisture profile and liquidity index profile of the subsoils are presented in Figures 8 and 9 respectively. In accordance with the moisture profile, the moisture contents from the original soil report done in 1997 are generally less than 15% (CB-1 and CB-2), while the soil borings performed recently (B-1M, B-2M and B-4M) and from this study (B-1 through B-17) shows a higher moisture contents (up to 33% in the top 5-ft subgrade). In addition, the liquidity index profile indicates that in general, more than half of the soil borings performed in this study have liquidity index values more than 1.0 which suggest that the subgrade was wetter at the time of our study than it originally was.
