CASE STUDIES OF RESIDENTIAL FOUNDATION MOVEMENTS IN SOUTHERN HOUSTON AREA

By H. Stephen Tien, Ph.D., P.E.¹ and David A. Eastwood, P.E.²

ABSTRACT

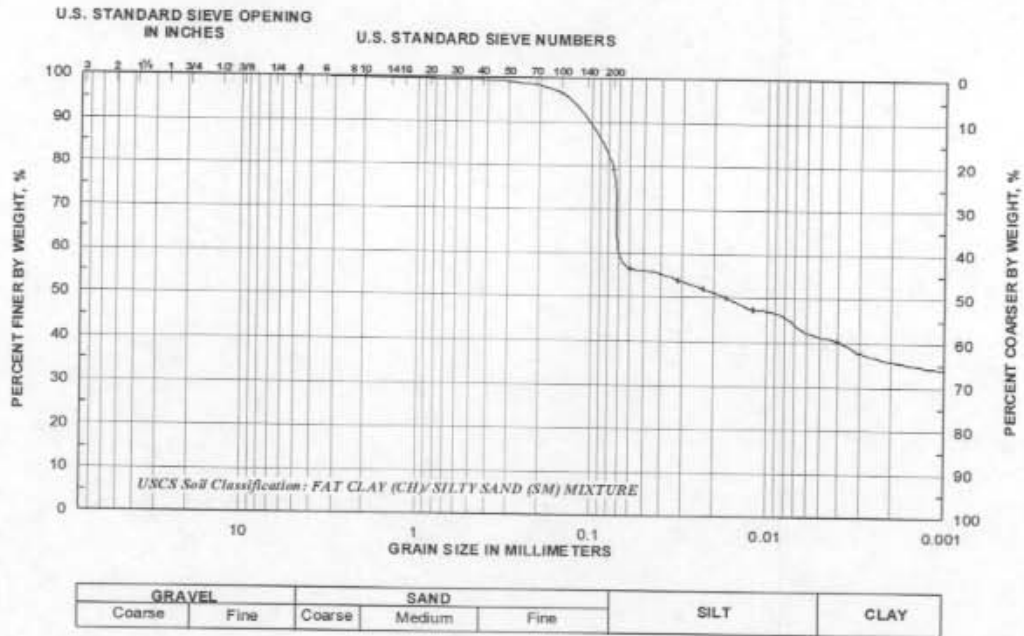
Figure 5. Grain Size Distribution Curve for Boring C-2 (0- to 1-ft) at the Clear Lake Residence

Poor Materials. Our review of the construction photo shown in Figure 7(b) indicated that significant amount of sandy soils were used for the construction pad. Our examination of the interior borings, C-1 through C-3, showed that silty sands and fat clay soils were mixed and used as fill materials on the site (see Figures 2(c) and 2(d)). In addition, the original soil report for the subject residence indicated that fill material within the building area should be lean clay having a plasticity index (PI) of 10 to 20 and a liquid limit of 28 or more. Among the three interior borings, Borings C-1 and C-3 have fill materials with plasticity indices (PIs) of 27 and 30 respectively, both over the required range. These sandy fill soils found in the interior borings, as well as in the test pit excavation next to the grade beams do not resist water to seep through these materials and travel under the foundation causing the expansive soils to swell and result in distress.

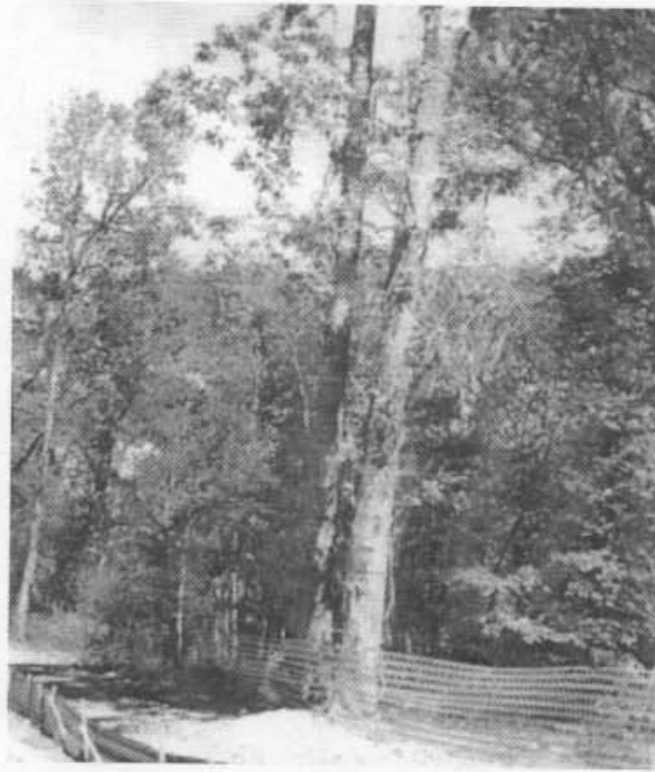
Figure 7. Project Site Conditions at the Clear Lake Residence: (a) Heavily Wooded prior to Construction and (b) Wet Ground Surface During Construction (prior to Concrete Pour)

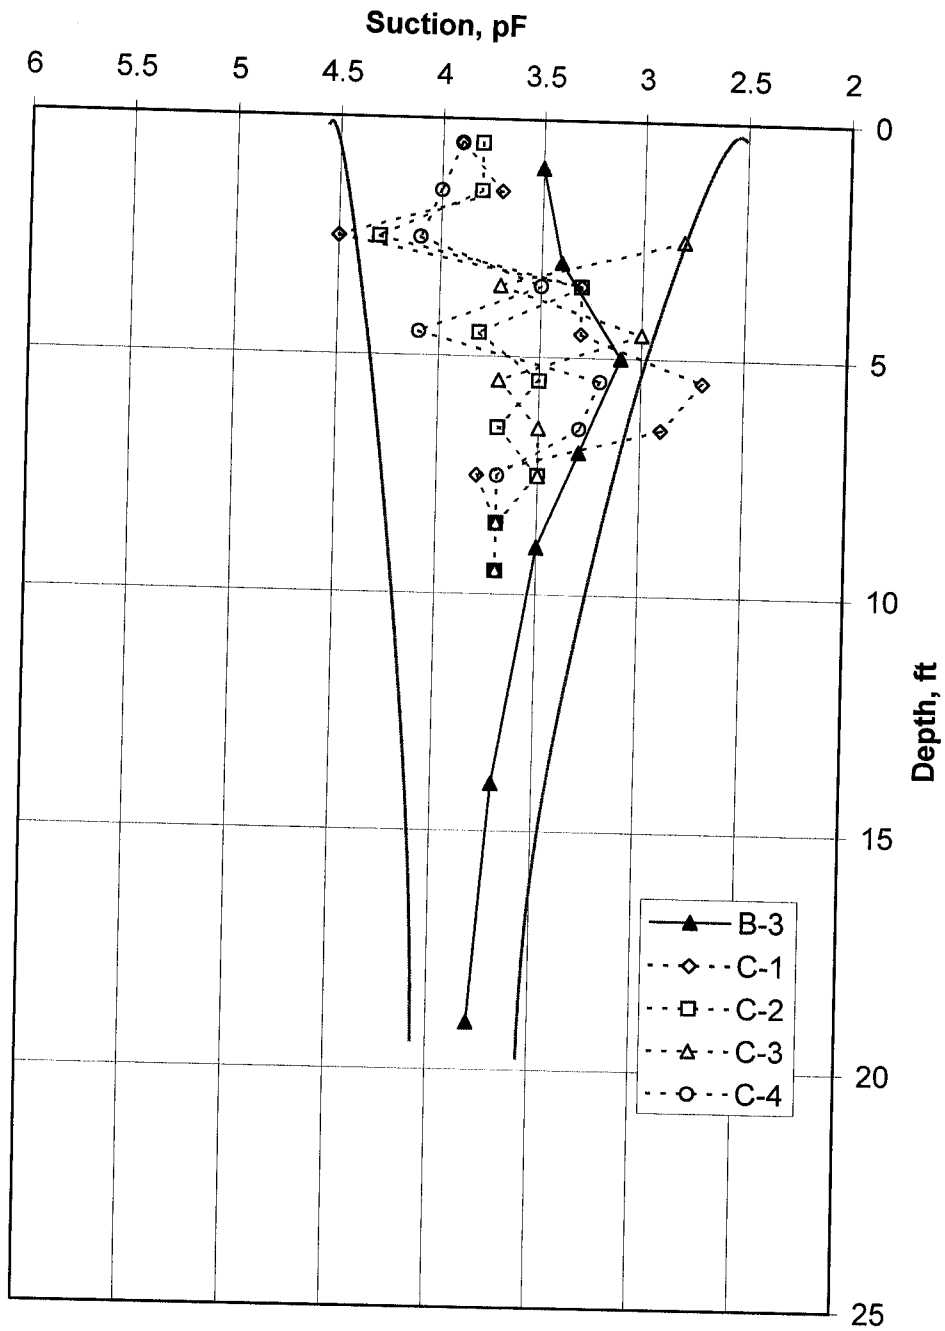
Figure 12. Soil Suction versus Depth at the Friendswood Residence

Soil suction in accordance with ASTM D5298 is a measure of the free energy of the pore-water in the soil. Soil suction in practical terms is a measure of the affinity of soil to retain water and can provide information on soil parameters that are influenced by the soils water, such as, volume change, deformation, and strength characteristics of the soil. The soil suction was measured using laboratory filter papers method. The results of these tests are shown in Figure 12. In general, the soil suction values showed that subsoils were wetter (i.e., closer to the "wet" profile", 2.5 pF) at the depth of about 5-ft.
