TECHNICAL
TRAINING SERIES

Nondestructive Evaluation for Structural Repair and Rehabilitation

Jacob Bice, Ph.D., P.E.

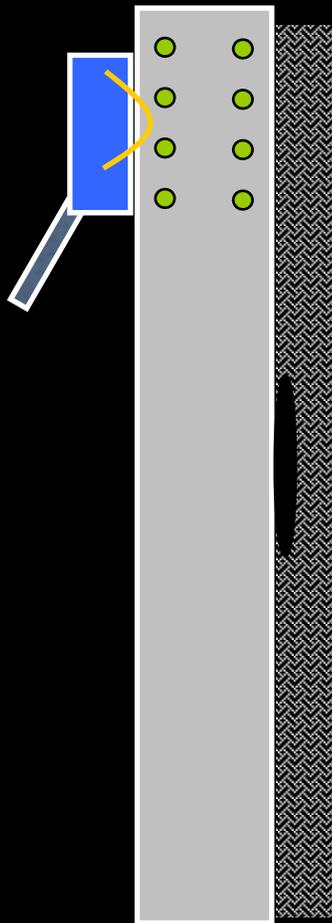
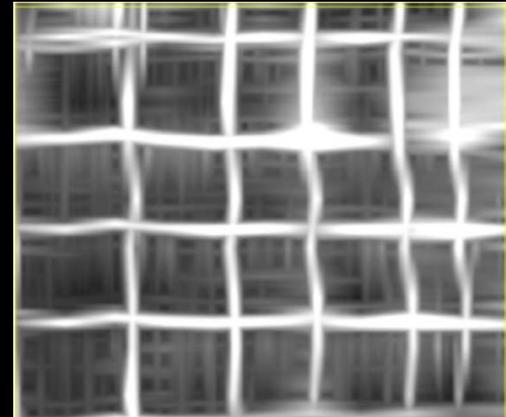
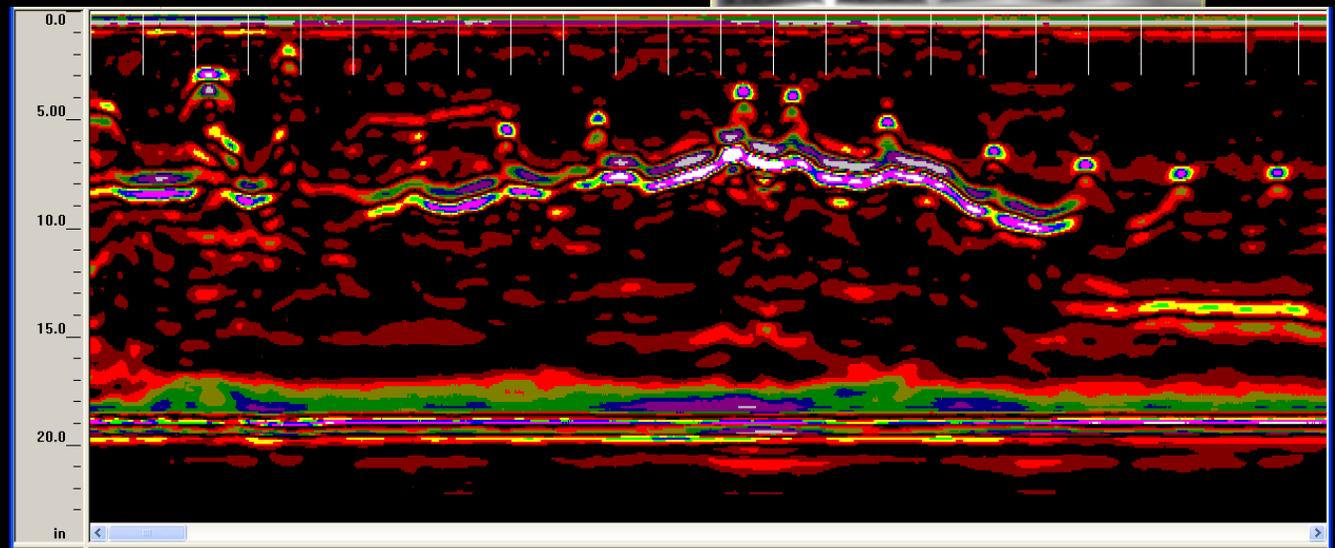
SPR Schematic

- Commonly known as GPR
- Reflected electromagnetic waves
- Applications
 - As-built conditions
 - Rebar location
 - Voids beneath slabs
 - CMU grouting
 - Honeycombing
- Limitations
 - Wet soils
 - Cannot detect small discontinuities

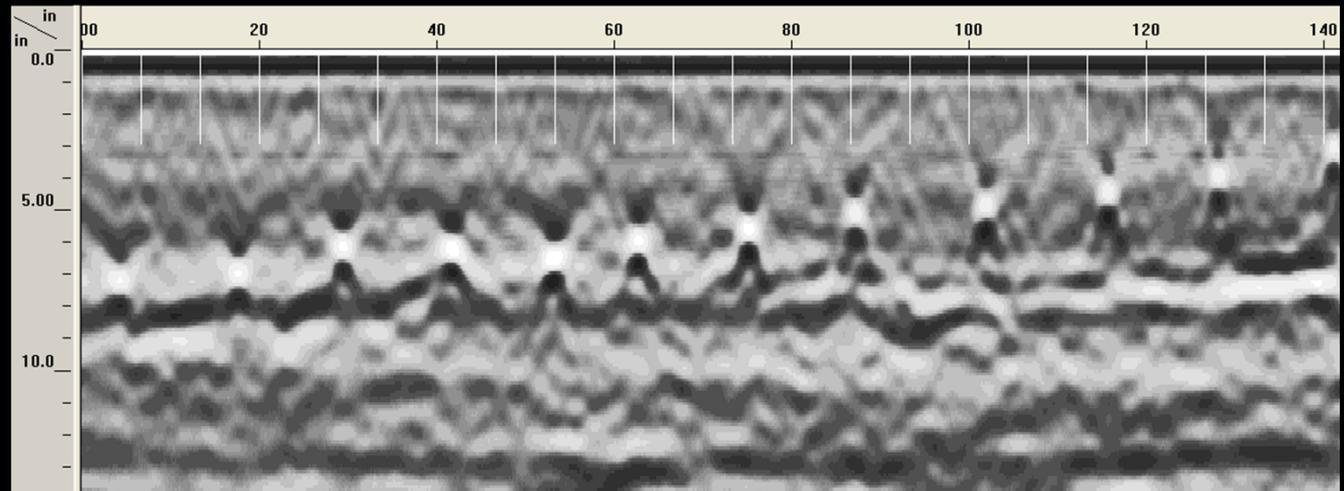
PT Slab

SPR: Common Limitations

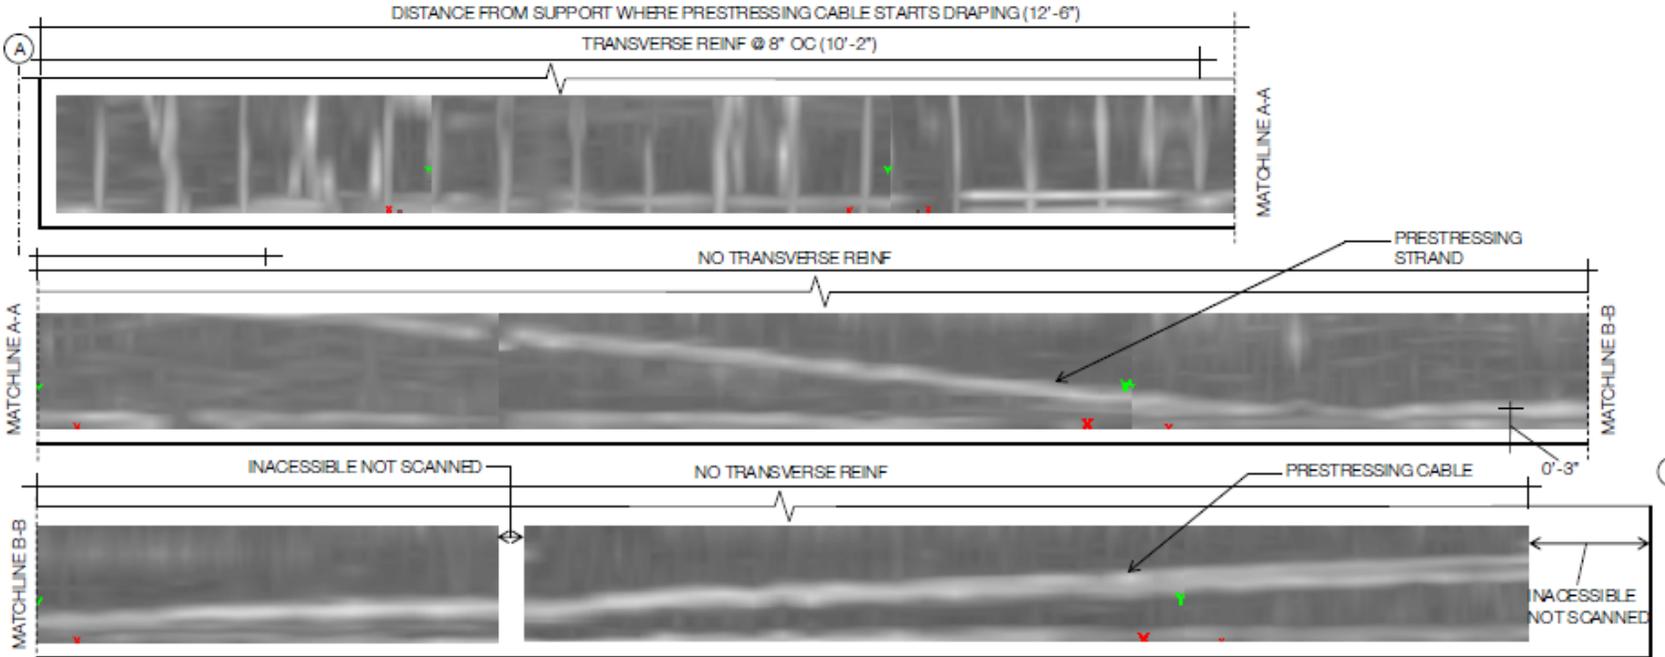
1 LEVEL P2 DOUBLE-TEE STEM DT-5 BETWEEN GRID LINES A & C AND 2 & 4

ELEVATION: GRID LOCATIONS (NTS)

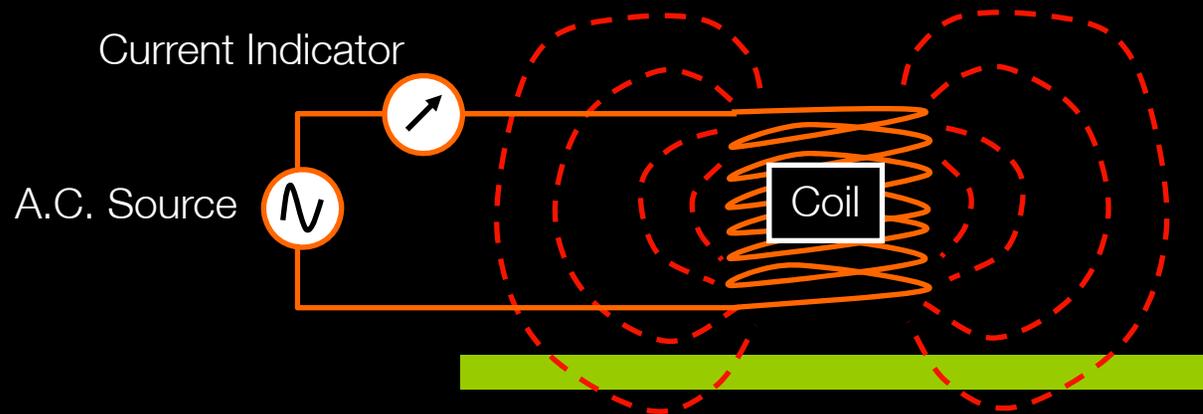
Cover Meter Schematic

- Presence of bar causes electrical flow
- Generates a secondary current
- Reinforcement inferred by monitoring current

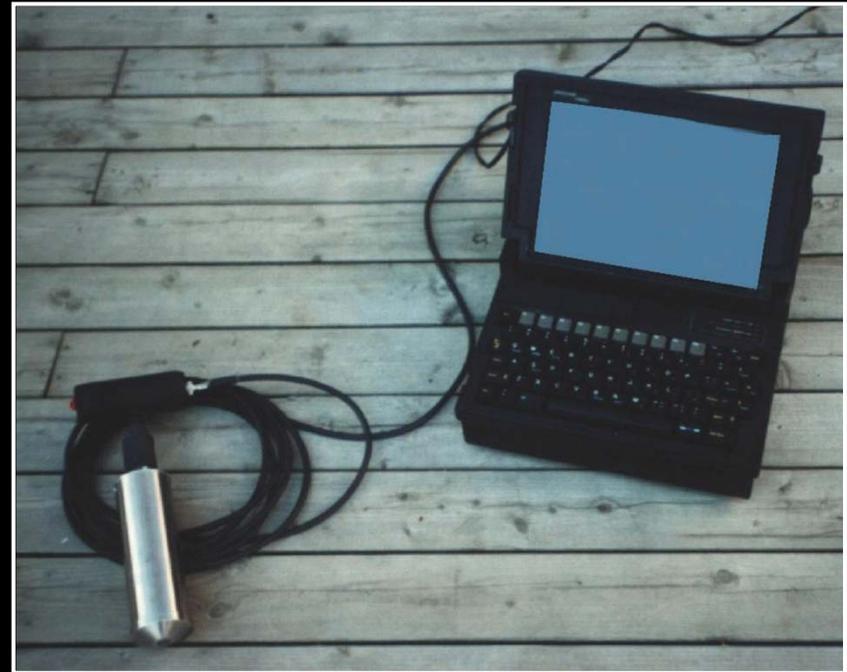
Impact-Echo Schematic

- Measure properties of reflected P-wave
- Applications
 - Concrete thickness
 - Crack depths
 - Delaminations
 - Unconsolidated concrete
- Limitations
 - Near surface discontinuities
 - Edge effects

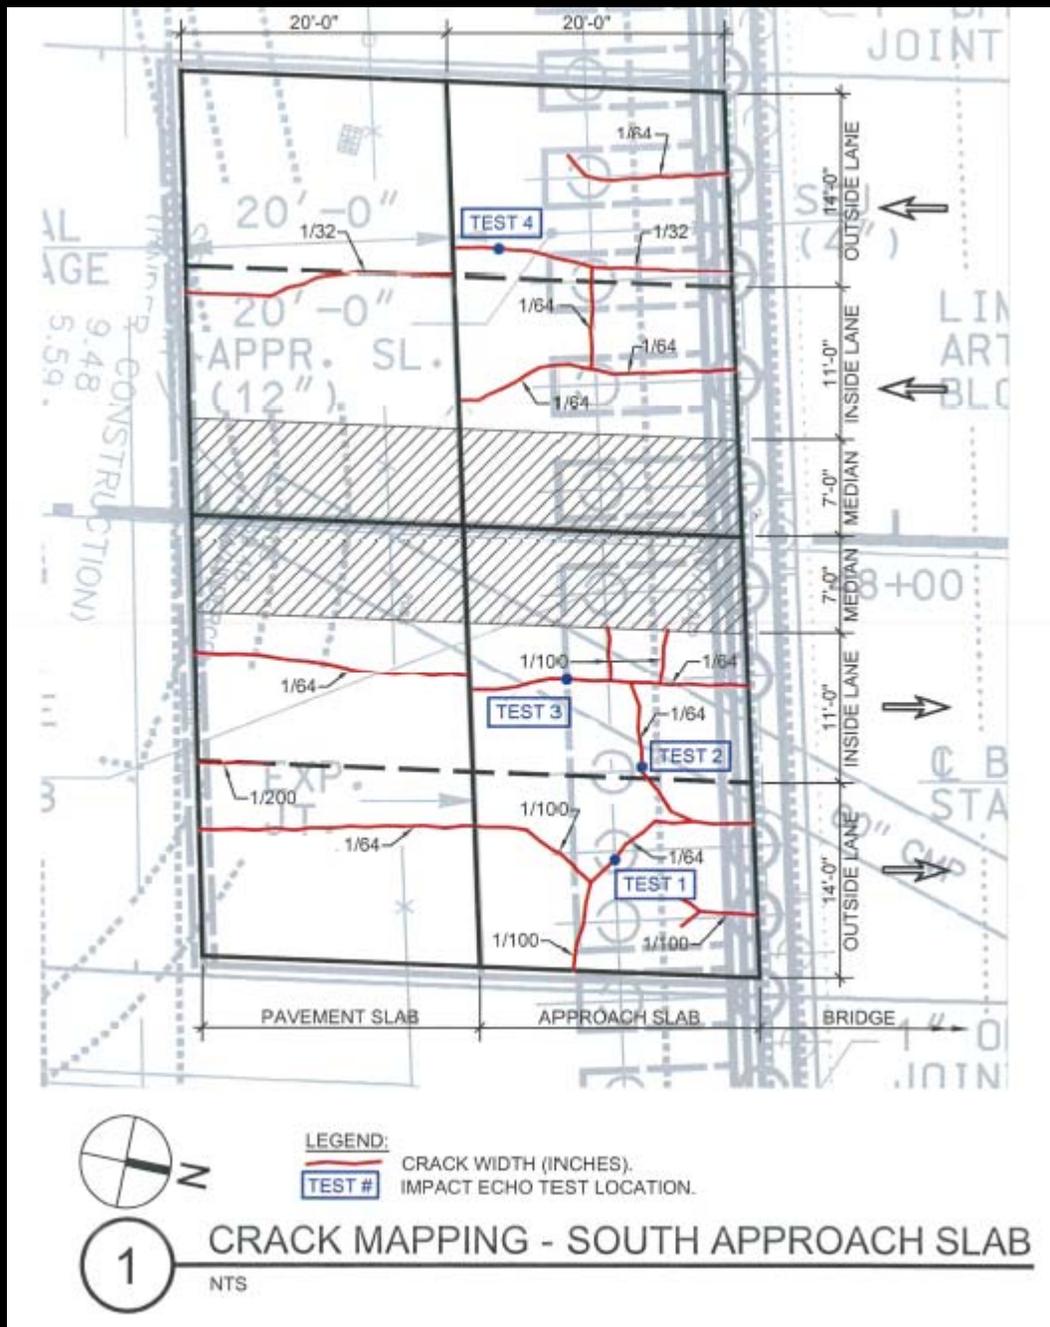
- 12" thick reinforced concrete slab
- Two layers of reinforcement
 - #5 bars @ 12" OC
 - Top and bottom
- *Are there voids beneath the slab causing settlement?*

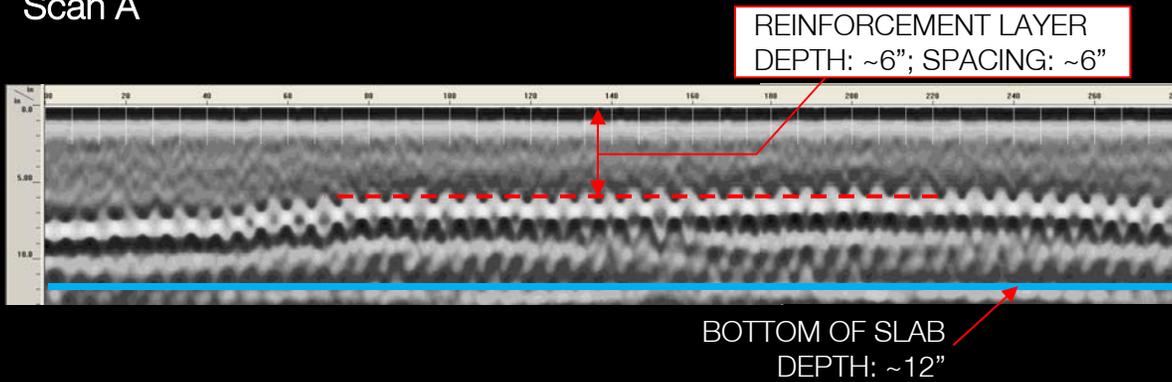
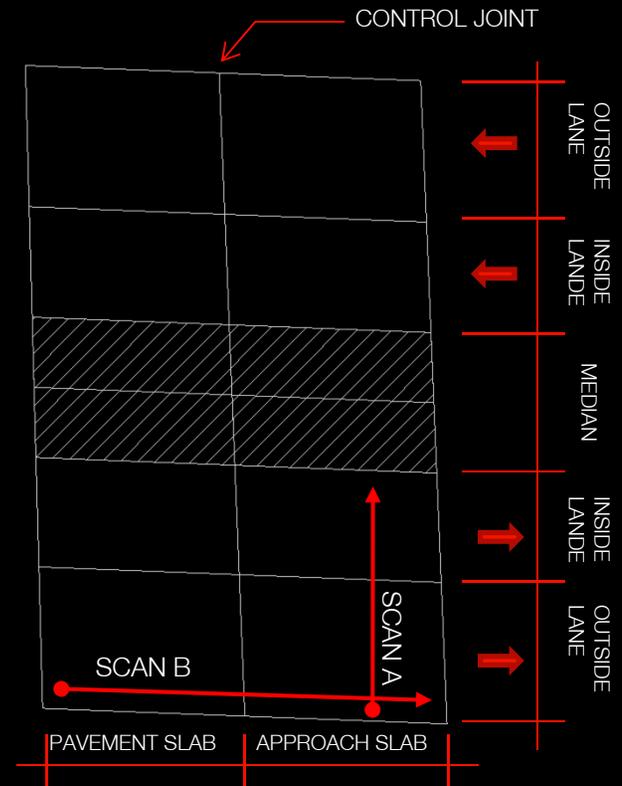
Scan A

Approach Slab GPR

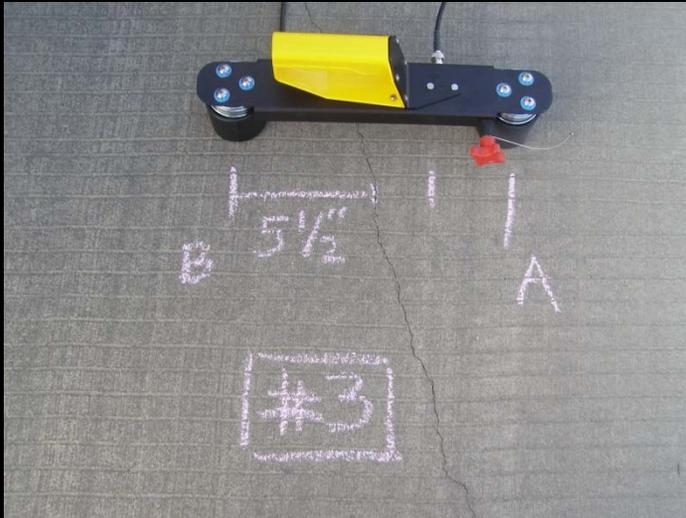
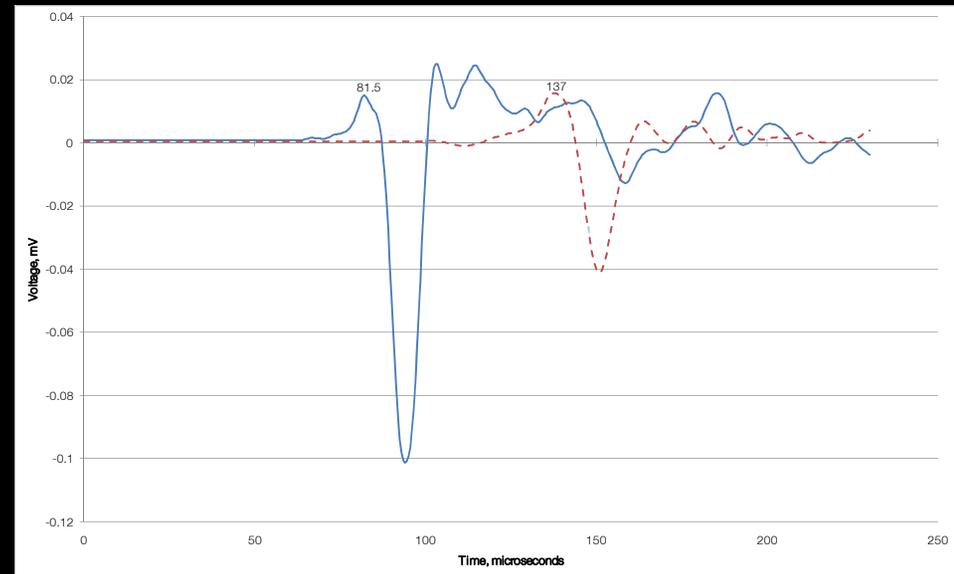
Impact-Echo Surface Crack Depths

t_1 (μs)	t_2 (μs)	Δt (s)	D (in.)
Test 1	81.5	137	7.53E-05	7.69
Test 2	81	130	6.88E-05	6.79
Test 3	83.5	132.5	6.88E-05	6.79
Test 4	59	99	5.98E-05	5.48
Test 5	41	73.5	5.23E-05	4.29

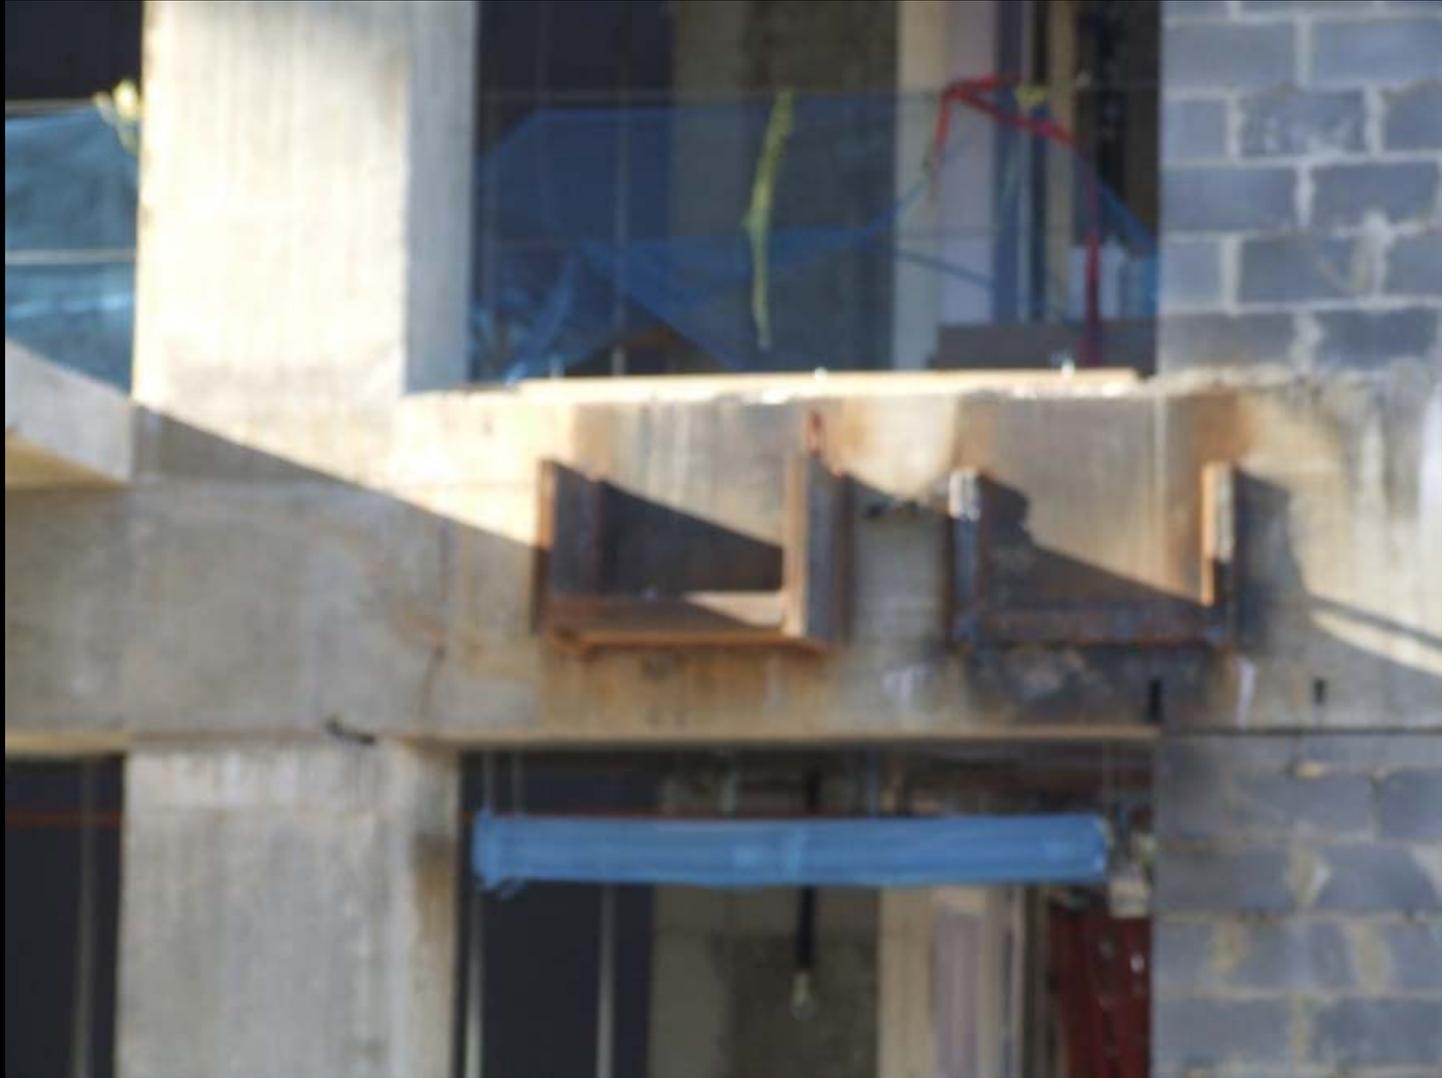
- Under Construction – 2012
- Two reinforced concrete structures
- Connected by steel framed breezeway
 - Supported on steel brackets

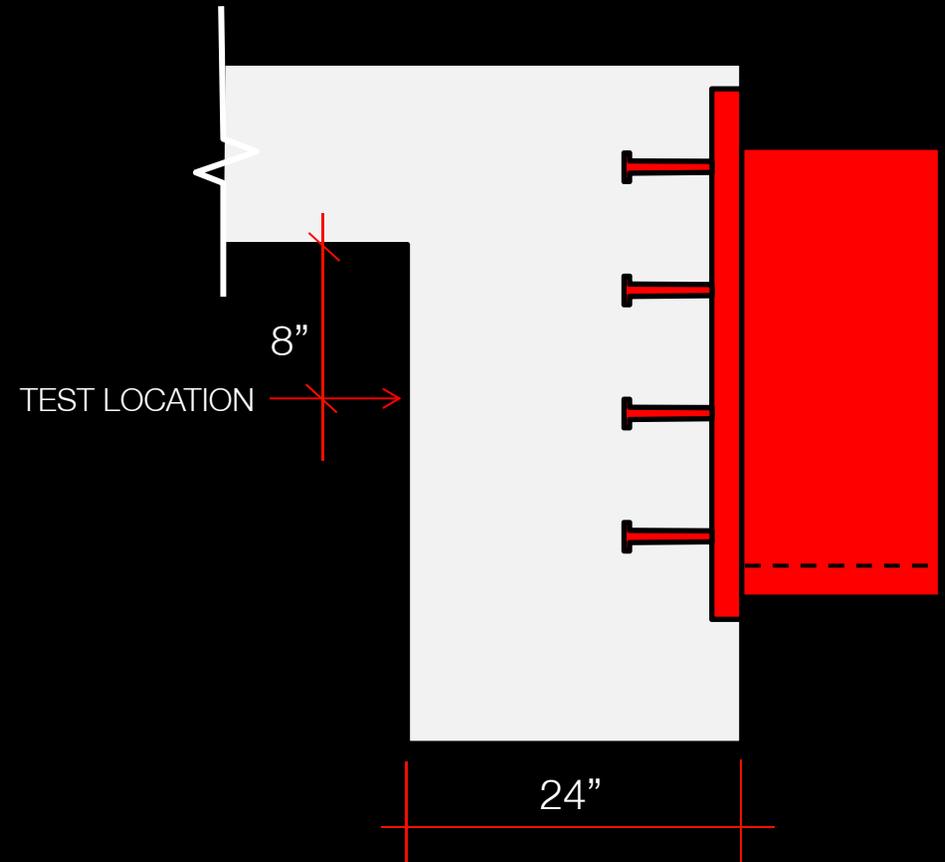
SECTION VIEW OF TYPICAL TEST LOCATION

- Impact Echo testing

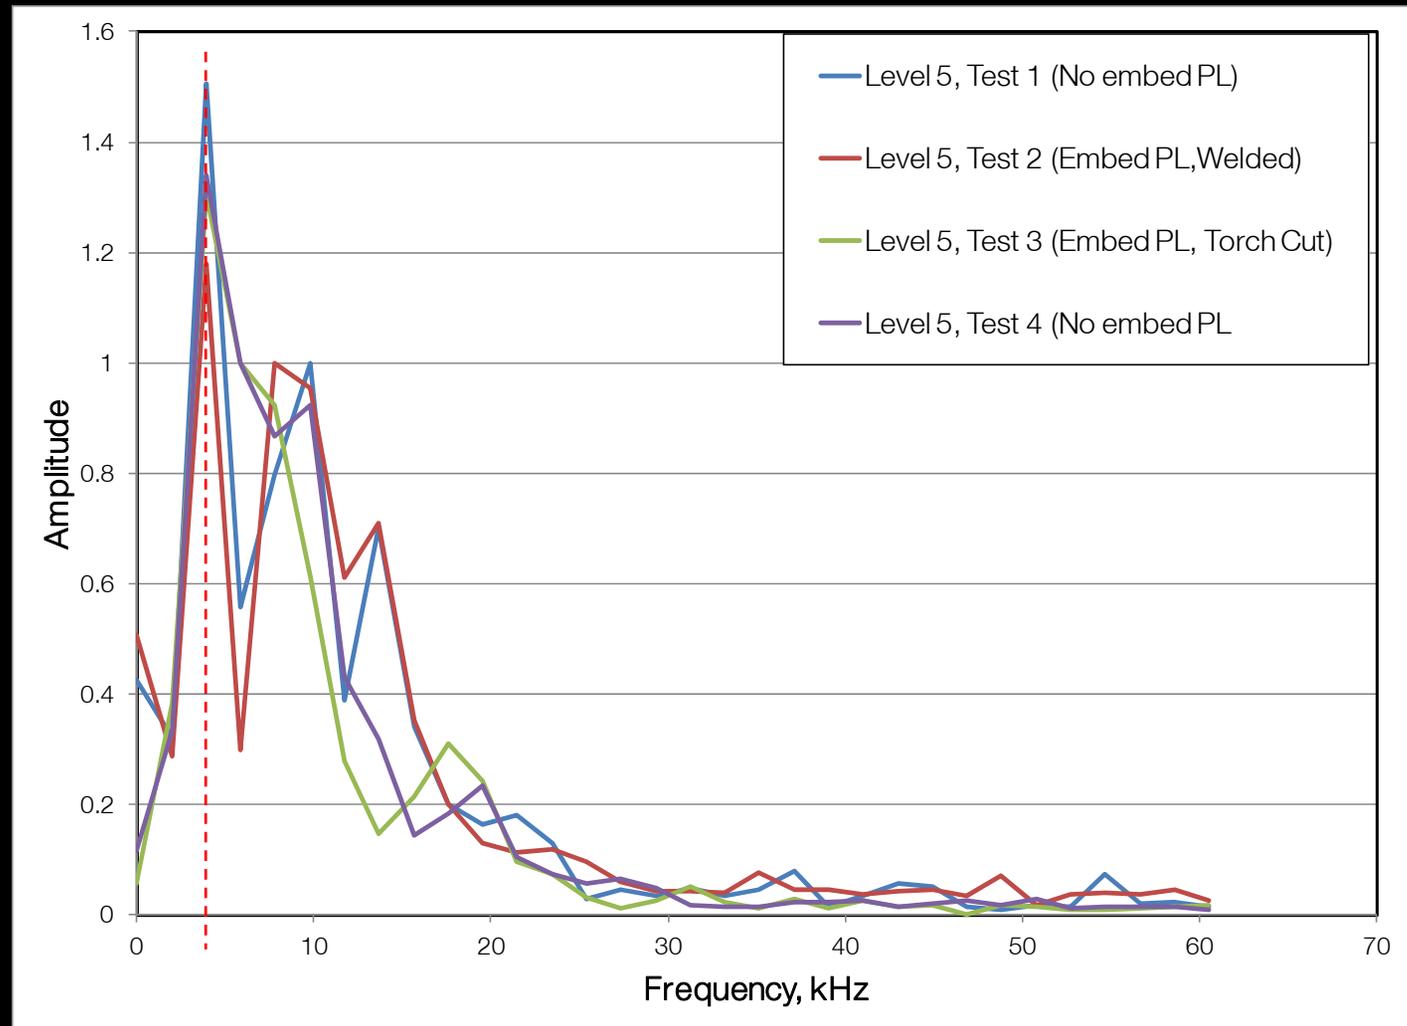
TYPICAL FREQUENCY DOMAIN RESPONSE

FDA Building 71: Testing Results

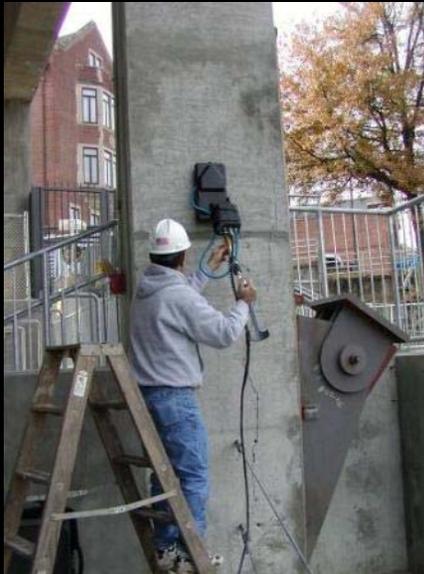
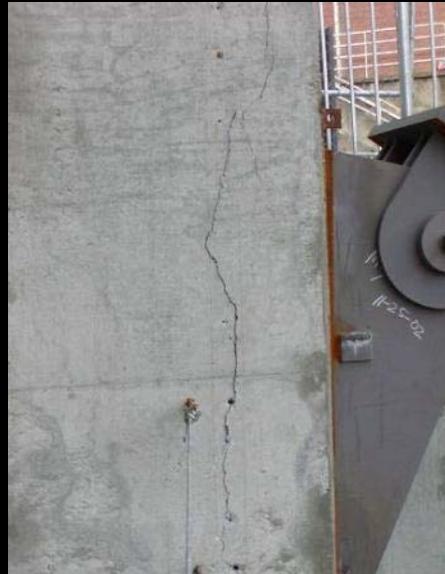
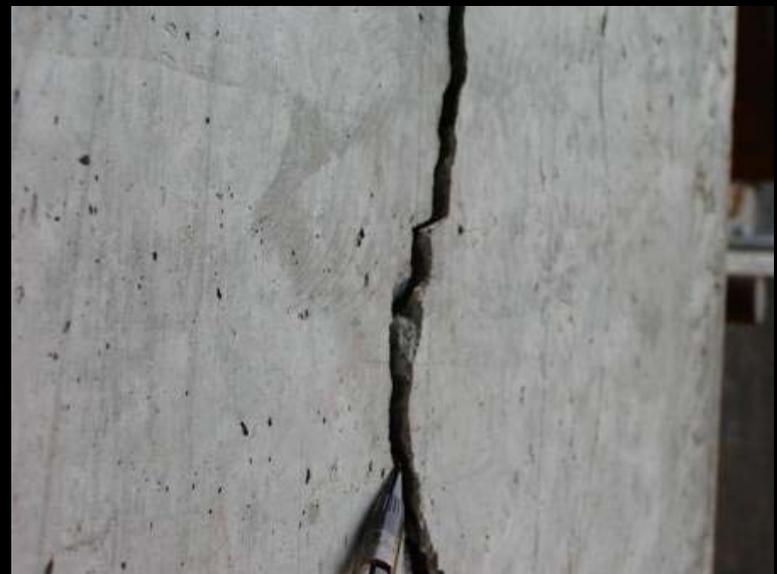
Case Study: Bobby Dodd Stadium

- Testing
 - SPR
 - Impact Echo

Findings of Field and NDT Study

- SPR of the columns
 - Concrete cover varied between 2” – 6”
 - Tie spacing was large at the embedment plate
 - Headed studs located outside rebar cage
- Impact Echo determined cracks were deep and hence needed to be repaired.

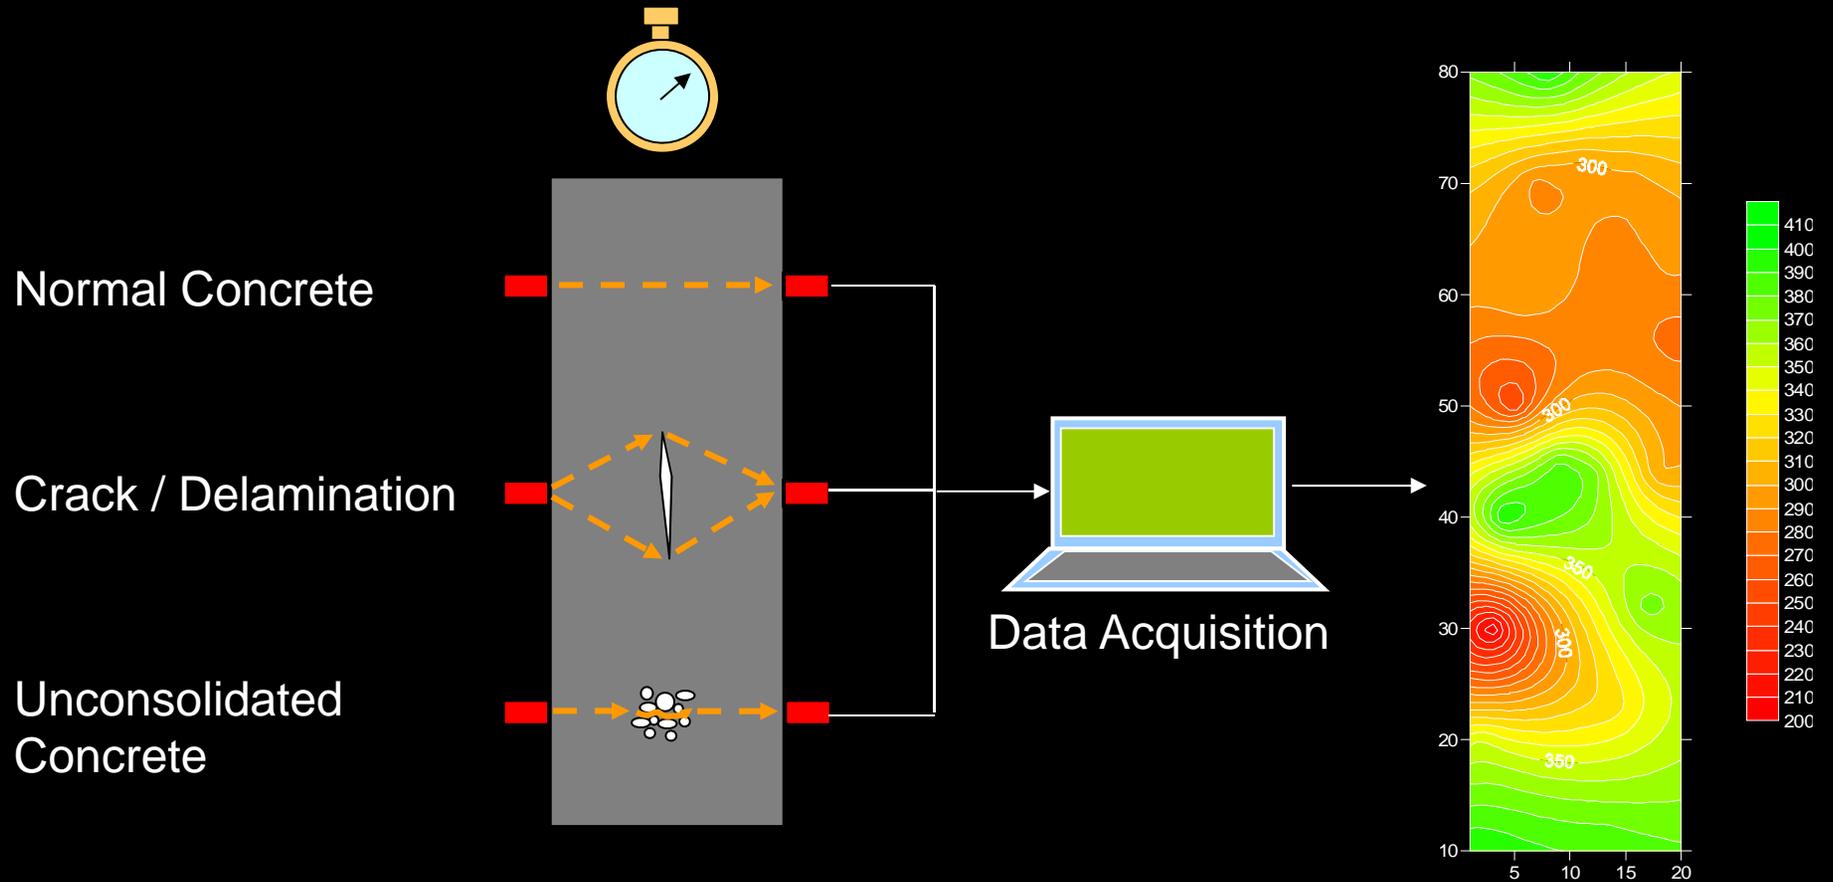
UPV Schematic

- Wave speed through concrete
- Applications
 - Delaminations
 - Unconsolidated Concrete
 - Concrete material properties
- Limitations
 - Access to both sides (preferred)
 - Qualitative

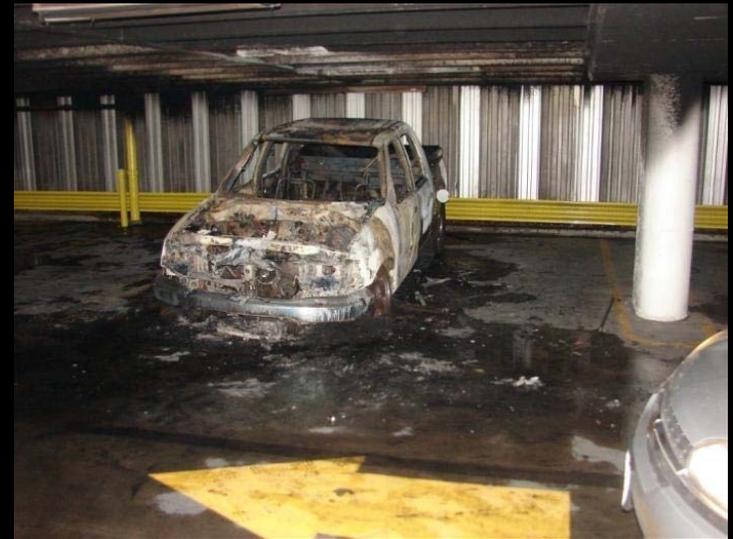
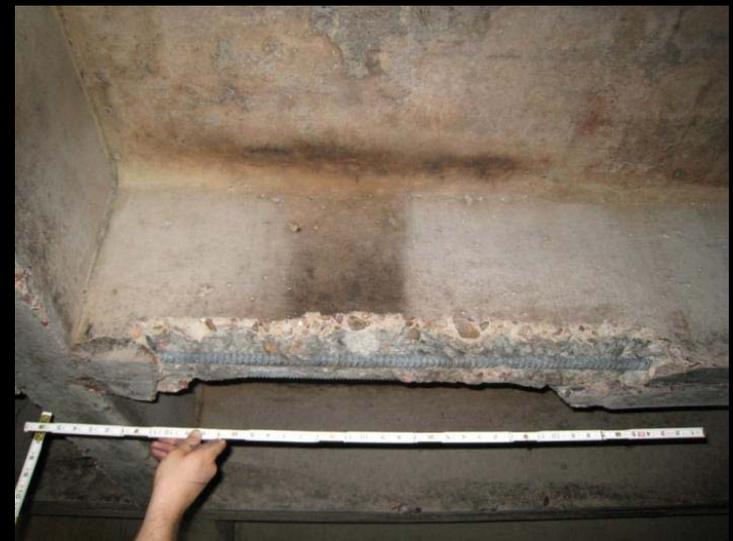
Parking Garage Fire

- Reinforced concrete pan-joint deck
- Ford F-150 @ 2 AM
- Visible spalls and delaminations
- Pink concrete
- *What is the extent of area which requires repair?*

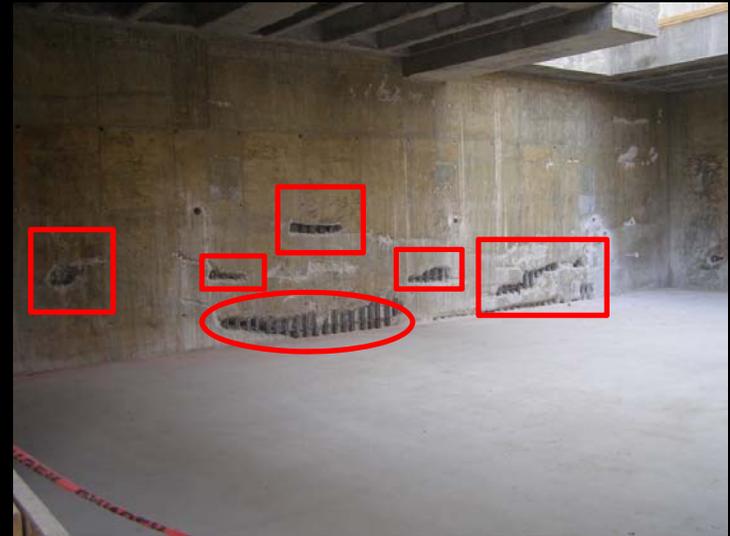
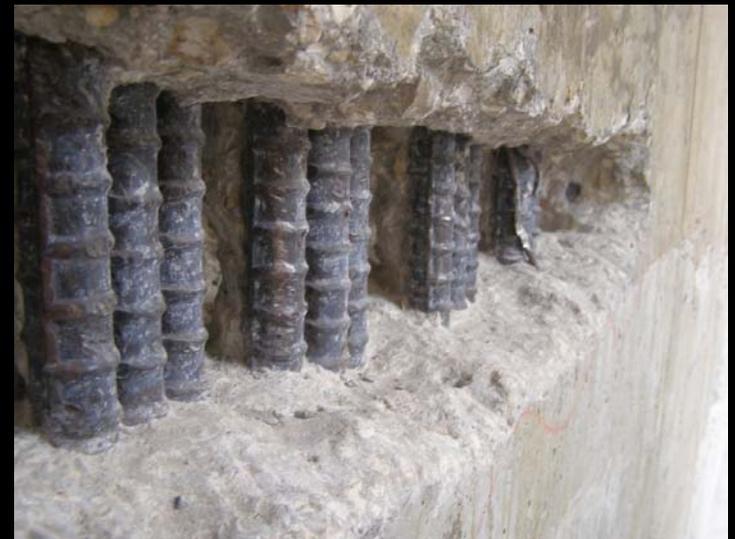
SAMMC Shear Wall

- 36-inch thick shear wall
- Voids observed after form removal
- Visible cold joints
- *Are there other locations with voids that are not visible?*

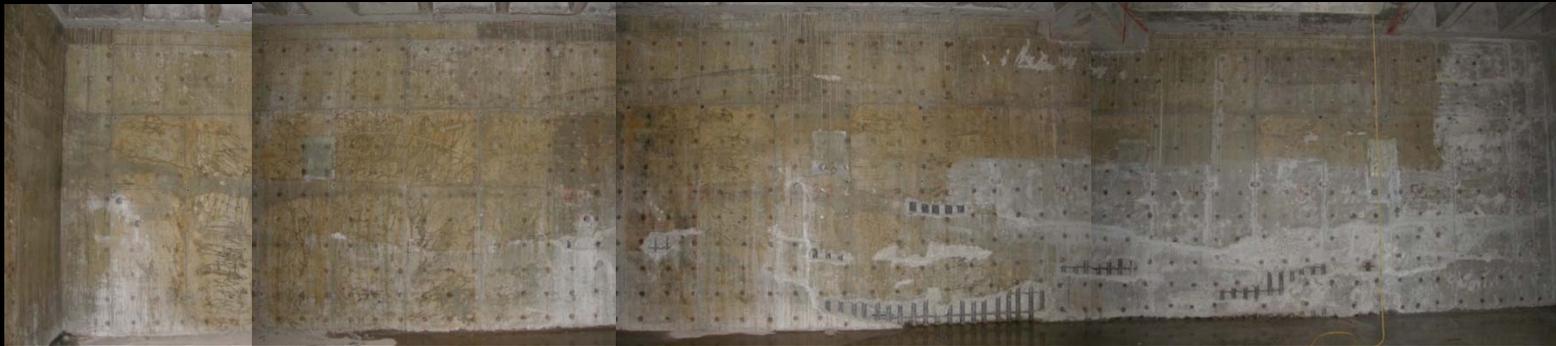
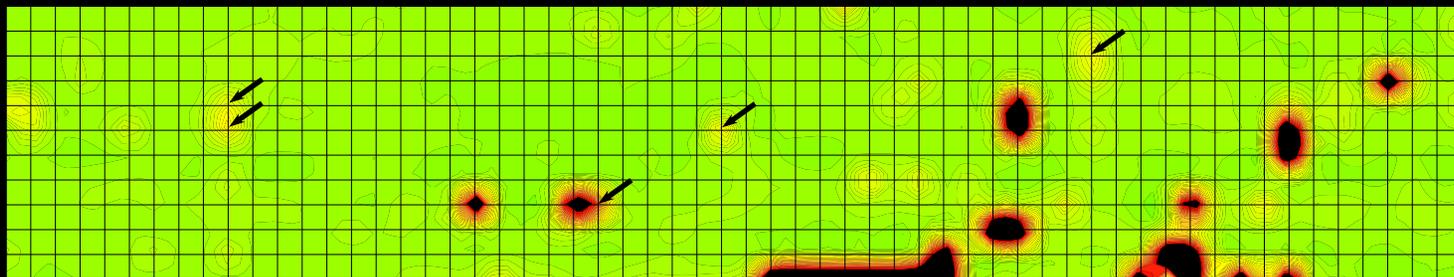
SAMMC Shear Wall

- Black areas denote locations with visible voids
- Arrows indicate recommended locations for coring

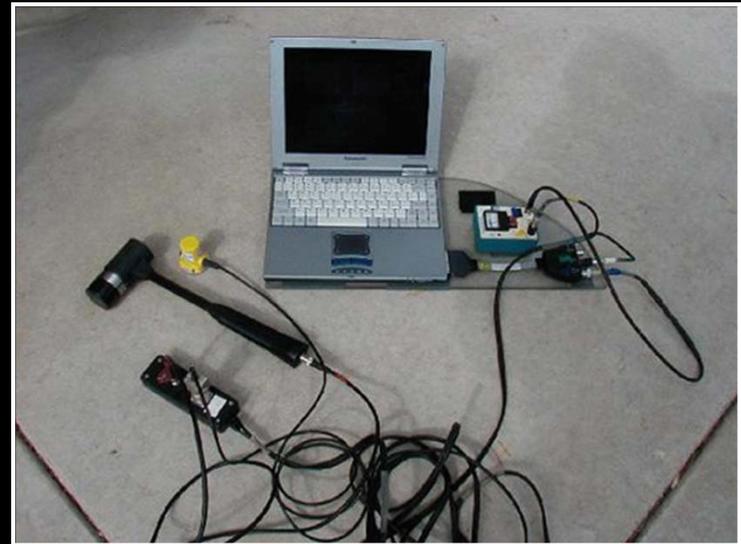
Impulse Response

- Low-strain impact
- Mobility plot
- Applications
 - Stress transfer
 - Delaminations
 - Deep foundation integrity
- Limitations
 - Cannot determine depth of flaws
 - Qualitative
 - Verify with coring

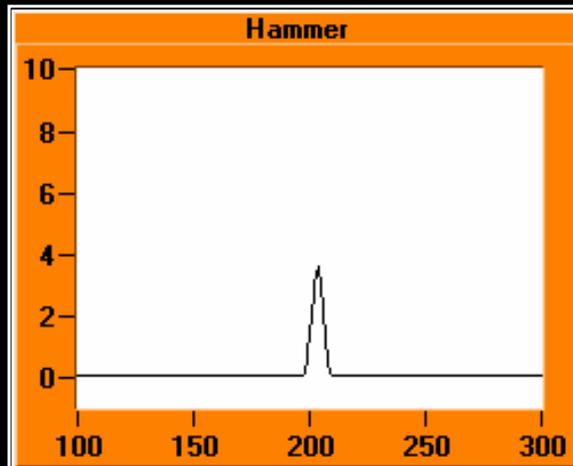
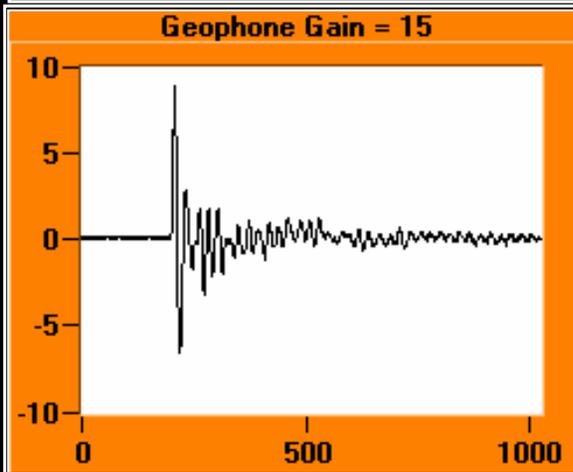
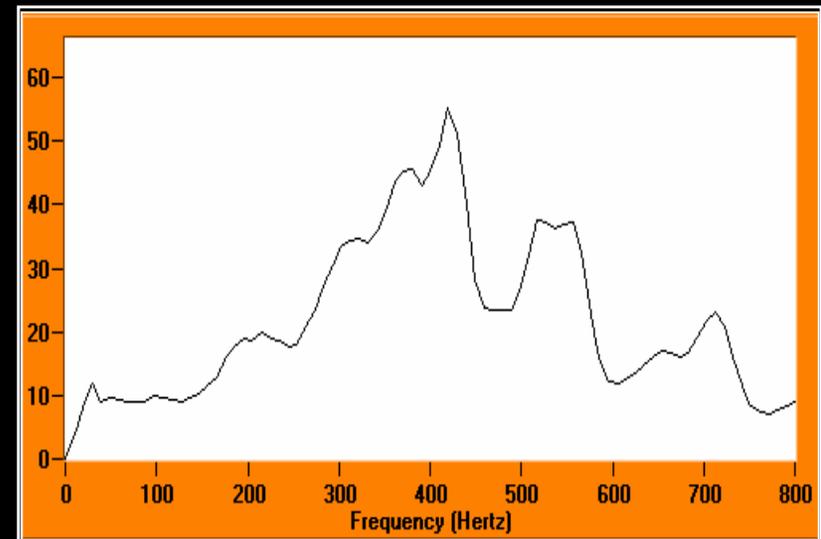
What is a Mobility Plot?

Force

Velocity

÷

Mobility

Frequency

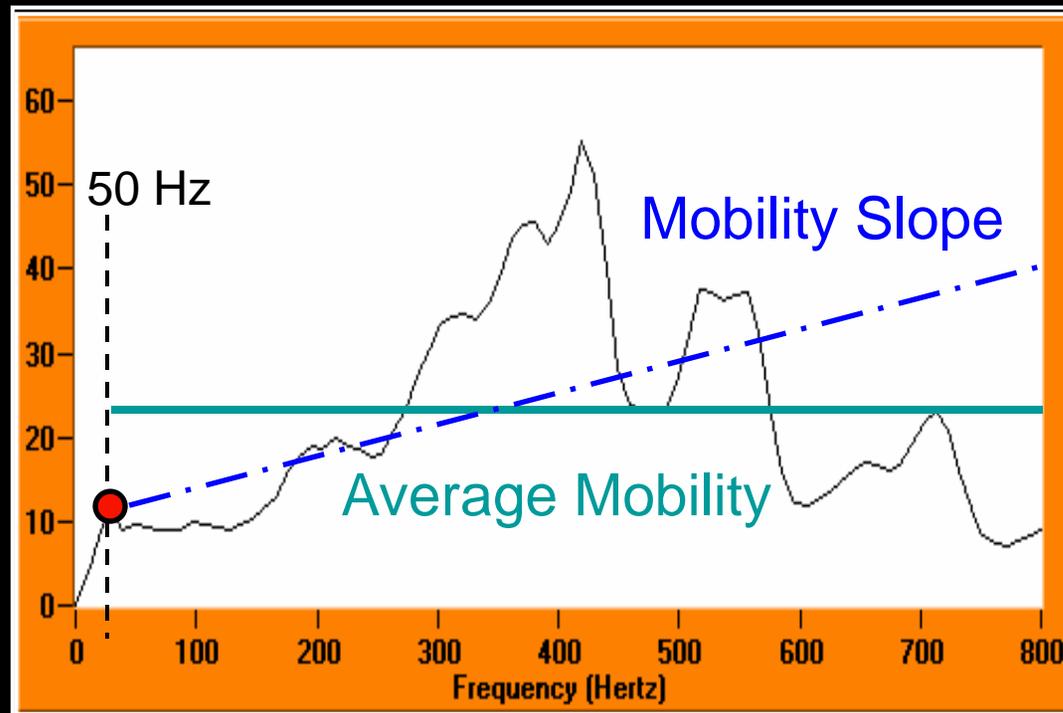
What Information is in a Mobility Plot?

Dynamic Stiffness

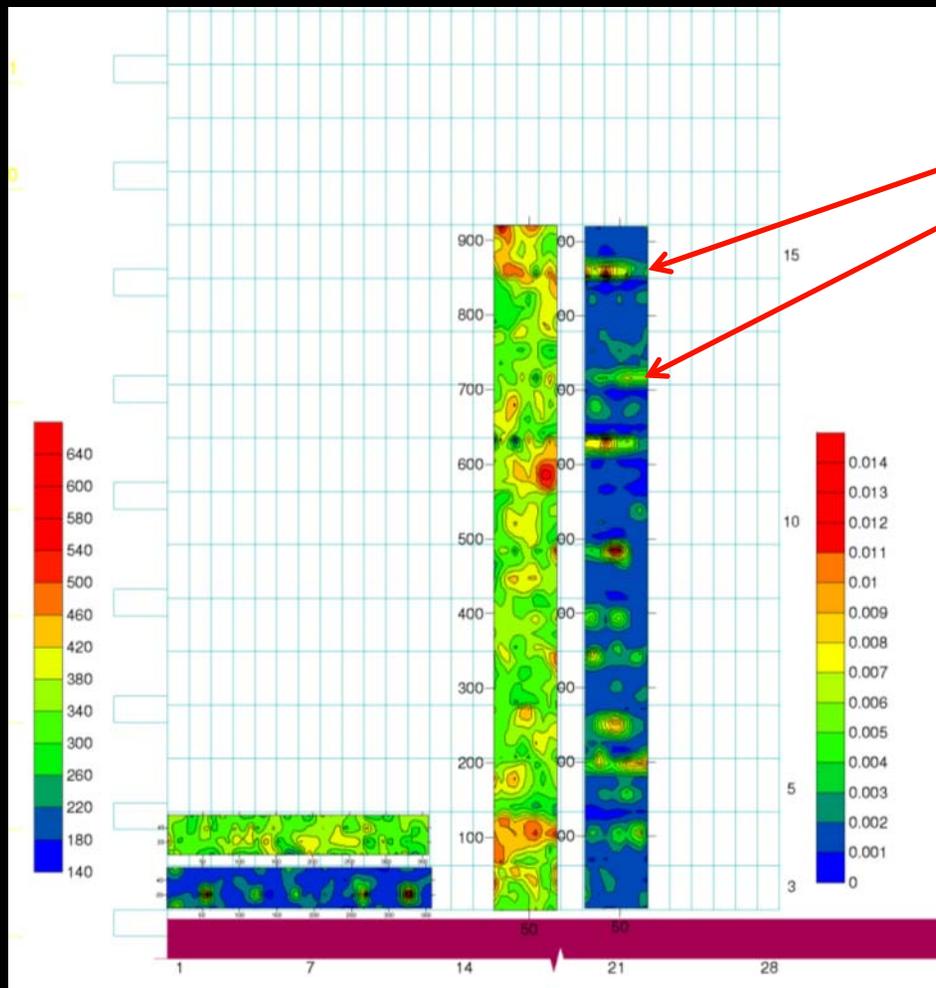
1020 Holcombe: Impulse-Response Results

Good Connections

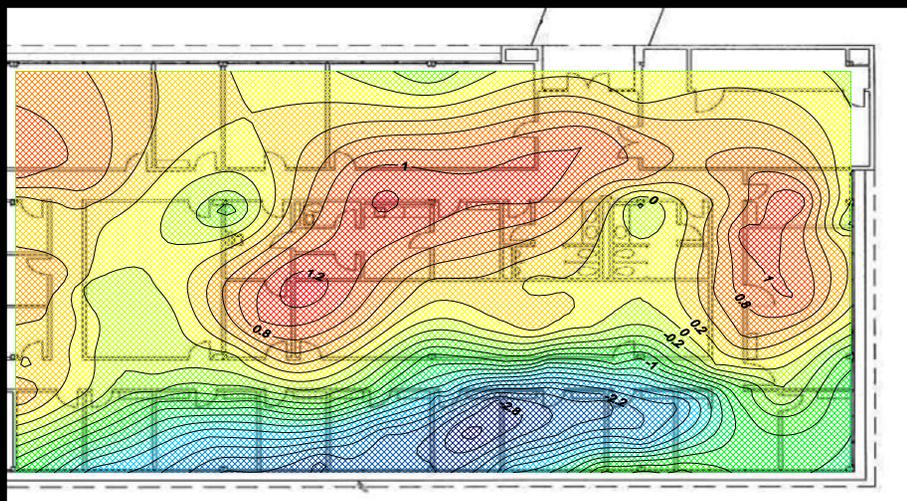
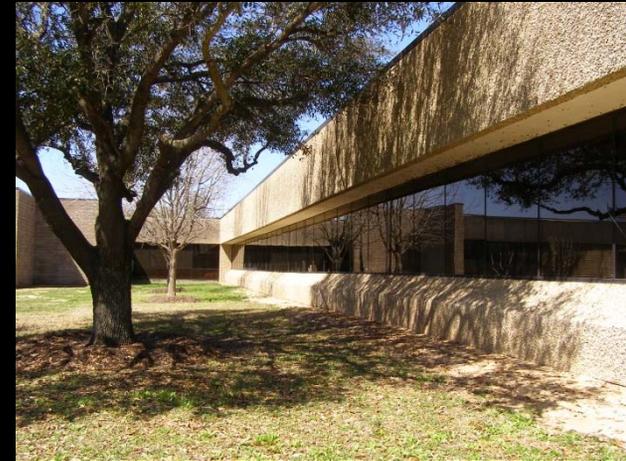
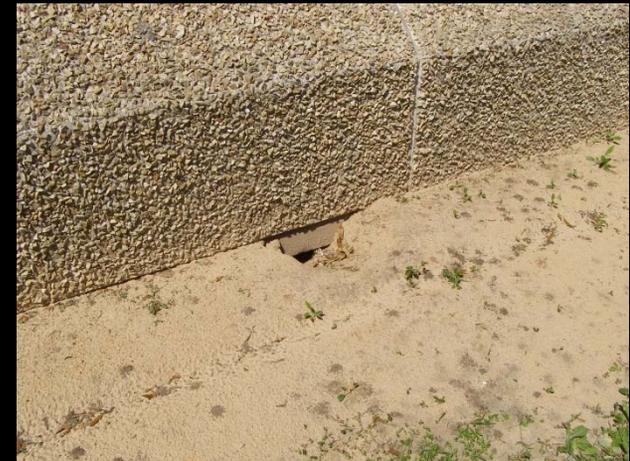
Voids beneath Slab on Grade

- Downward movement reported by owner
- Evidence of possible voids visible
- *What are the extents of the void?*

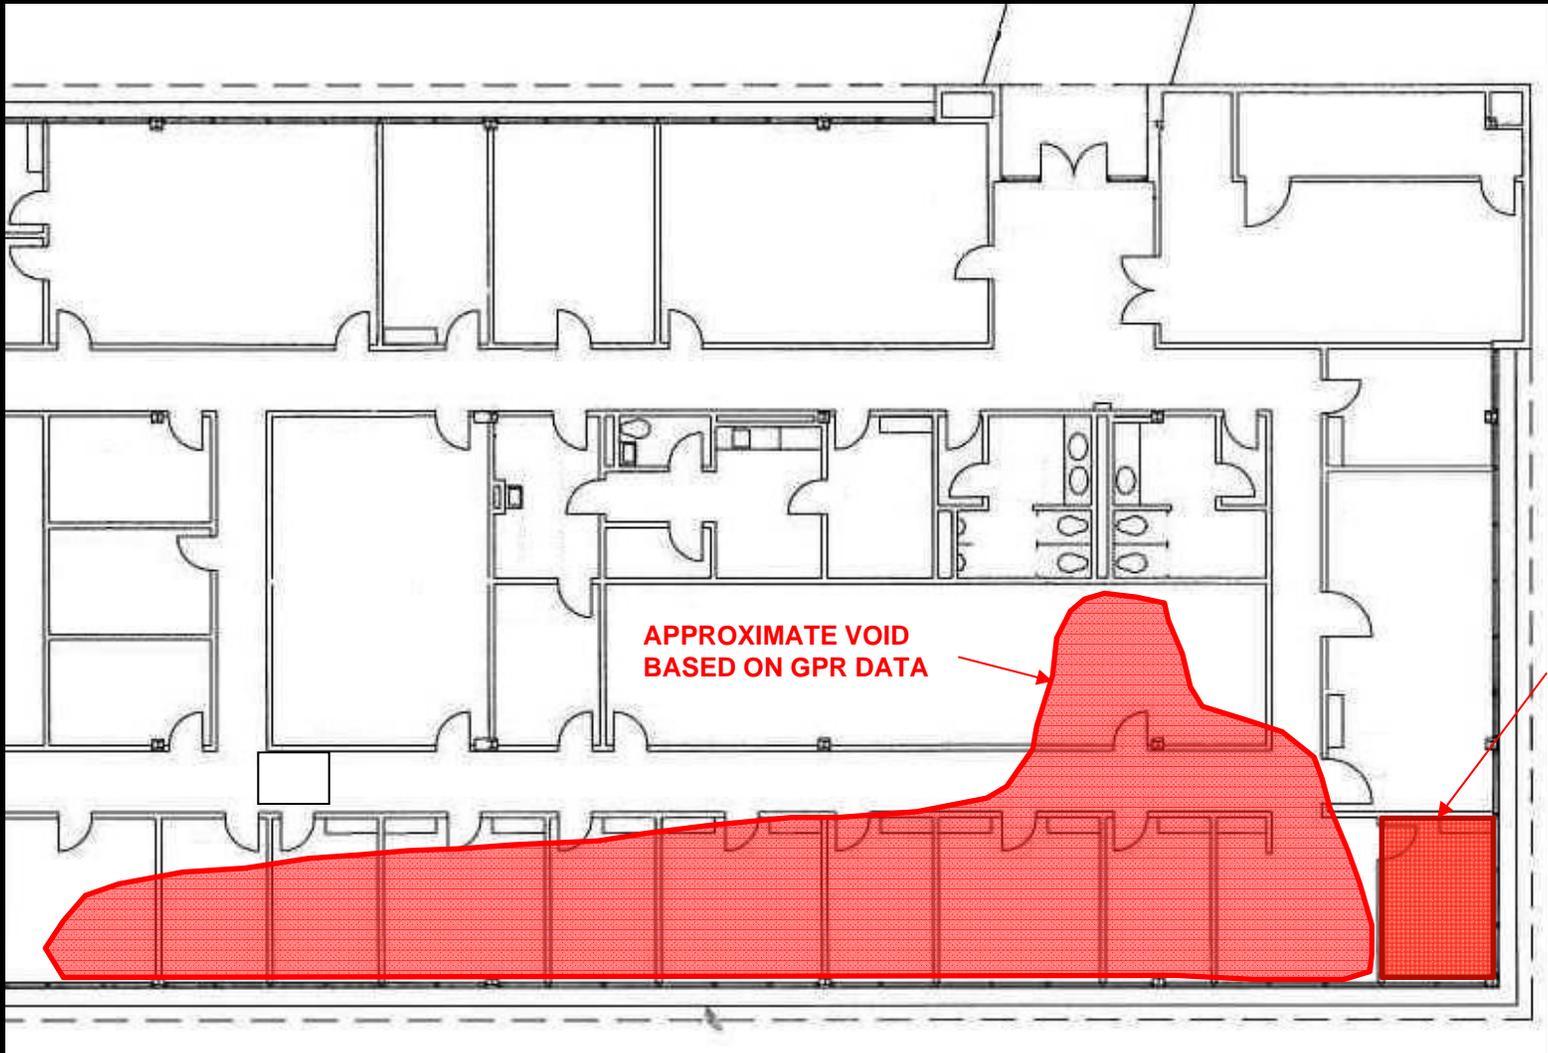
APPROXIMATE VOID
BASED ON GPR DATA

NO
ACCESS
TO THIS
ROOM
