TECHNICAL
TRAINING SERIES

Nondestructive Evaluation for Structural Repair and Rehabilitation

Jacob Bice, Ph.D., P.E.

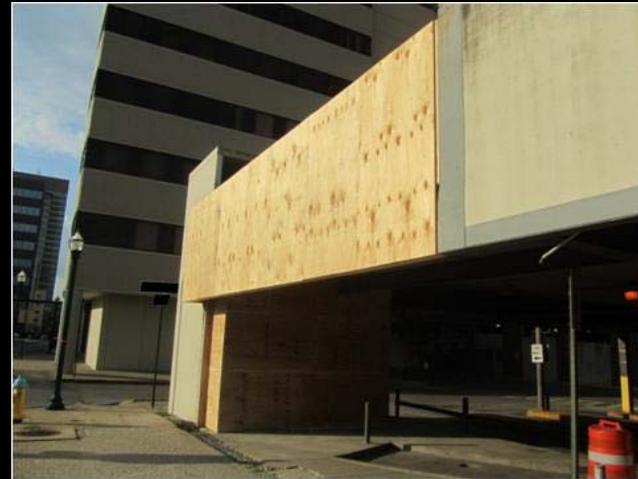
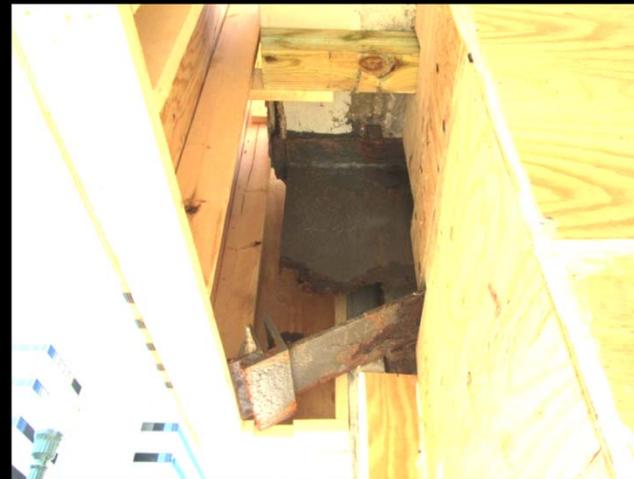
Parking Garage Bumper Wall Failure

- Precast Concrete Bumper Wall panel supported by steel beams fell off of the side of the parking structure.
- *Are there other locations where there is a hidden problem?*

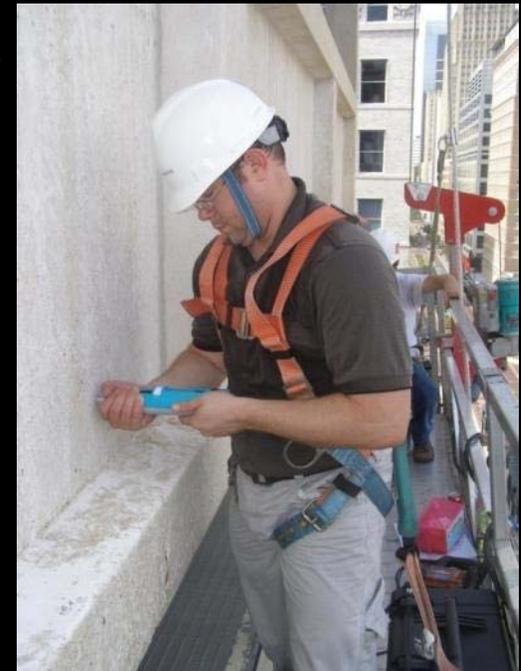
Rebound (Schmidt) Hammer

- Elastic rebound of hammer impact
- Applications
 - Concrete compressive strength
 - Fast, qualitative assessment of overall quality
- Limitations
 - Near-surface properties only
 - Affected by many variables
 - Uniformity of concrete

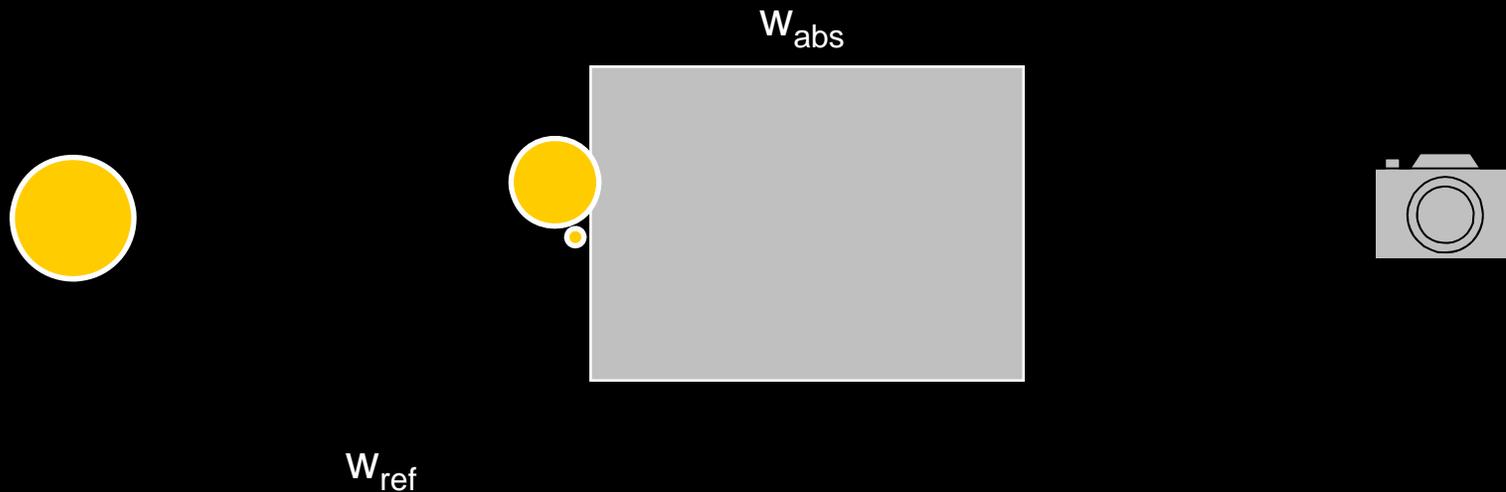
Infrared Techniques

- Infrared thermal emissivity
- Noncontact
- Highly absorptive materials
 - Concrete
 - Masonry

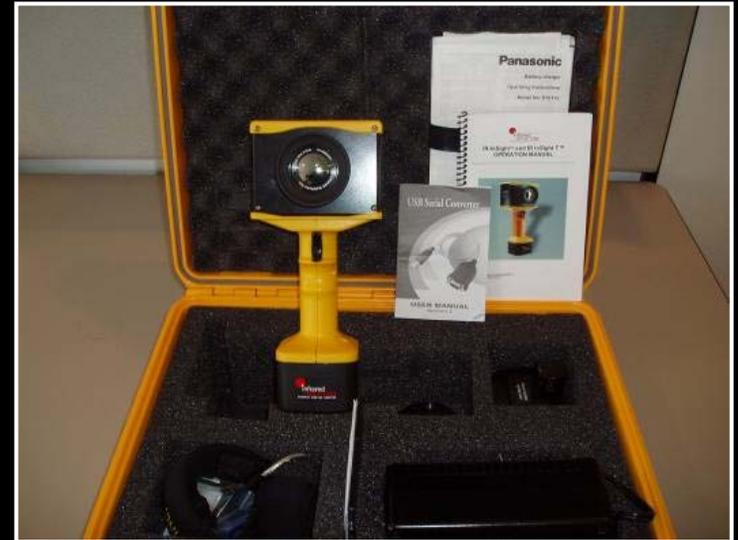
What is Thermography?

- Infrared thermal emissivity
- Applications
 - Water Intrusion
 - Air leakage
 - Bonding of FRP sheets
 - Location of termite infestation
- Limitations
 - Not effective with reflective materials

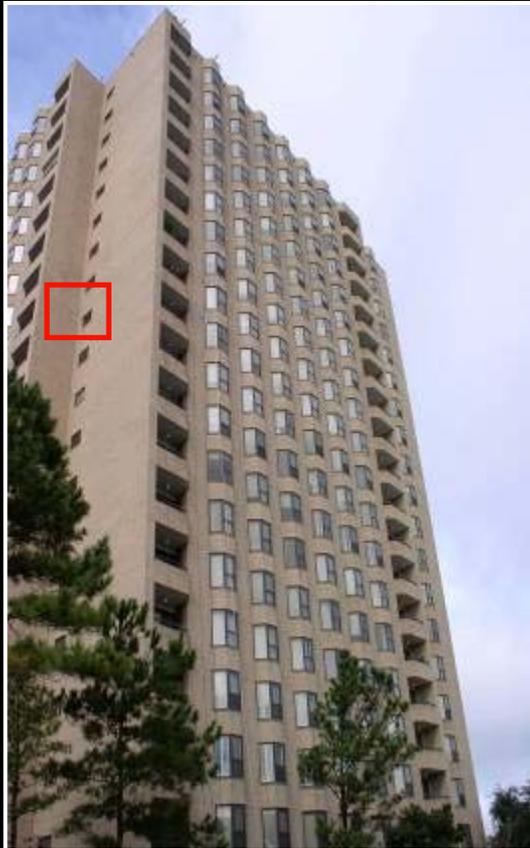
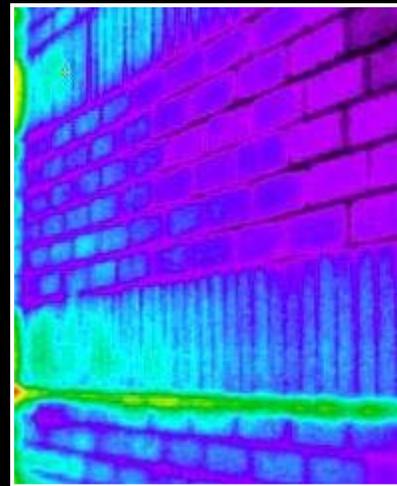
Before Coating

Case Study: Moisture Infiltration

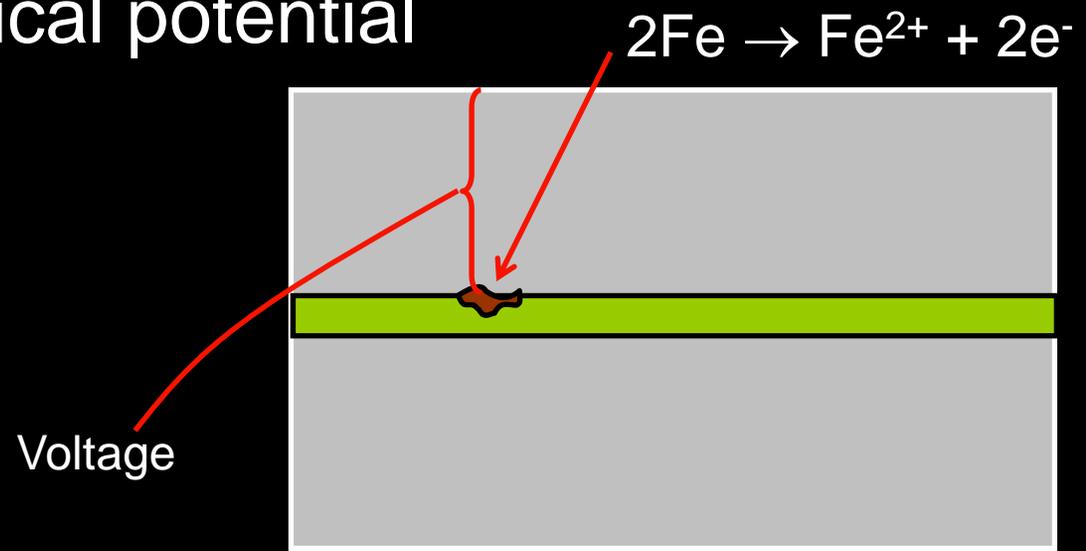
What is Half-Cell Potential?

- Electrochemical reaction

- Galvanic corrosion

- Measure electrical potential

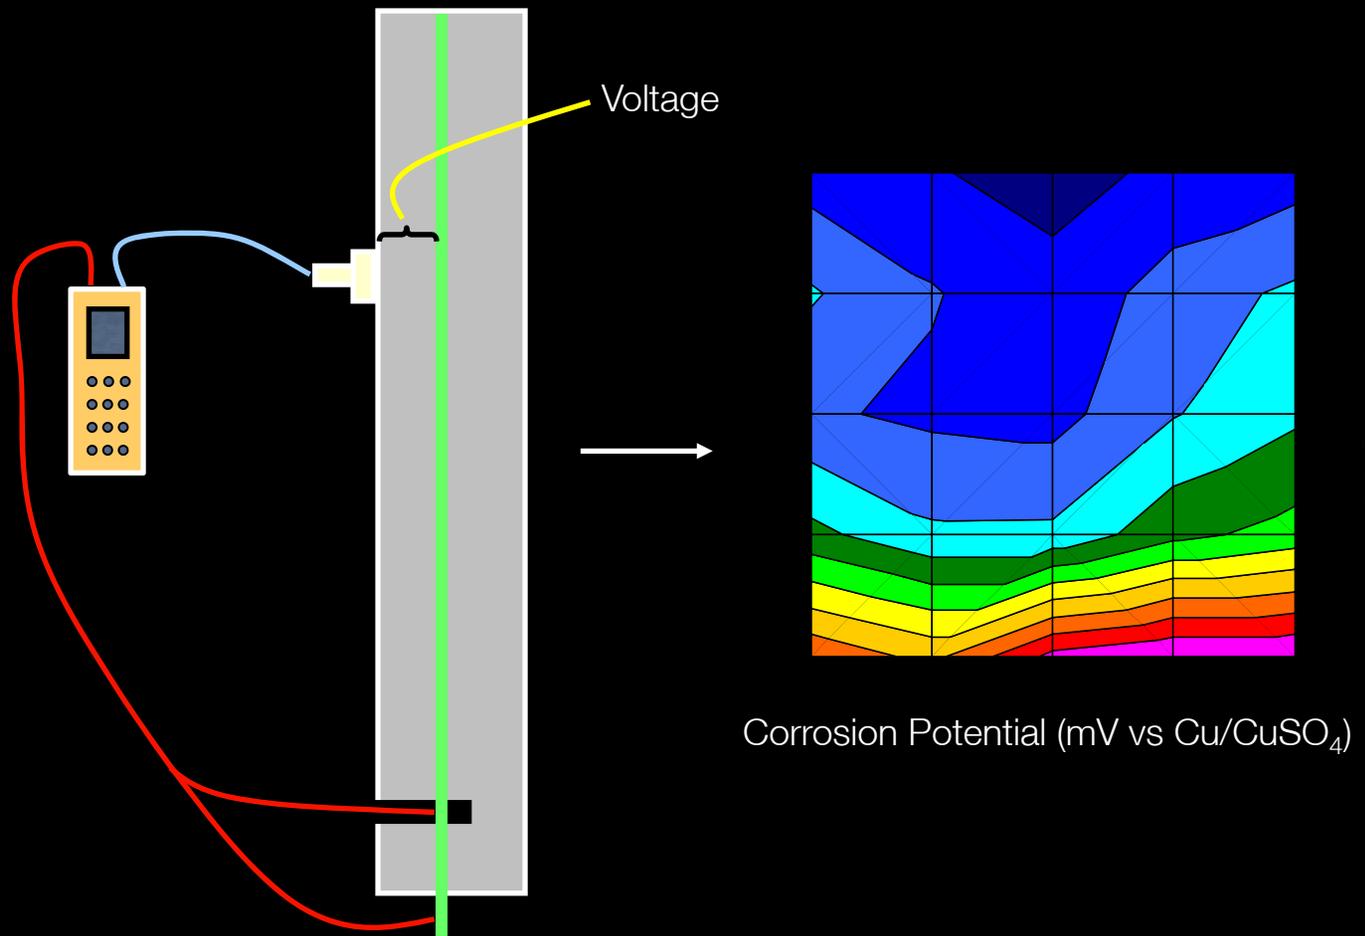
Half-cell Potential Schematic

Half-Cell Potential & Corrosion Rate

- Linear Polarization Technique
- Measures corrosion activity
- Applications
 - Corrosion prediction
- Limitations
 - Cathodic protection
 - Requires connection to rebar
 - Depth of cover less than 4 inches
 - Saturated concrete*

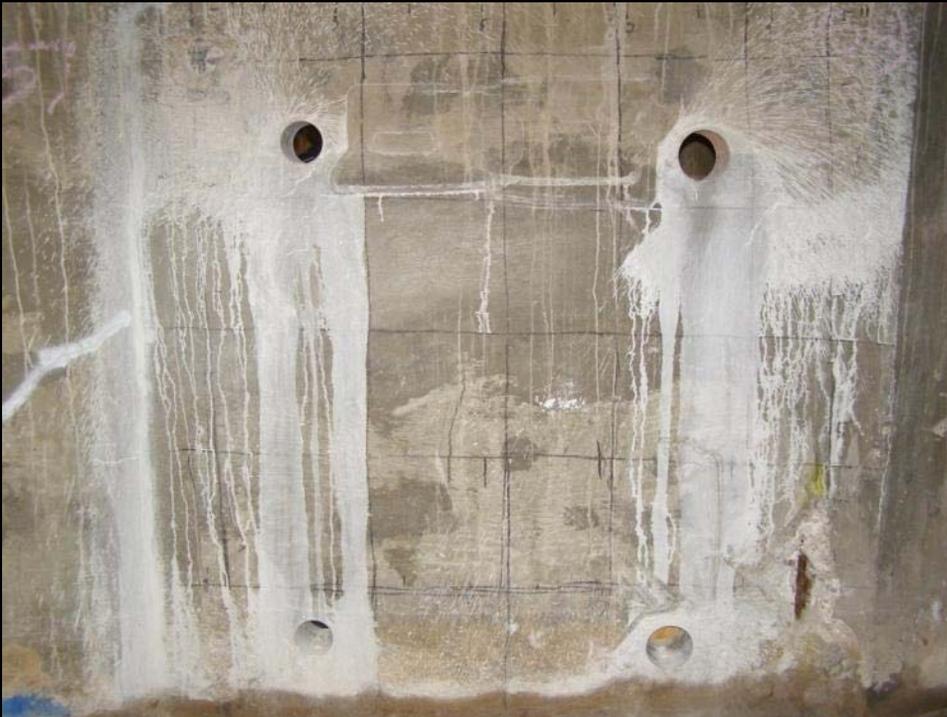
LCRA: SPR

SPR used to position sample locations

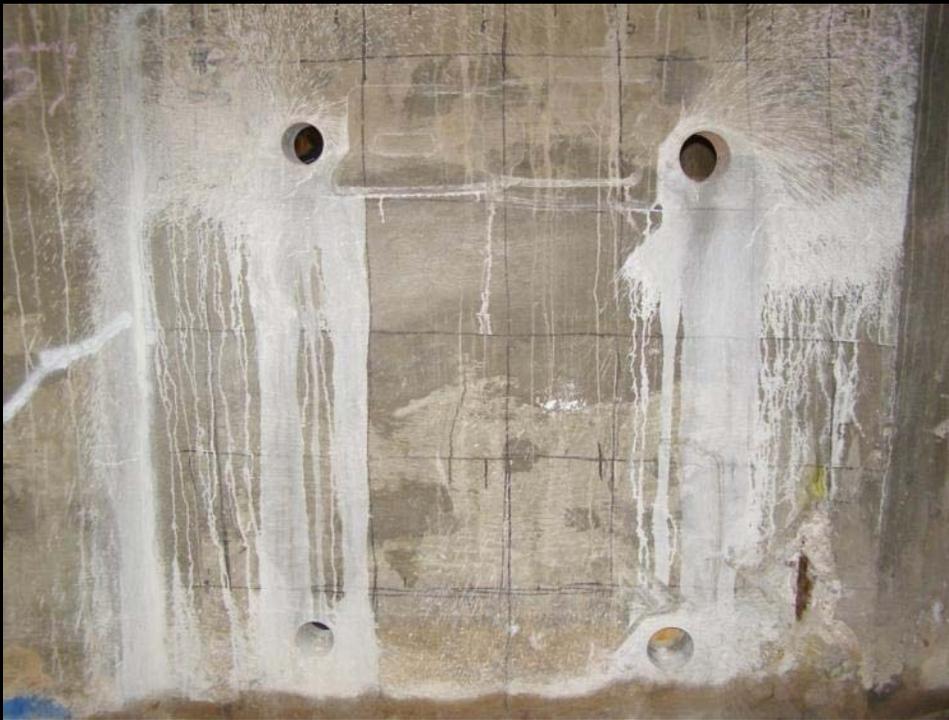
LCRA: Sub-basement Level

Fin F56 – Ultrasonic Pulse Velocity (UPV)

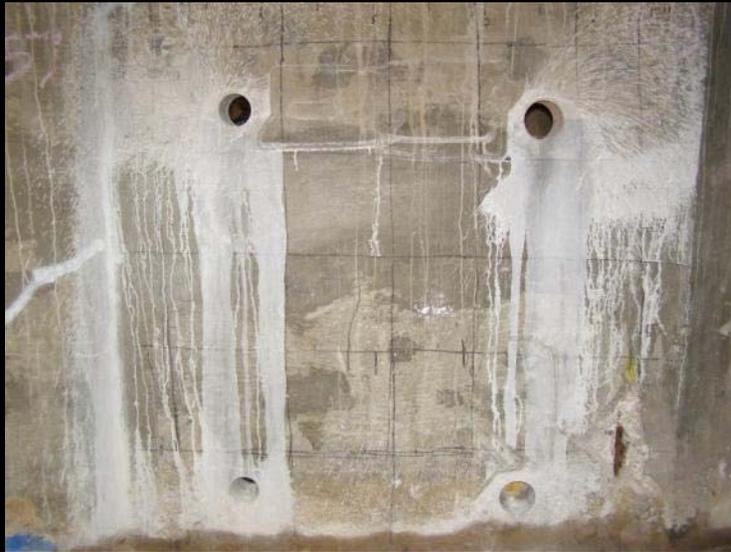
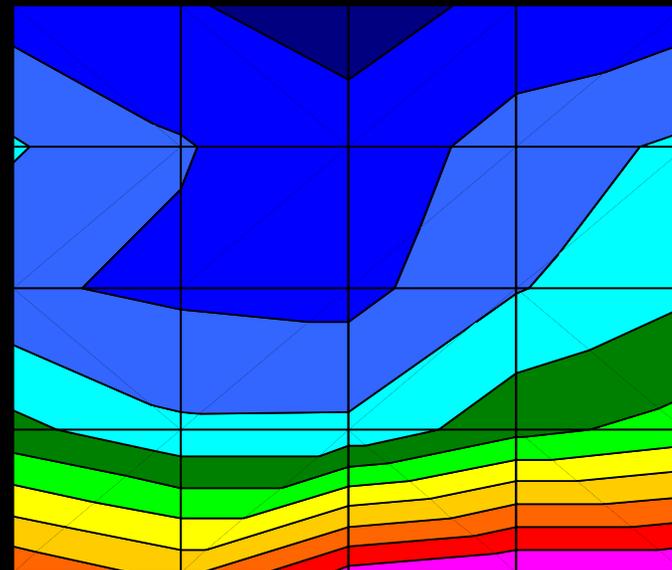
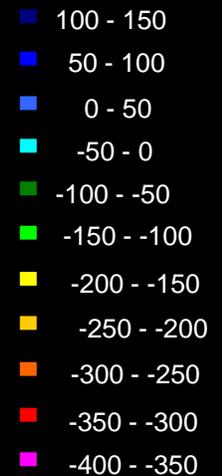
LCRA: Sub-basement Level

Fin F56 – Corrosion Testing

Half-cell Potential vs. $\text{Cu/CuSO}_4^{(1)}$	Probability of Corrosion
More positive than -200 mV	Less than 10%
Between -200 and -350 mV	Uncertain
More negative than -350 mV	More than 90%

Corrosion Potential
(mV vs. Cu/CuSO_4)

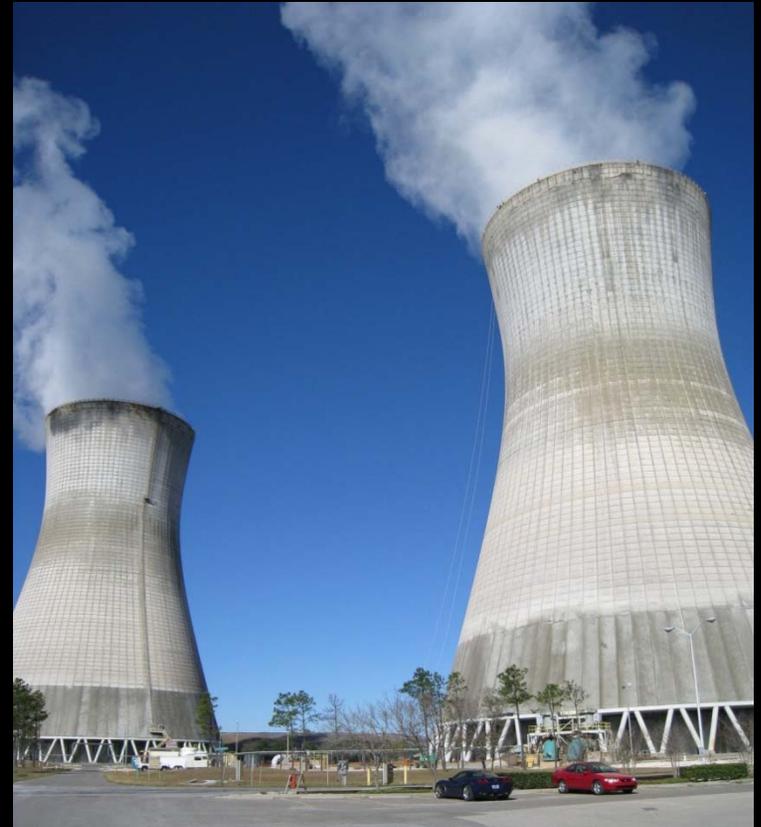
Evaluation of Cathodic Protection System

- 2 Hyperbolic Natural-Draft Cooling Towers
 - Reinforced Concrete Shells
 - 453 feet tall
 - 320 feet diameter at base
- Cathodic Protection (CP)
 - Life Jackets on columns
 - Zinc mesh over lifts 1-12

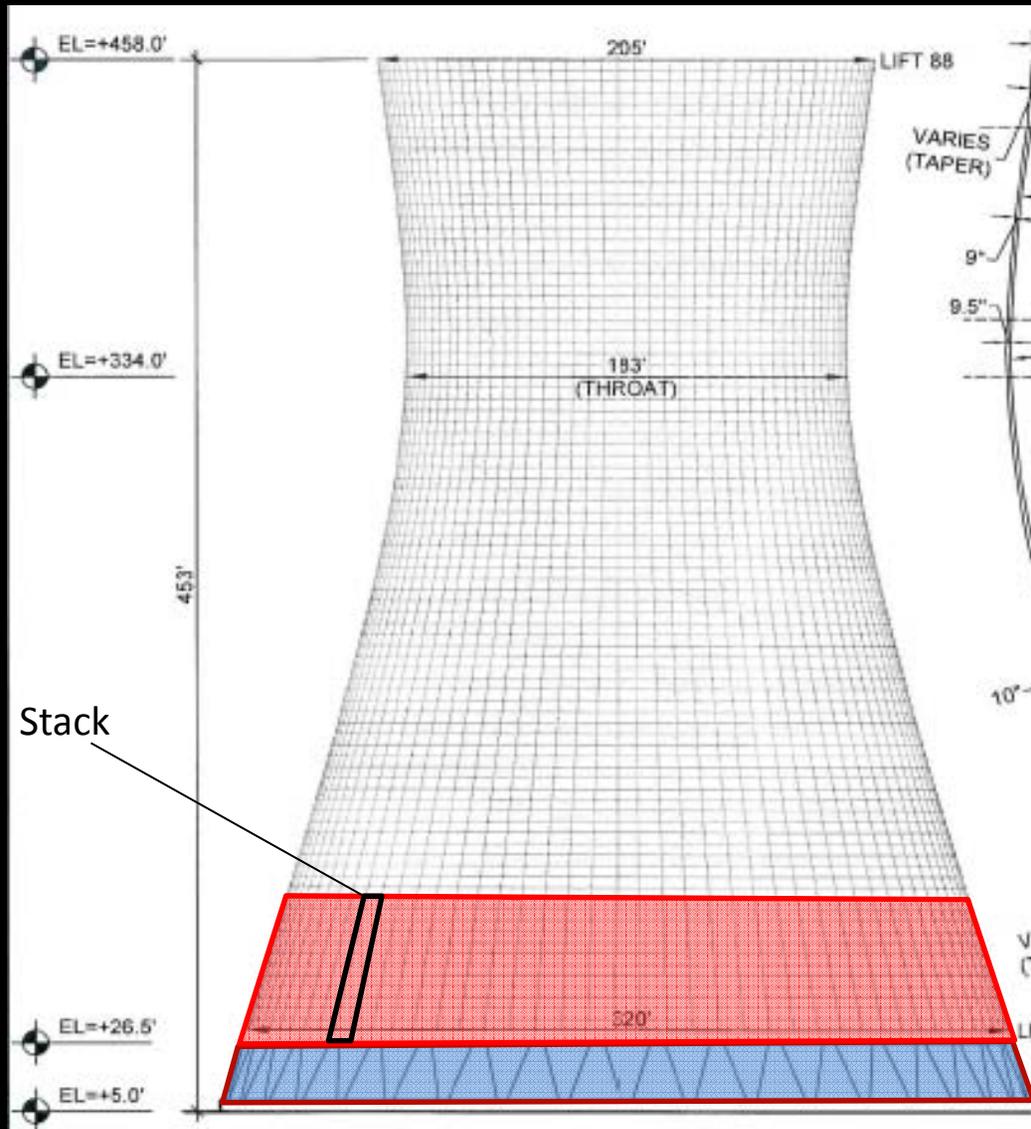
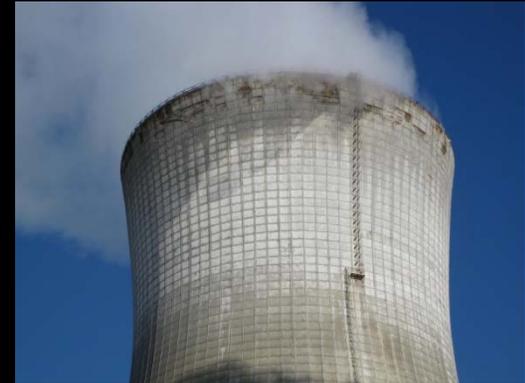
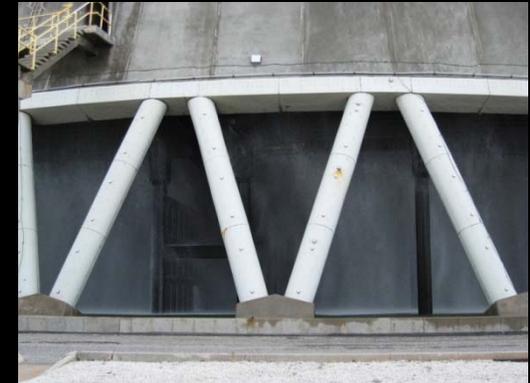
Tower Elevation

Lifts 1-12

Columns

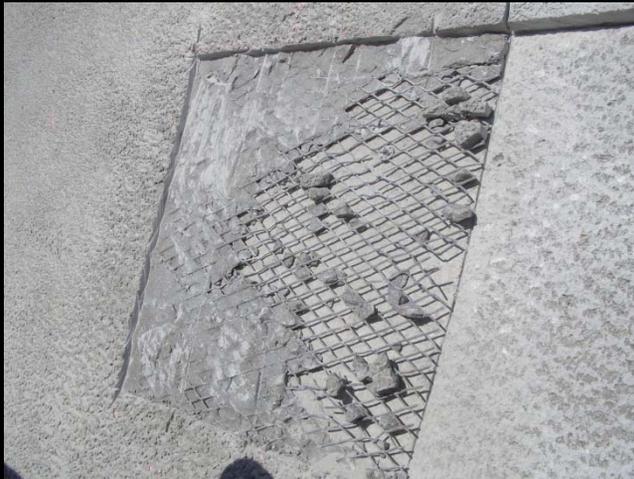
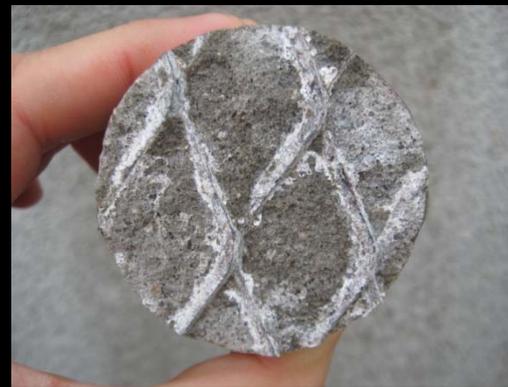
Passive CP System

- Zinc Mesh

- Electrically connected to reinforcement
- Guniting shotcrete overlay
- *Is the CP system working?*
- *Is the overlay sound?*

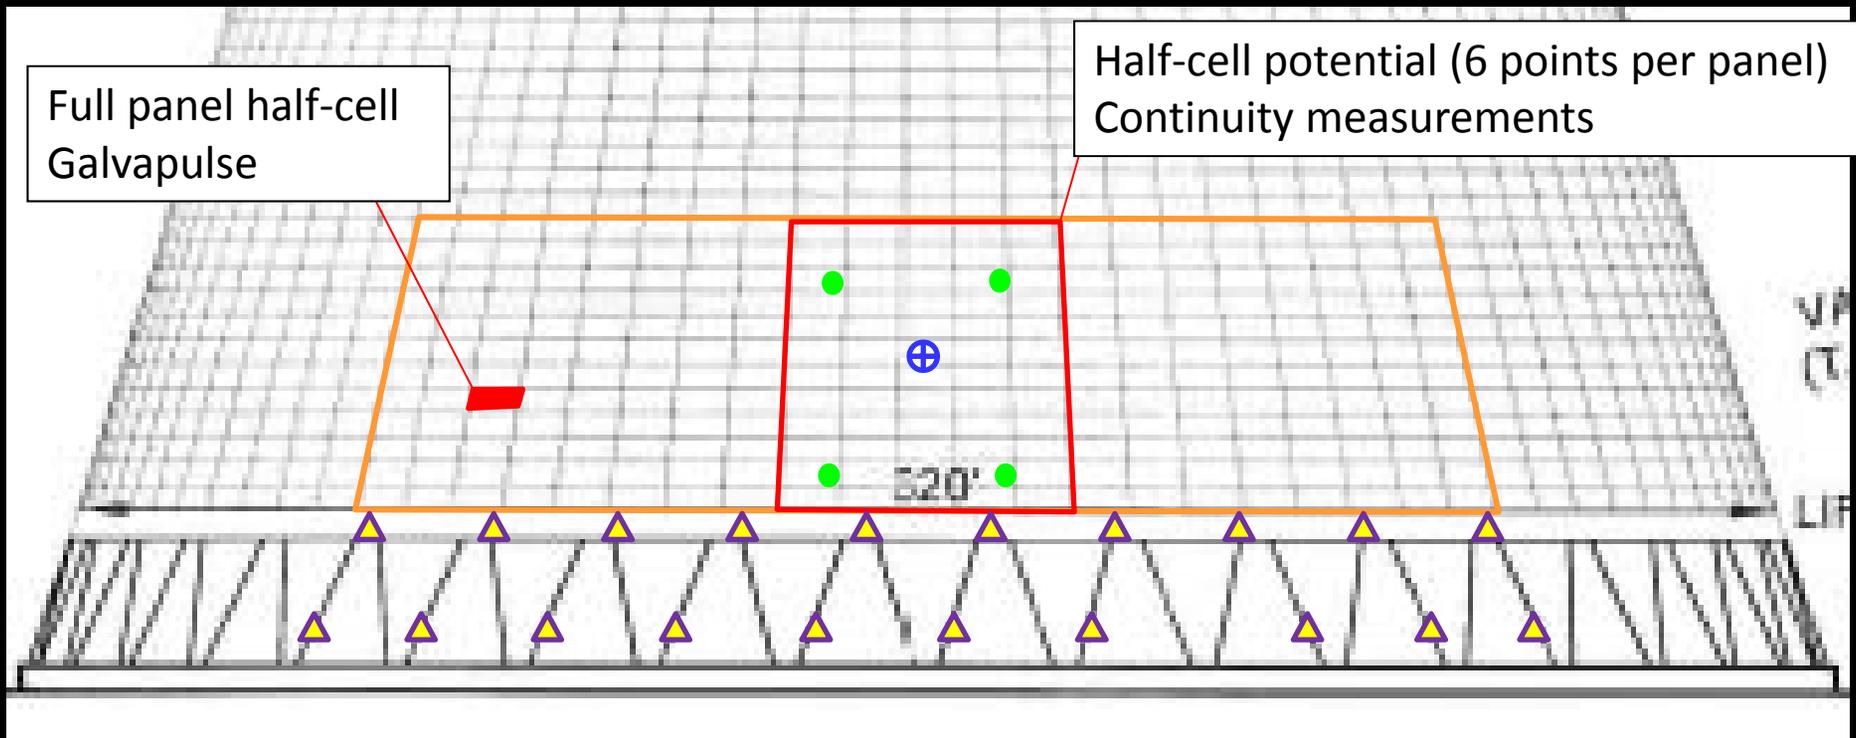
NDE Quadrant Summary

- ▲ Potential Readings Test
- ⊕ Bond Test
- Impulse-Response

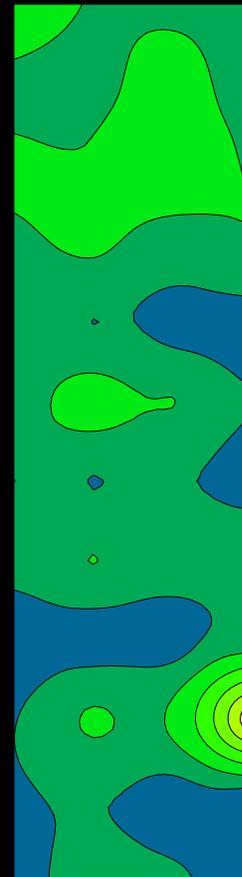
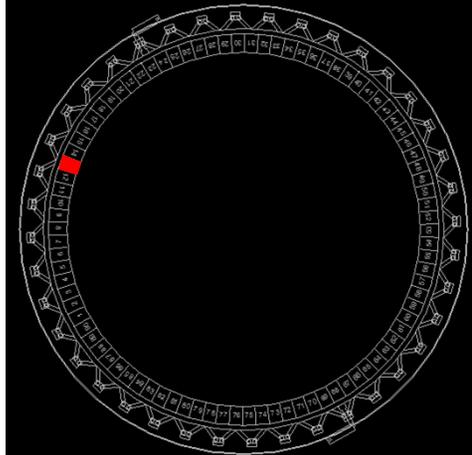
Impulse-response testing

- Grids over 60' of stack
- Low voids index values

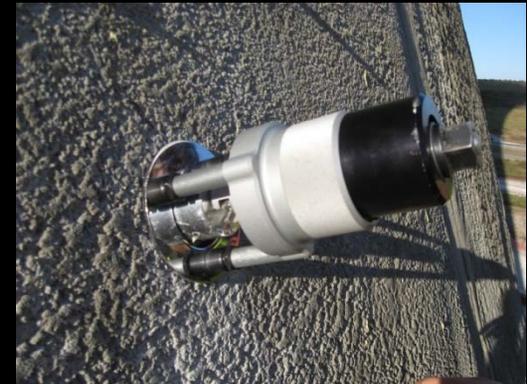
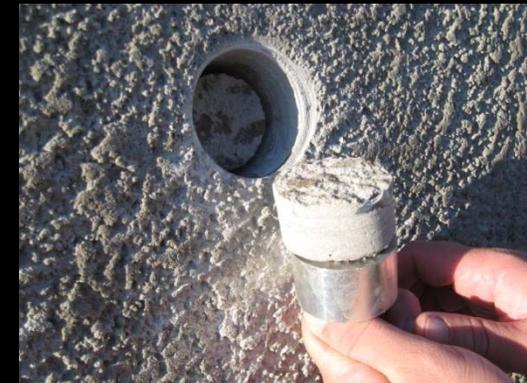
Supplemental testing

- Pull-off testing
 - Bond strength 25 psi – 150 psi
- Chloride Testing
 - High chlorides (~2,000 ppm)
